# Conceptual Design of MacMasters Beach Seawall - Coastal Processes, Design Conditions and Design Concepts

Authors:	David Wainwright
Prepared For	Central Coast Council
Version	REVISED FINAL
Date	27/03/2017

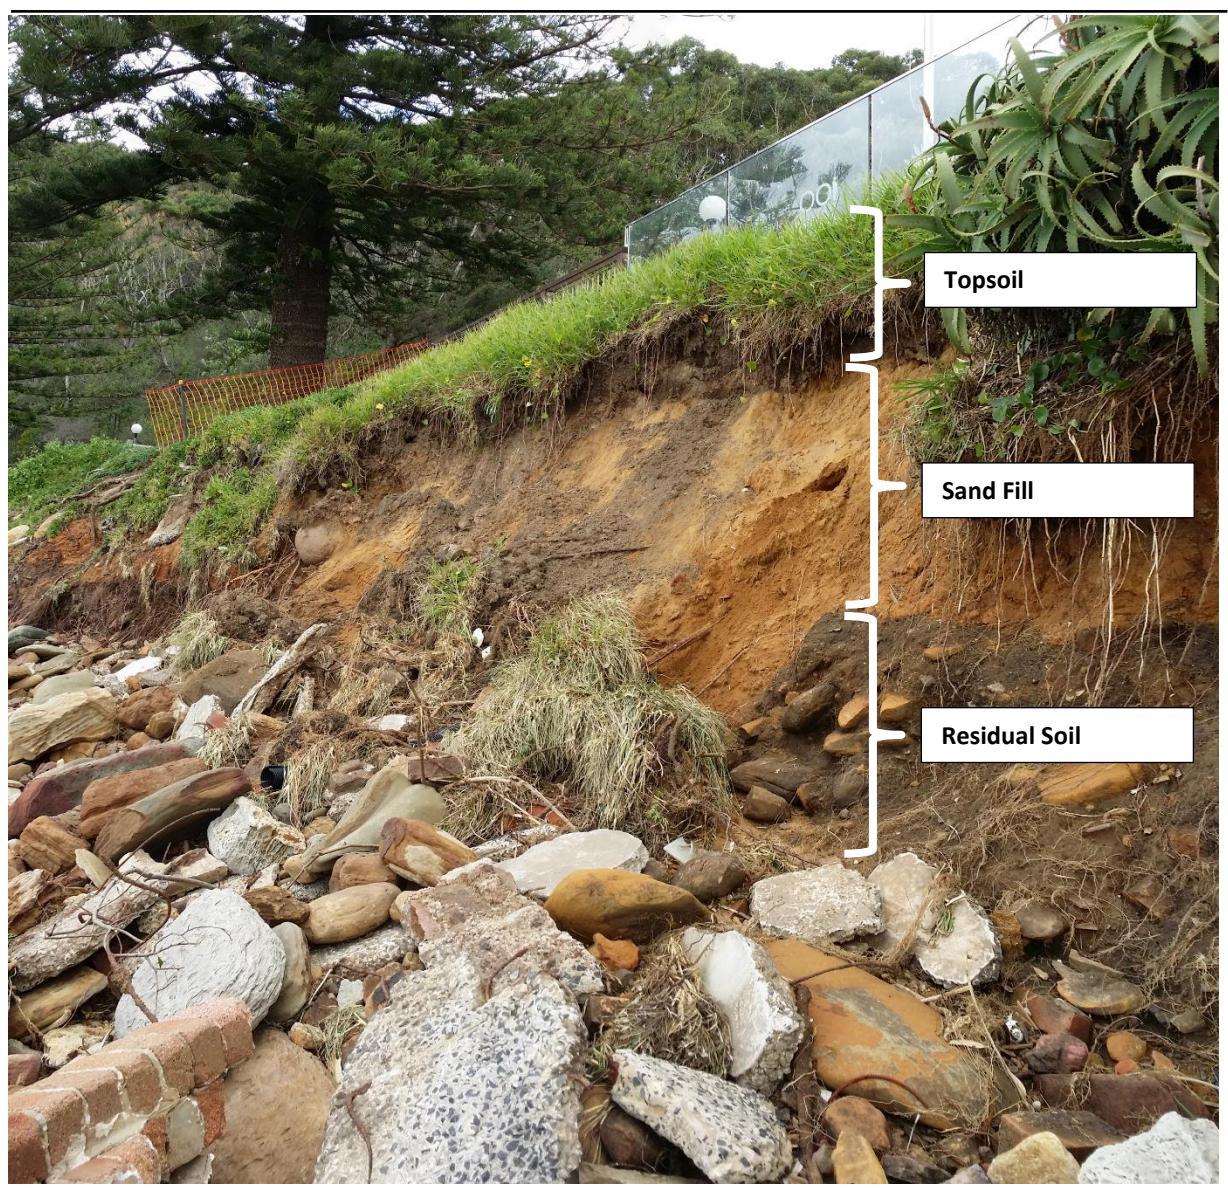
Figure 3 Eroded Foreshore, June 2016

During the storm, waves impacted directly against the base of the embankment. SLSC members have reported that the width of a grassed verge adjacent to the front edge of the dining area (i.e. seaward of the glass barrier visible in Figure 3) had receded by more than a metre during and immediately following the storm. SLSC members were concerned that further collapse was imminent and eventually placed bags filled with sand in front of the embankment. These can be seen in Appendix A (Figure A2).

Examination of the embankments soil stratigraphy reveals surface topsoil, underlain by loosely placed (i.e. uncompacted) sand which differs from the quartzose sand present on the beach face to the north of the site. The sand fill overlies what appears to be residual soil resulting from weathering of the underlying bedrock. Considering overall topography of the site, and the prevalence of smoothed Hawkesbury sandstone boulders across the foreshore (mixed with some building

The embankment at this location remains vulnerable, particularly if it is exposed to a further storm sufficiently severe to enable waves to attack the loosely placed, imported sand fill layer. Collapse of the embankment and parts of the outdoor dining area could foreseeably occur if the situation is not addressed. The sand bags placed by the SLSC do not provide a suitable level of protection against coastal erosion.

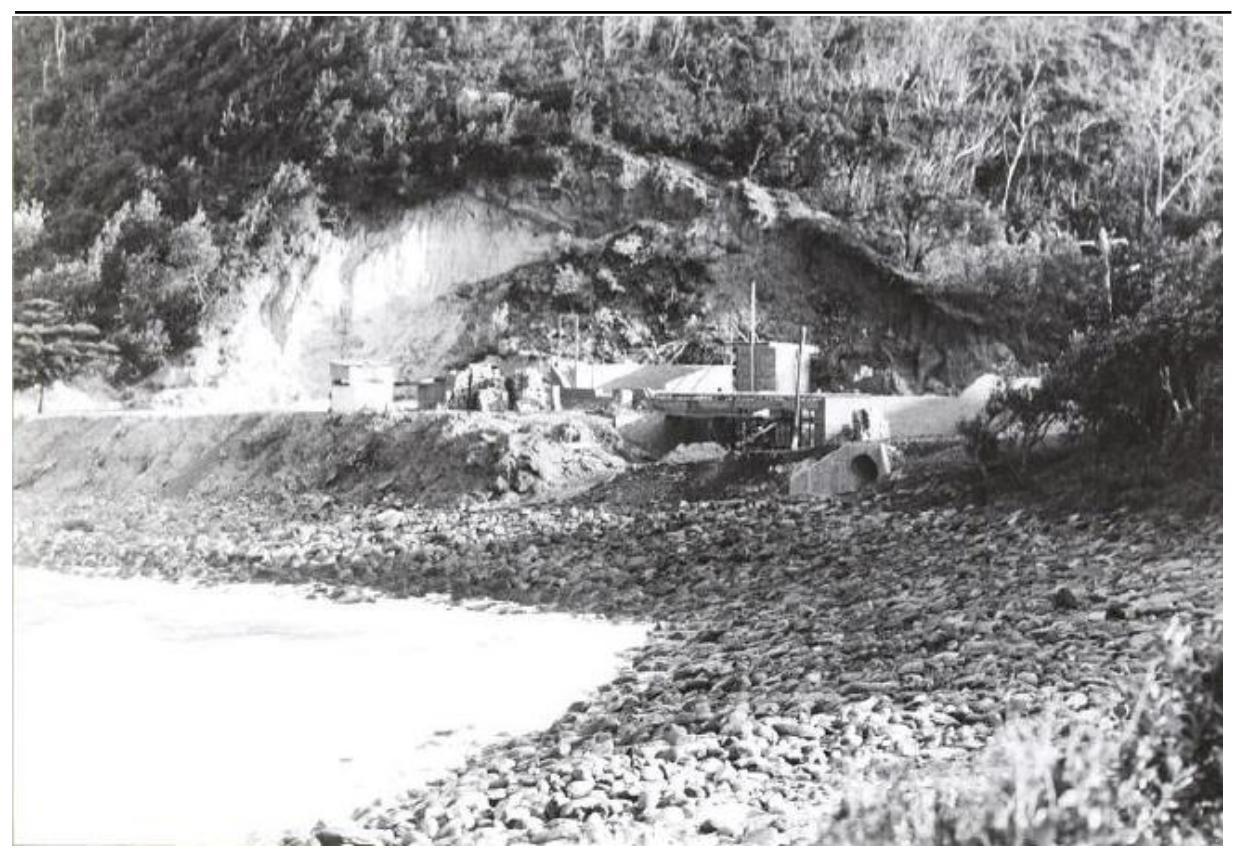
# Figure 4 Eroded Southern end of Beach in 1974, showing extent of protective cobble/boulder armour and construction of the SLSC building (from Worley Parsons, 2014)

It is likely that, near the SLSC building, the natural armour protection continues for some distance landward, below the filled platform. Worley Parsons (2014a) recommended that a subsurface investigation be undertaken to assist with refining an estimate of storm erosion demand. The field investigation undertaken as part of this study (see Appendix C) provides some information that may assist in this regard. Worley Parsons reported that, during the May-June 1974 storm sequence, wave run-up overtopped the "dune crest" at the southern end of the Beach and that the lower part of SLSC building was inundated. Considering the elevations shown in Figure 1 and that Worley Parsons calculate a design wave run-up level of 6.0m AHD, it appears that this "lower part" refers to the storage area immediately landward of the boat ramp. At present, the paved outdoor dining area fronting most of the SLSC is unlikely to be inundated by anything but the most extreme storms (i.e. larger than the 1 in 100-year storm).

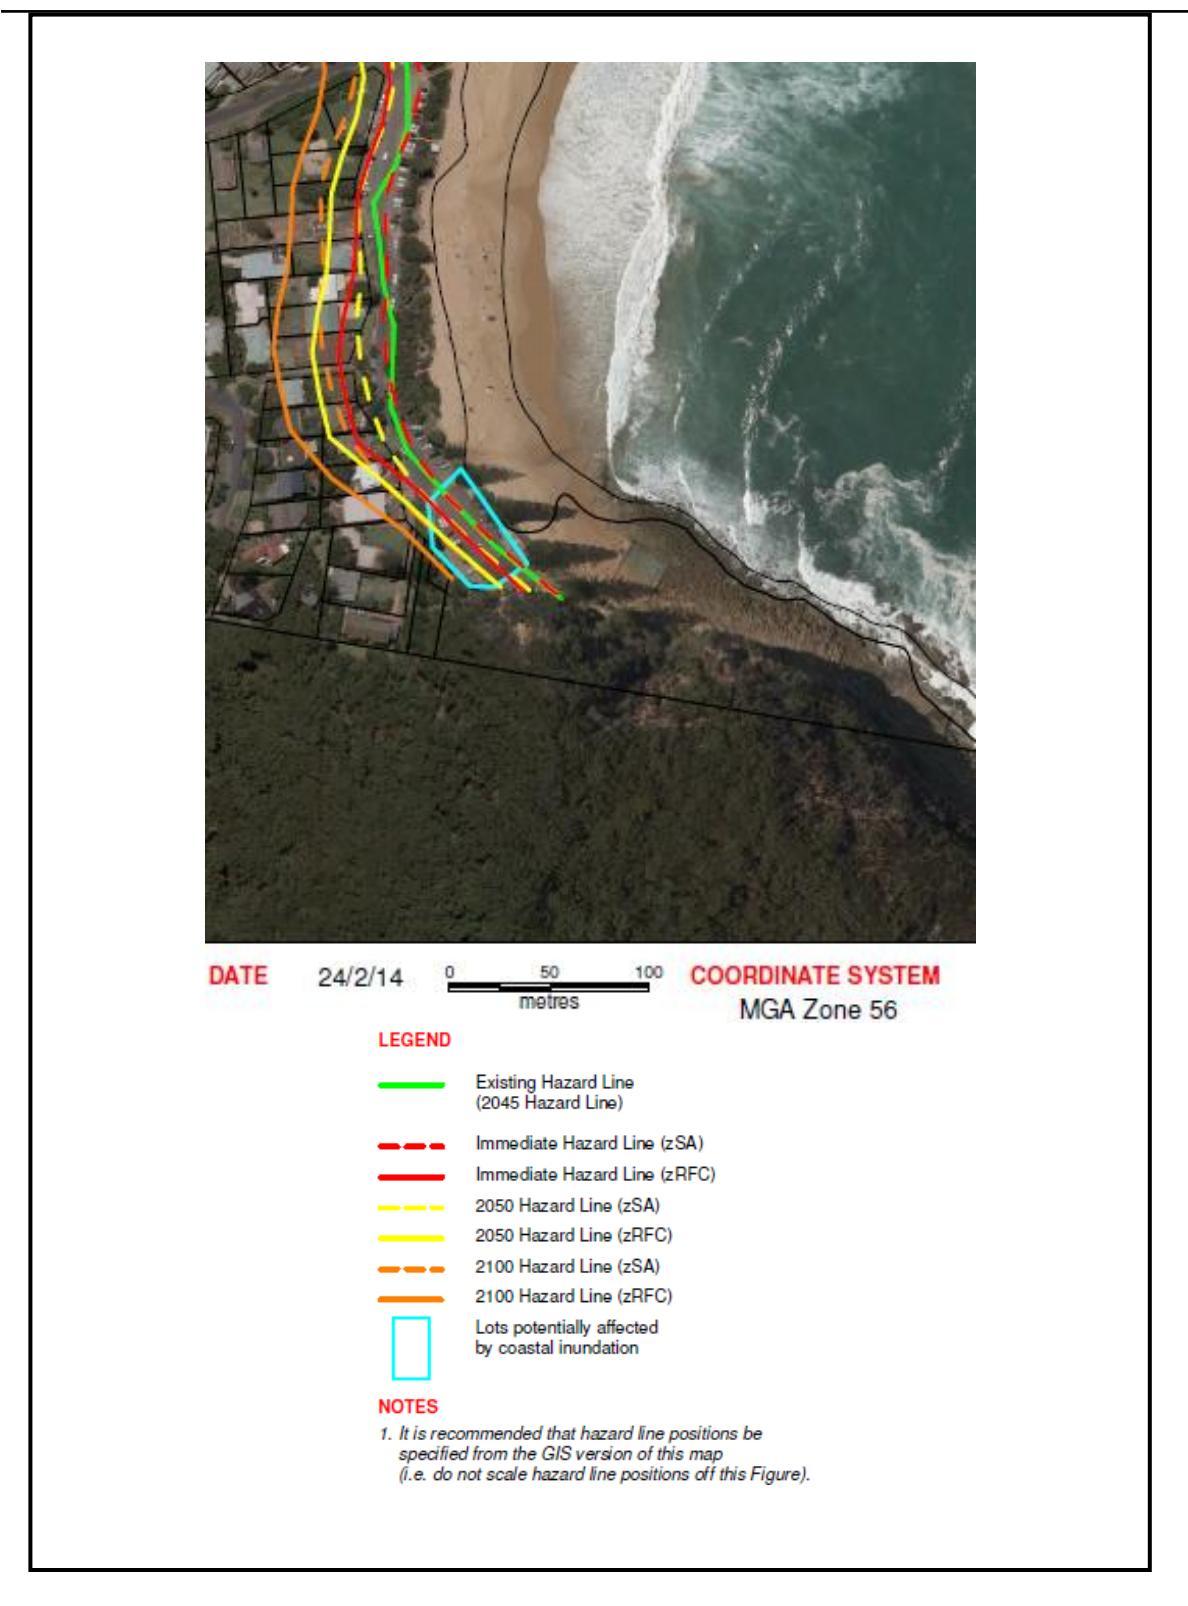
The resulting mapped hazard line for the southern end of MacMasters Beach is reproduced in Figure 5. Therein, the SLSC building is subject to 'immediate' coastal hazards, meaning that the building could be destabilised during a rare but foreseeable coastal storm, depending on how the building is founded.

#### Figure 5 Hazard Lines for Southern MacMasters Beach, as determined by Worley Parsons (extract from Worley Parsons(2014b))

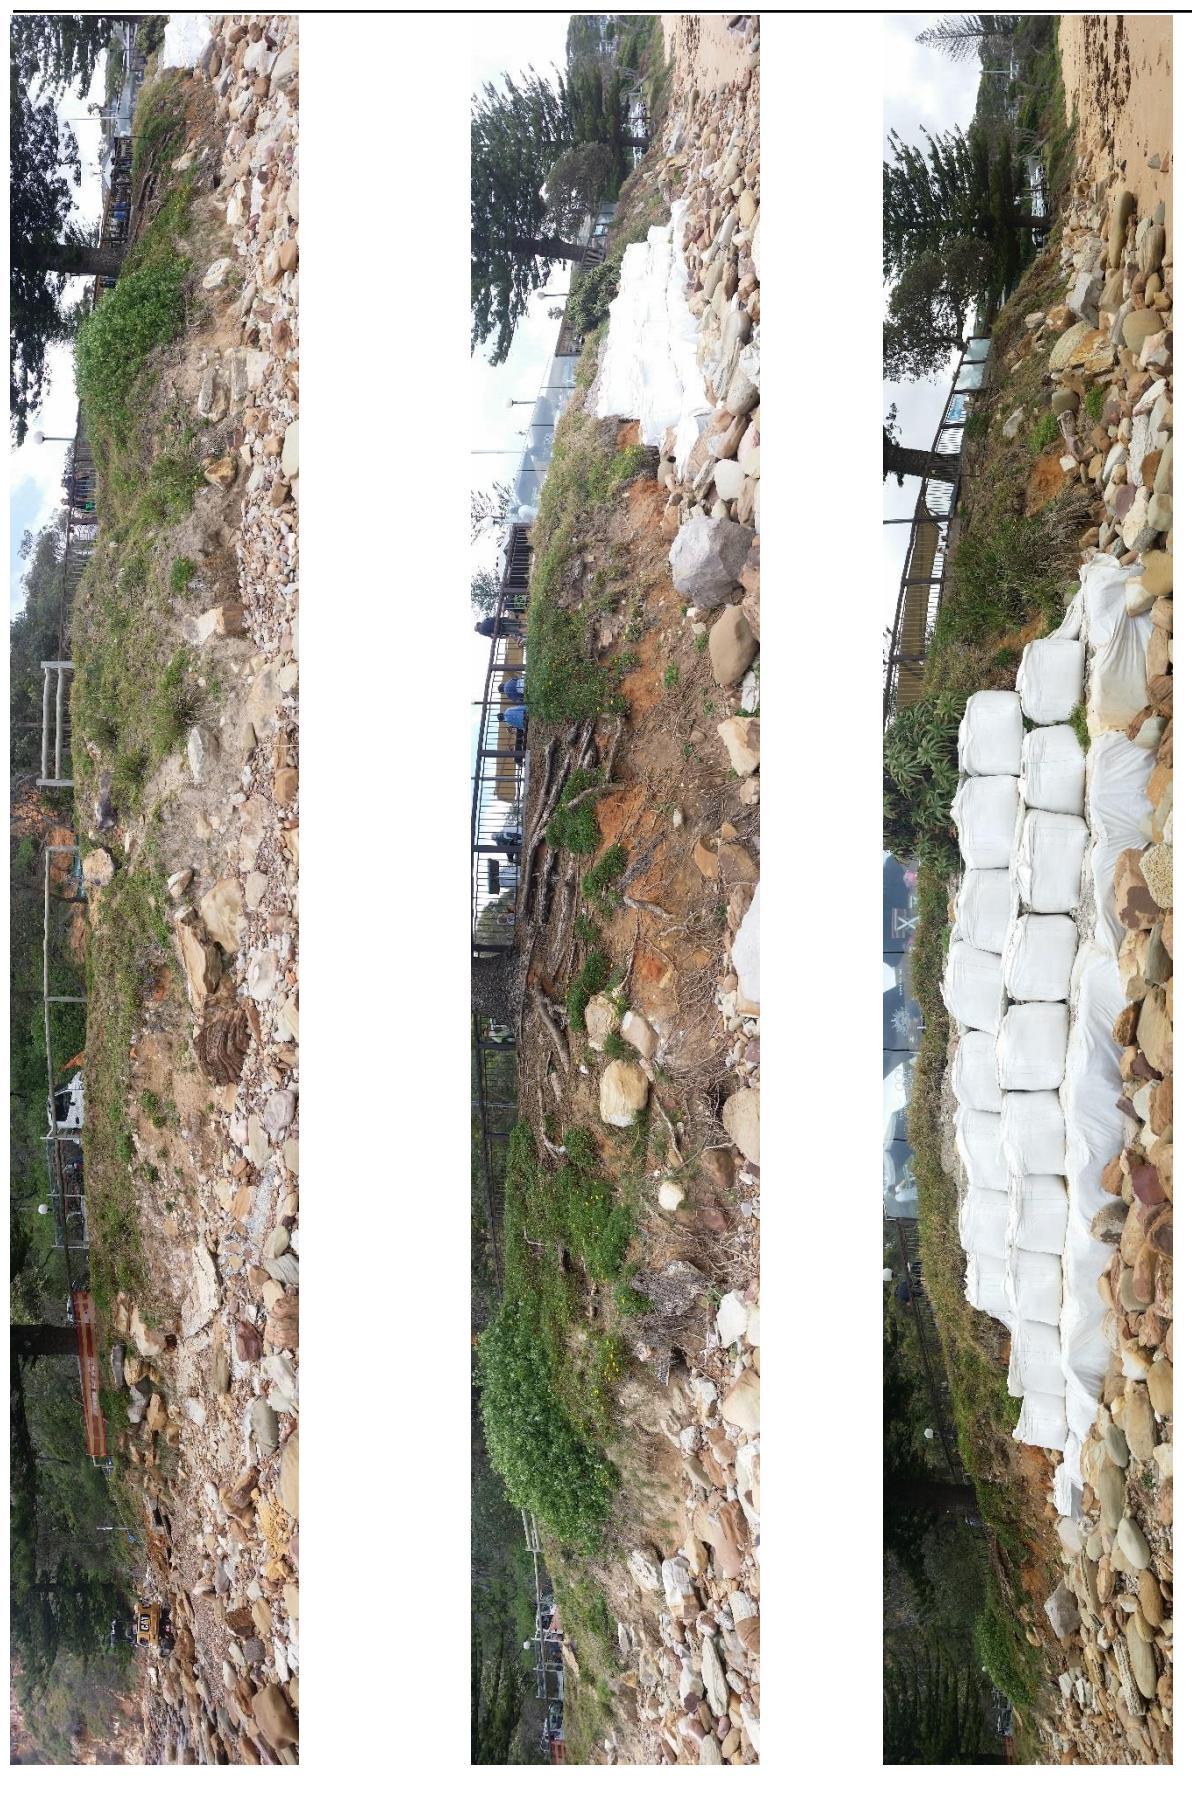
Figure A1 Panoramic Capture of Foreshore, 30<sup>th</sup> November, 2016 (Left most images are of the southernmost end of the foreshore of interest)

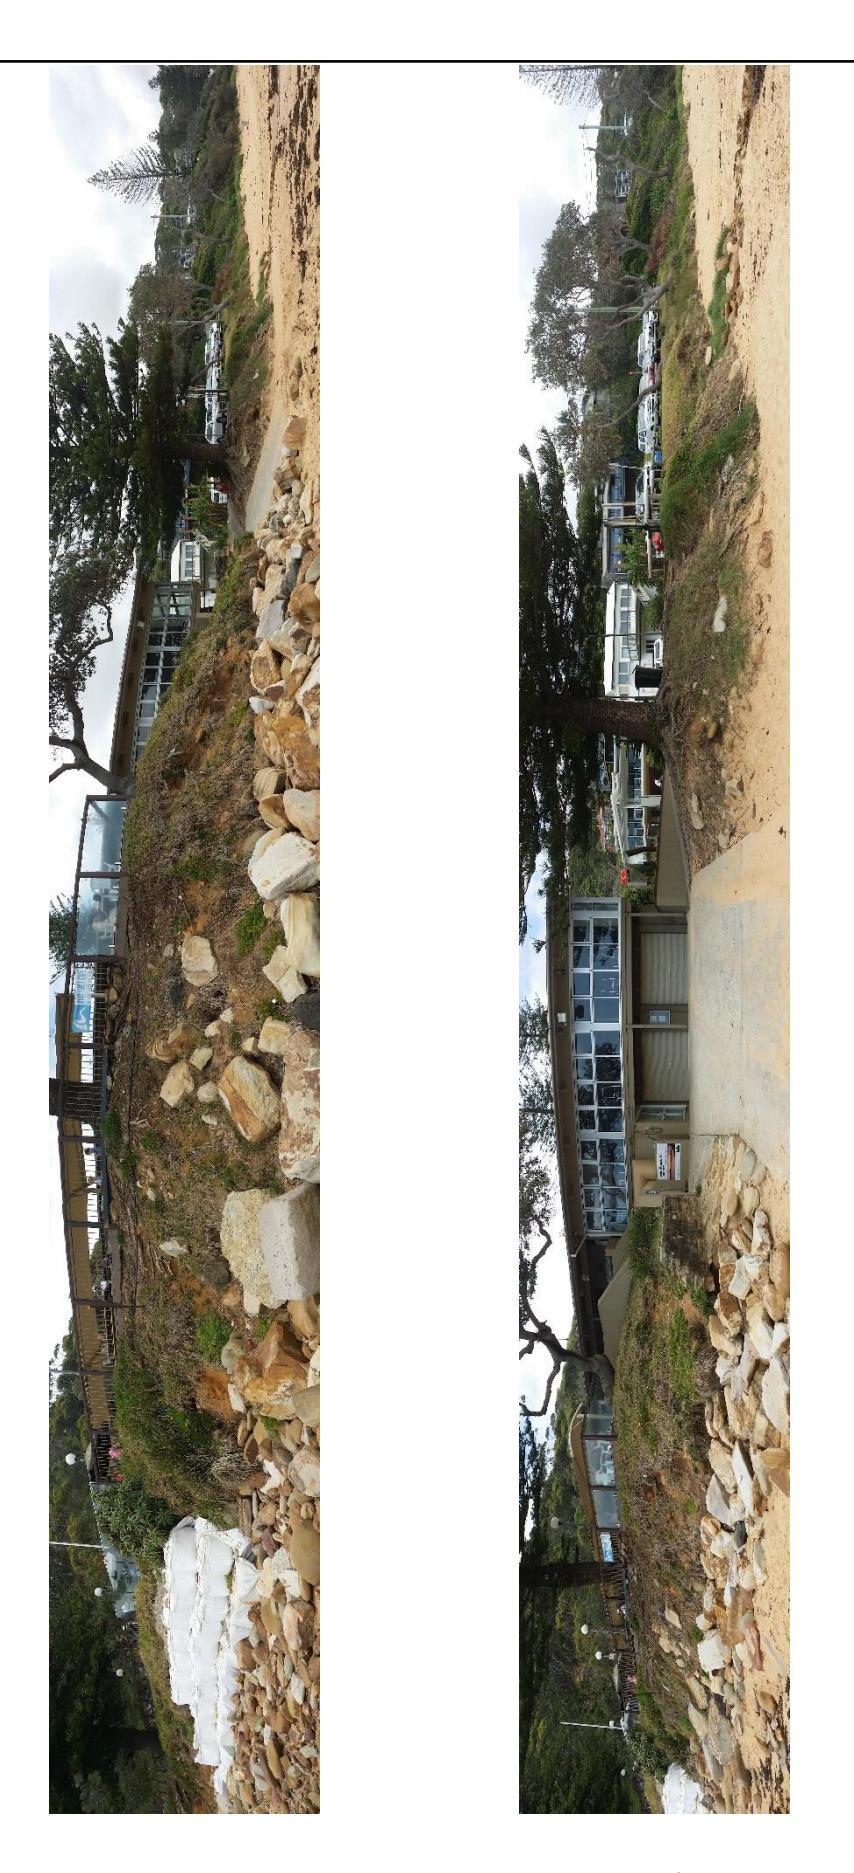
Figure A2 Panoramic Capture of Foreshore, 30<sup>th</sup> November, 2016 (Right most image is of the northernmost end of the foreshore of interest)

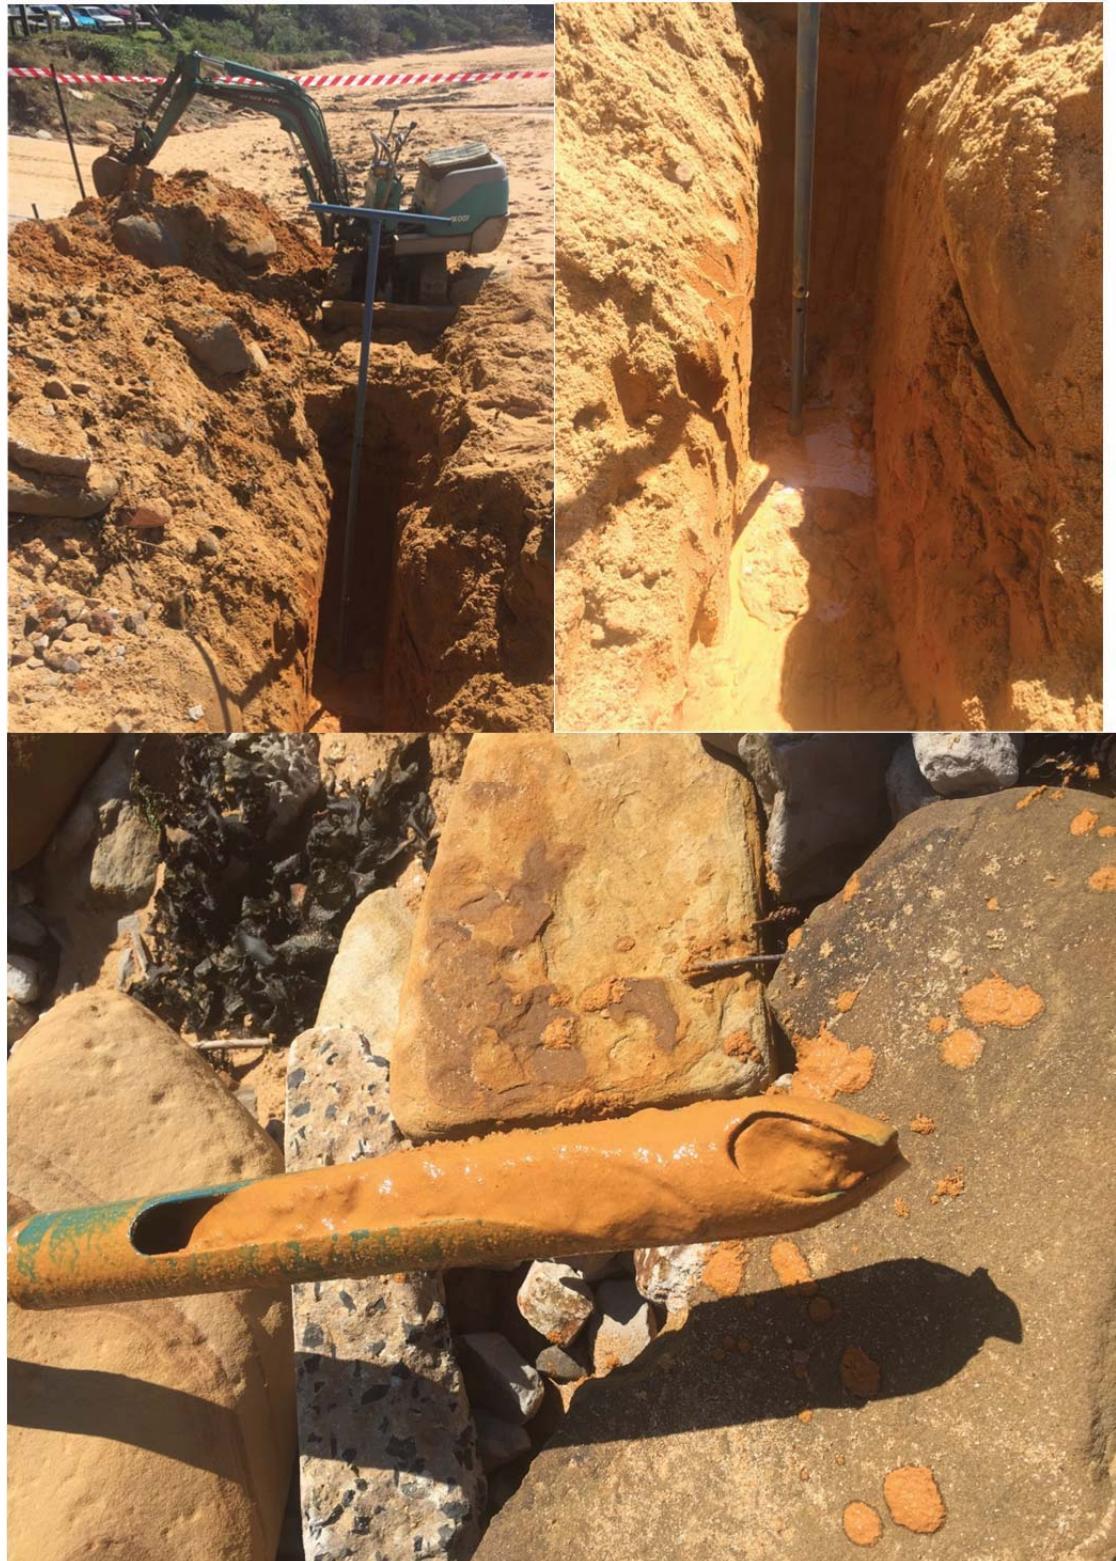
Figure 5 - Photographs from TP1

Test pitting was undertaken at 4 locations along of alignment of the toe of the proposed structure (Figure 4). It was found that the boulders / cobbles do not typically lie directly on an underlying bedrock layer. Rather, the boulders are poised on a layer of silty sand of the same composition as material that was used for the bench of fill that supports the clubhouse. Photographs of test pits TP1 to TP4 are shown in Figures 5 to 8 below. Note that bedrock, below the silty sand layer, was encountered only at TP2 and TP3 (it was below the ~ 3m reach of the excavator at the remaining locations).

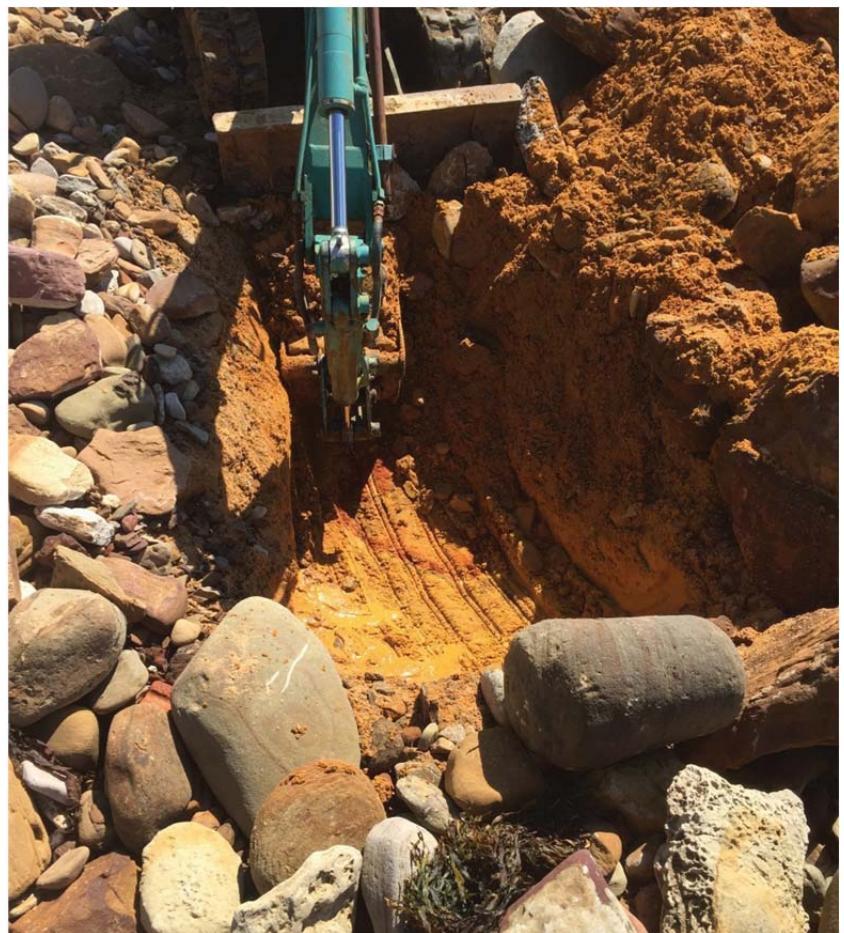
Figure 6 – Bedrock encountered at TP2

Where the wave cut platform extends close to the surface (eg TP2), it makes sense that the toe of the proposed wall is founded on bedrock. However, there are indications that the bedrock level may vary considerably, to depths that are unnecessary to excavate down to. The design must therefore be flexible to allow founding of the toe on a depth of orange silty sand encountered across the site.

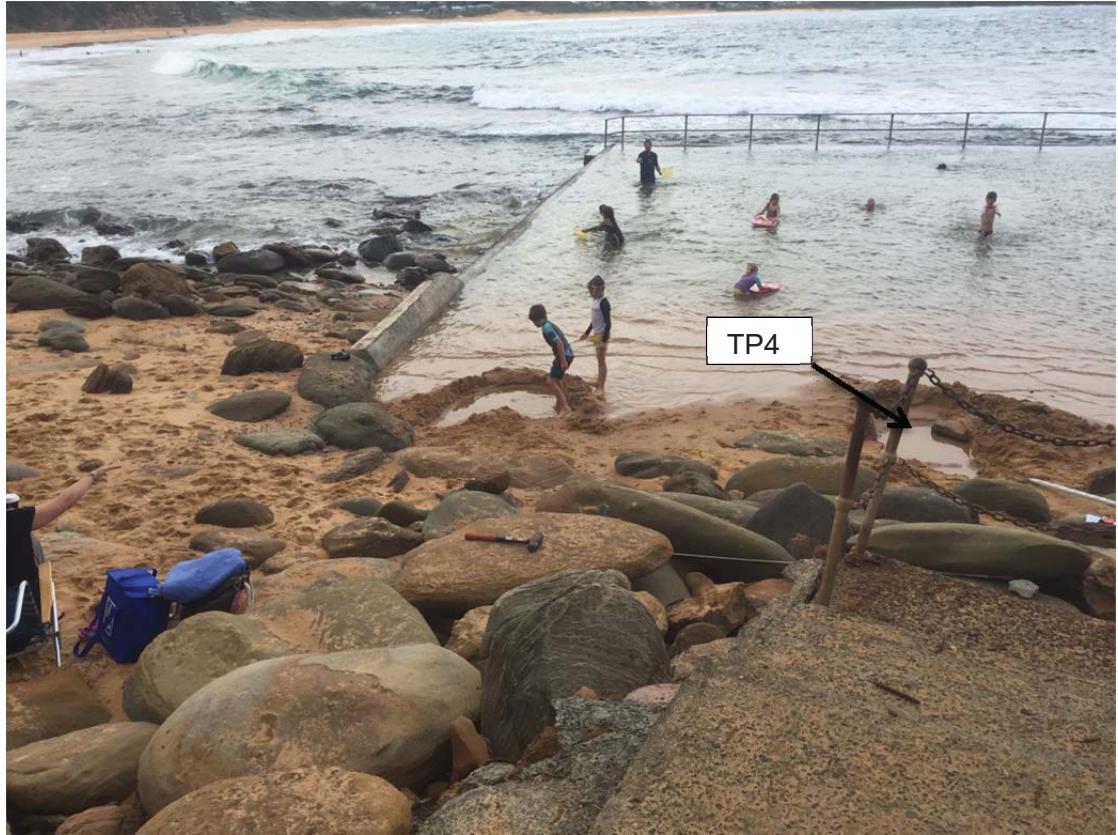
Figure 8 – The landward edge of the concrete bed of the pool was found to intersect bedrock.

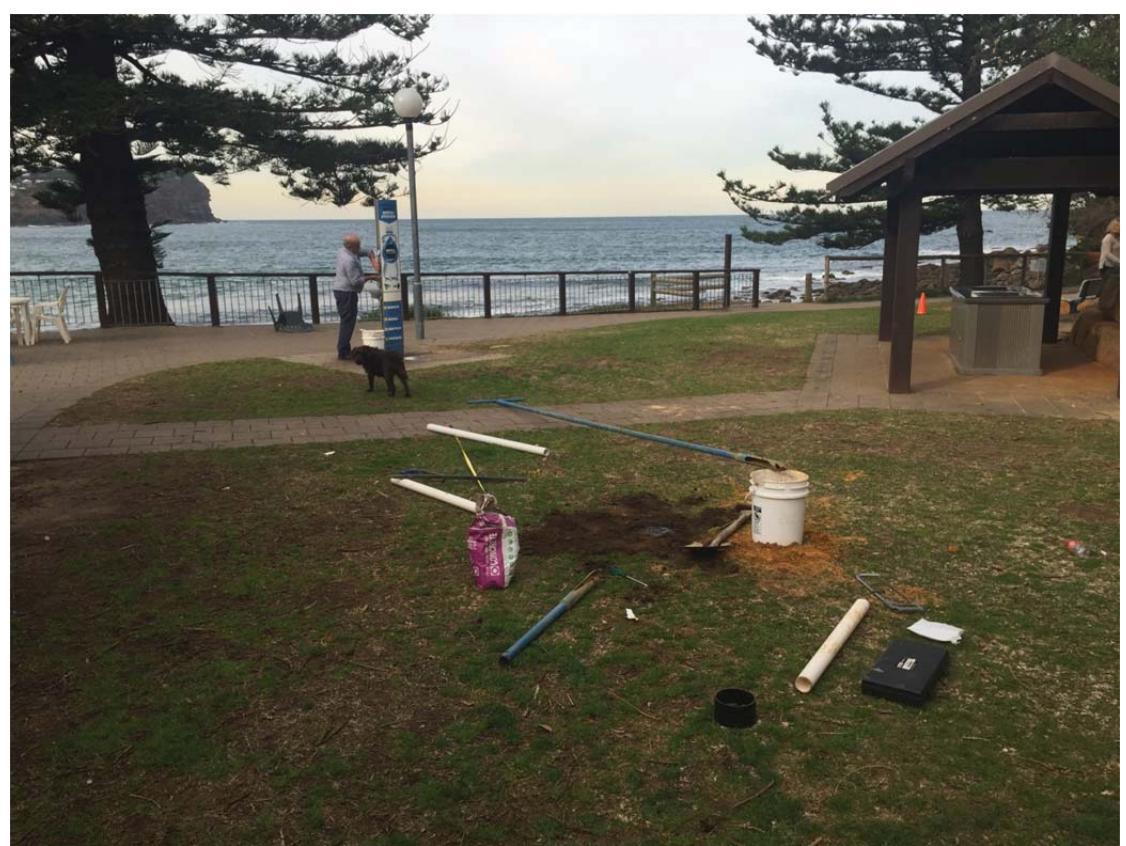
The borehole adjacent to the clubhouse (BH1) was augered to 4.5 m below ground level, encountering the same orange coloured silty sand throughout its depth. Its location is shown in Figure 9. A screened standpipe piezometer was installed in the bore and, despite the materials appearing damp during excavation, there was no standing water observed in the standpipe, even by the following day.

Figure 9 – Location of bore augered to 4.5 m depth.

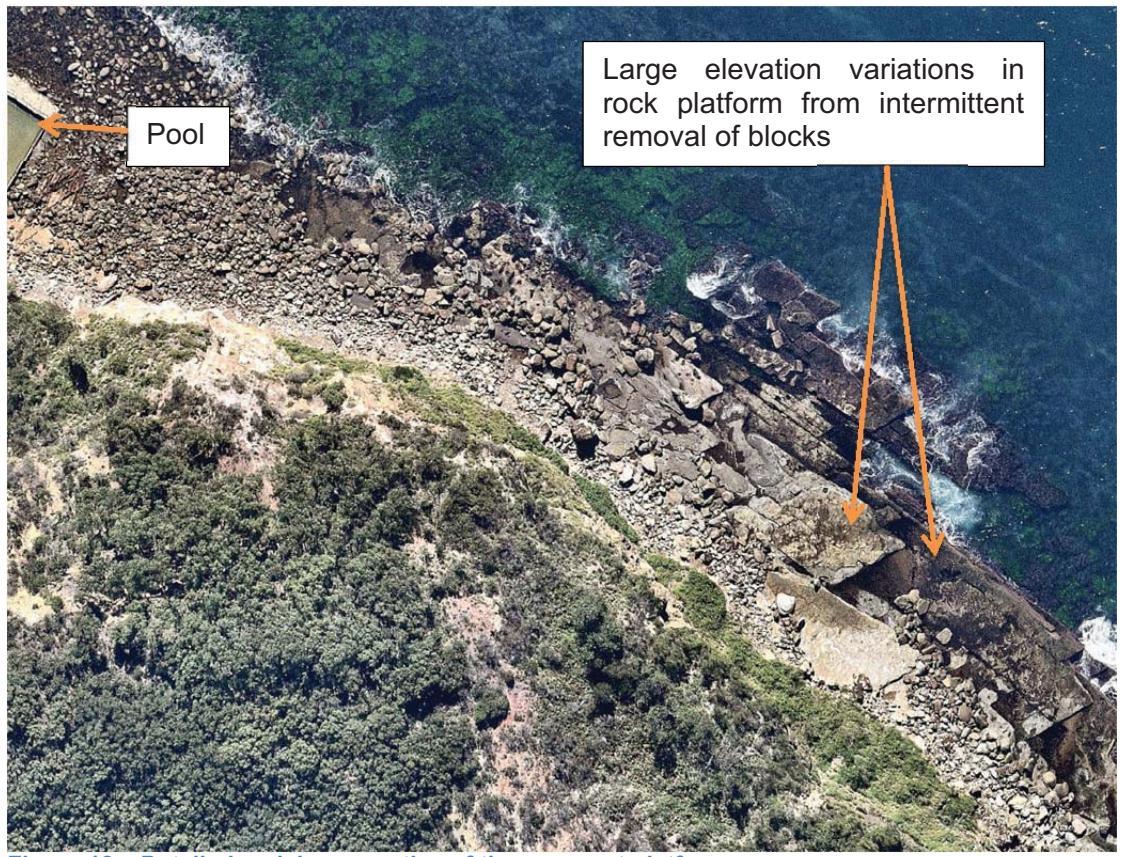
Although the bedrock was inconsistently observed in test pit locations, it is maintained that the majority of the proposed wall is underlain by bedrock of a wavecut platform. It is anticipated that the wave-cut platform would be around 0 to +1 m AHD, but the significant localised variation may be incurred by shifting of large blocks of bedrock, along fracture and bedding lines under historical wave action. This can be observed, for instance, at the rock platform east of the pool (Figure 12).

Figure 12 – Detailed aerial perspective of the wave-cut platform

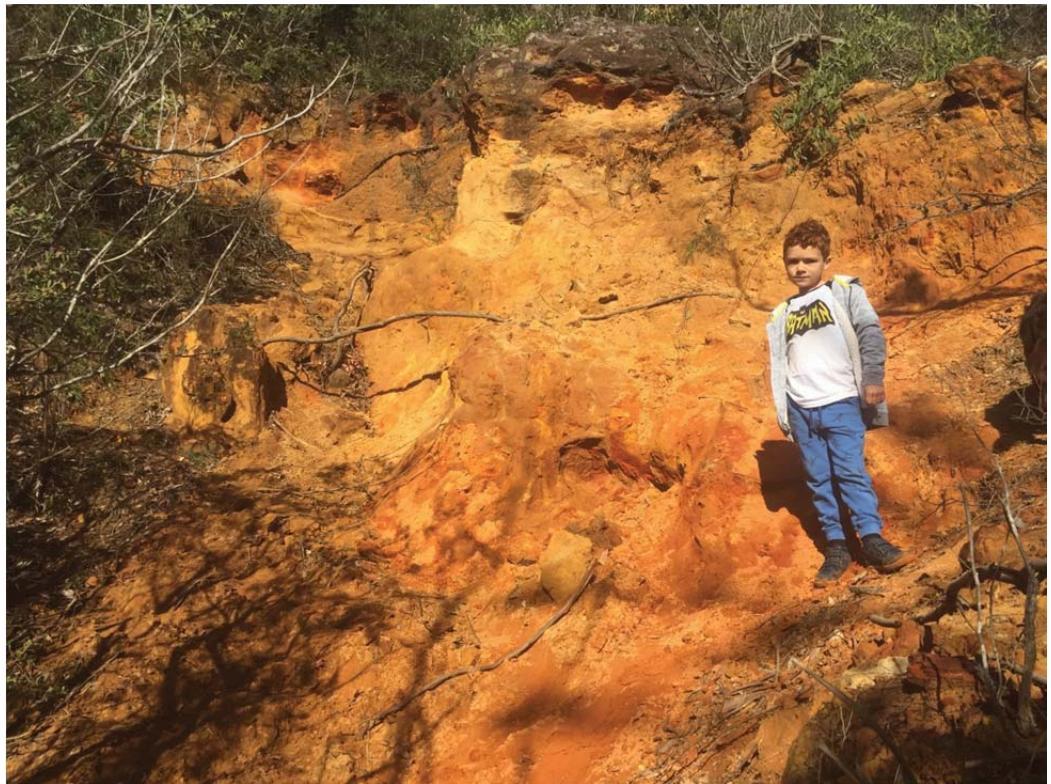
The orange silty sand found in BH1 and in all test pits underneath the boulders is also observed to cover the forested slopes to the south west of the clubhouse (Figure 13). This material is distinguished from local 'beach sand', aside from its orange colour, by being slightly silty (<20%) and including some or a trace of clay (perhaps ~ 5%).

Figure 13 – Insitu residual orange silty sand
