The 80 year battle with nature:

A short history of coastal management at Ettalong and Umina

Warren Brown
Coastal & Estuary Officer
warren.brown@centralcoast.nsw.gov.au

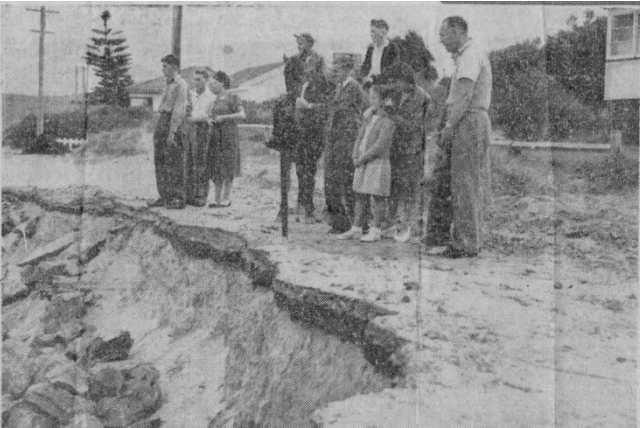
WAVES have washed away four feet of this Ettalong road since last Wednesday. People living near the beach fear that their homes will be undermined.

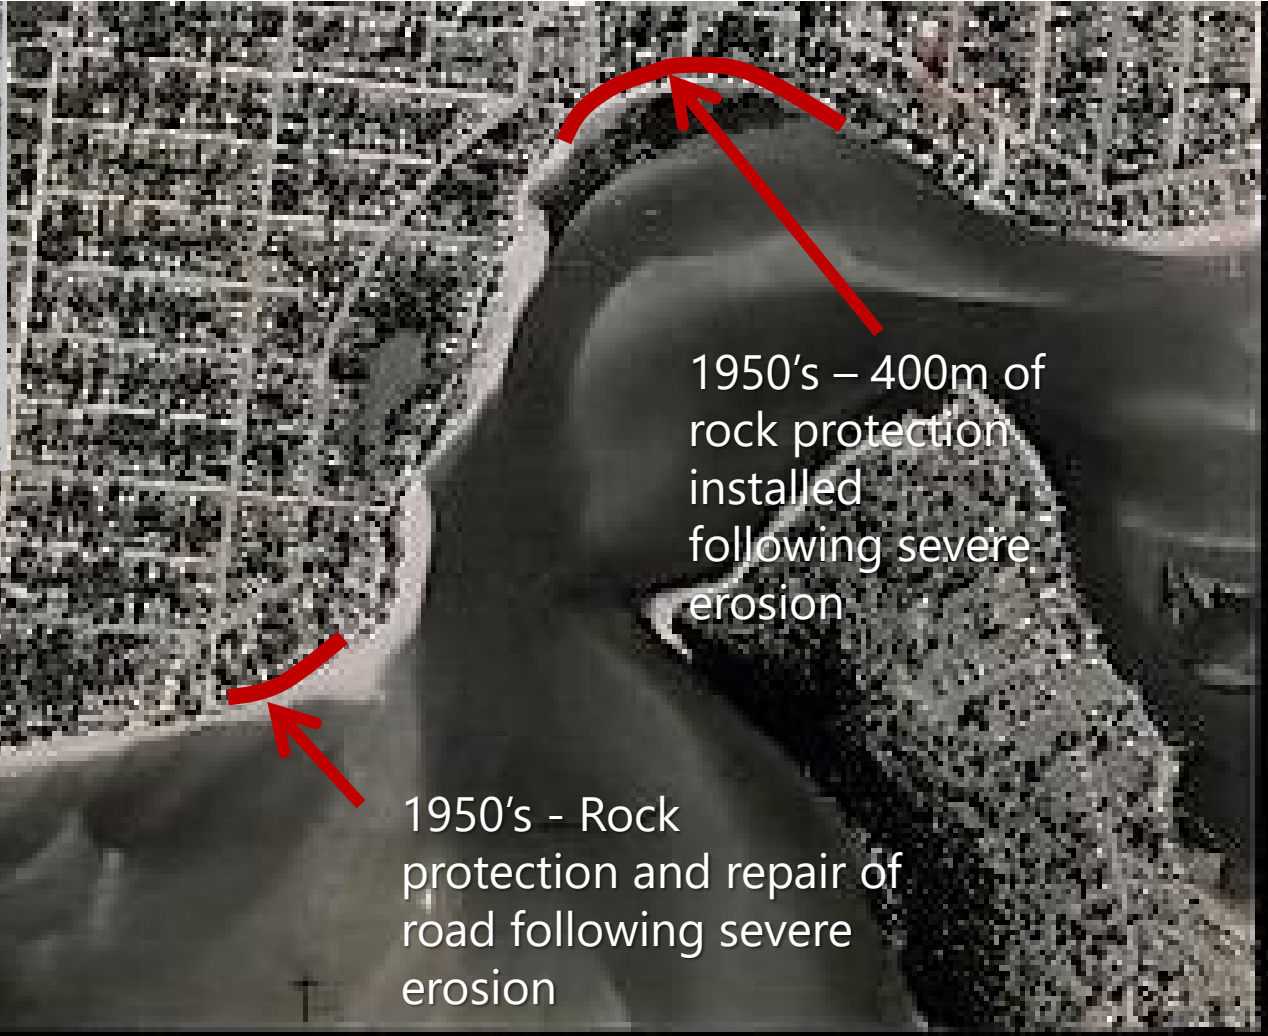
Aerial – 1954

1950's – 400m of rock protection installed following severe erosion

1950's - Rock protection and repair of road following severe erosion

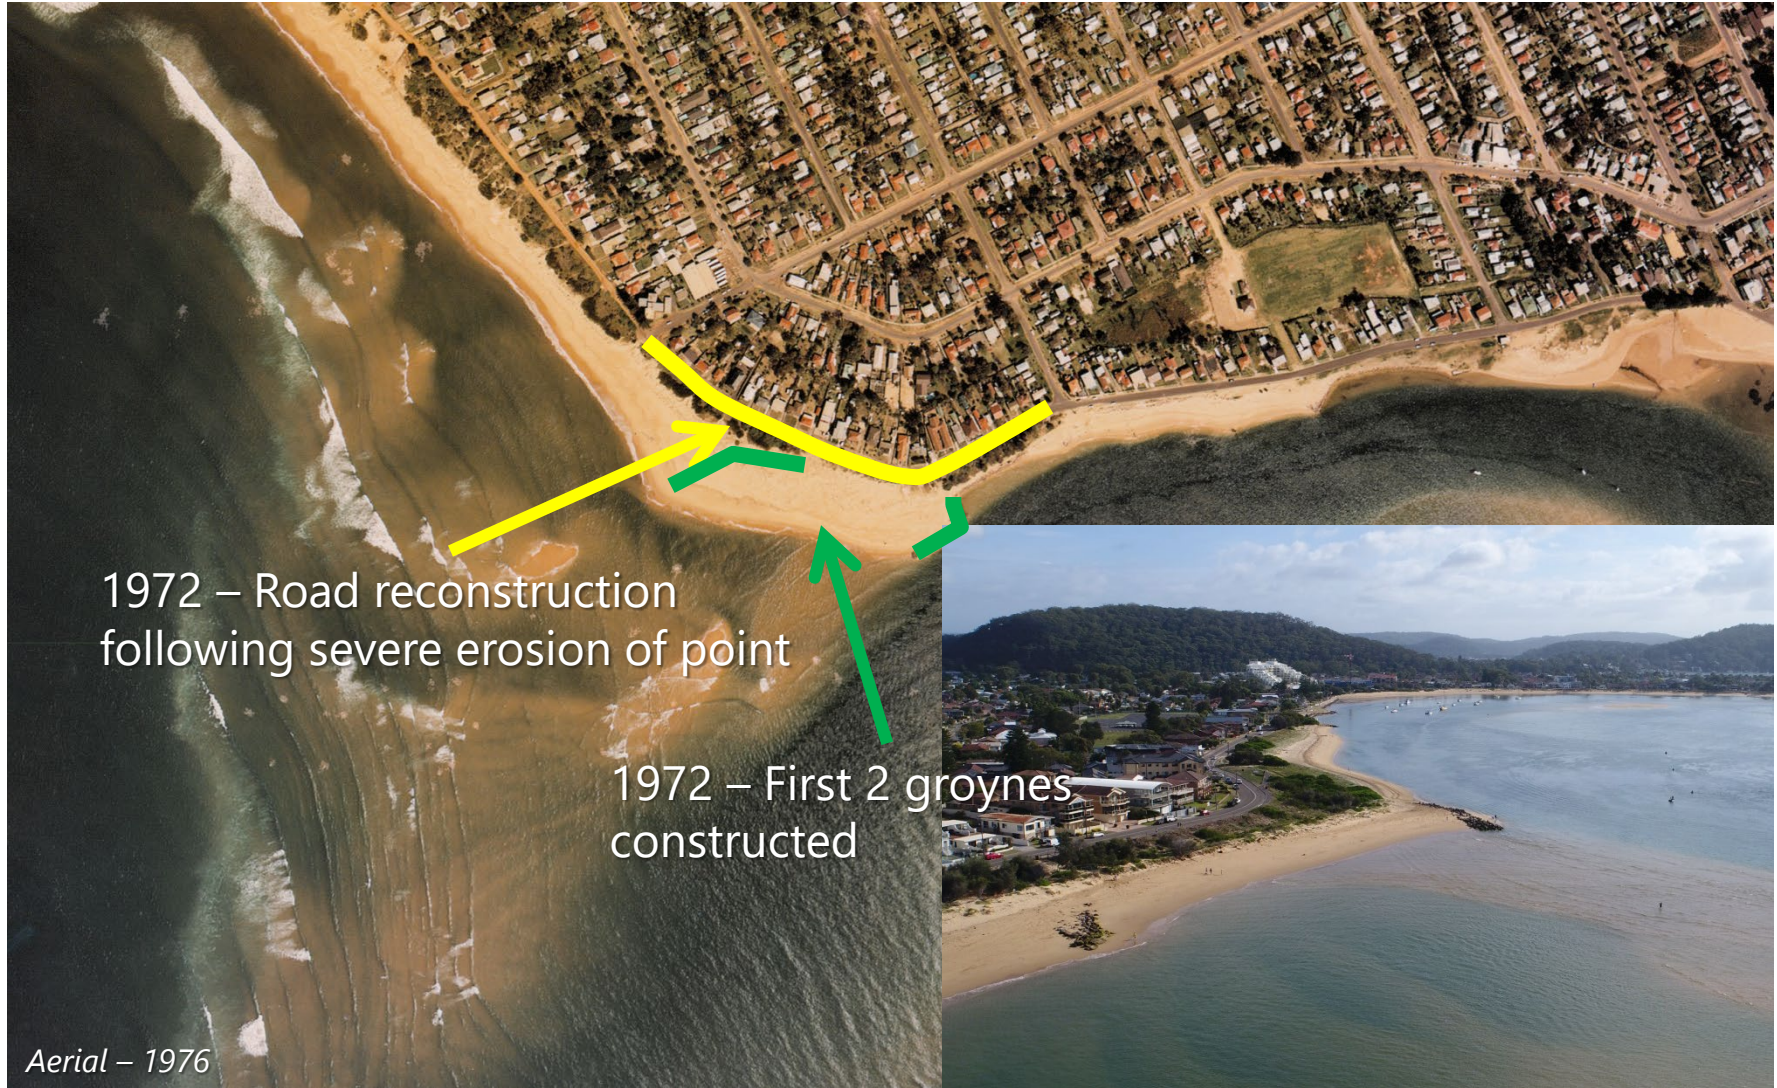
Coastal Protection Works – 1970's

1972 – Road reconstruction following severe erosion of point

1972 – First 2 groynes constructed

Aerial – 1976

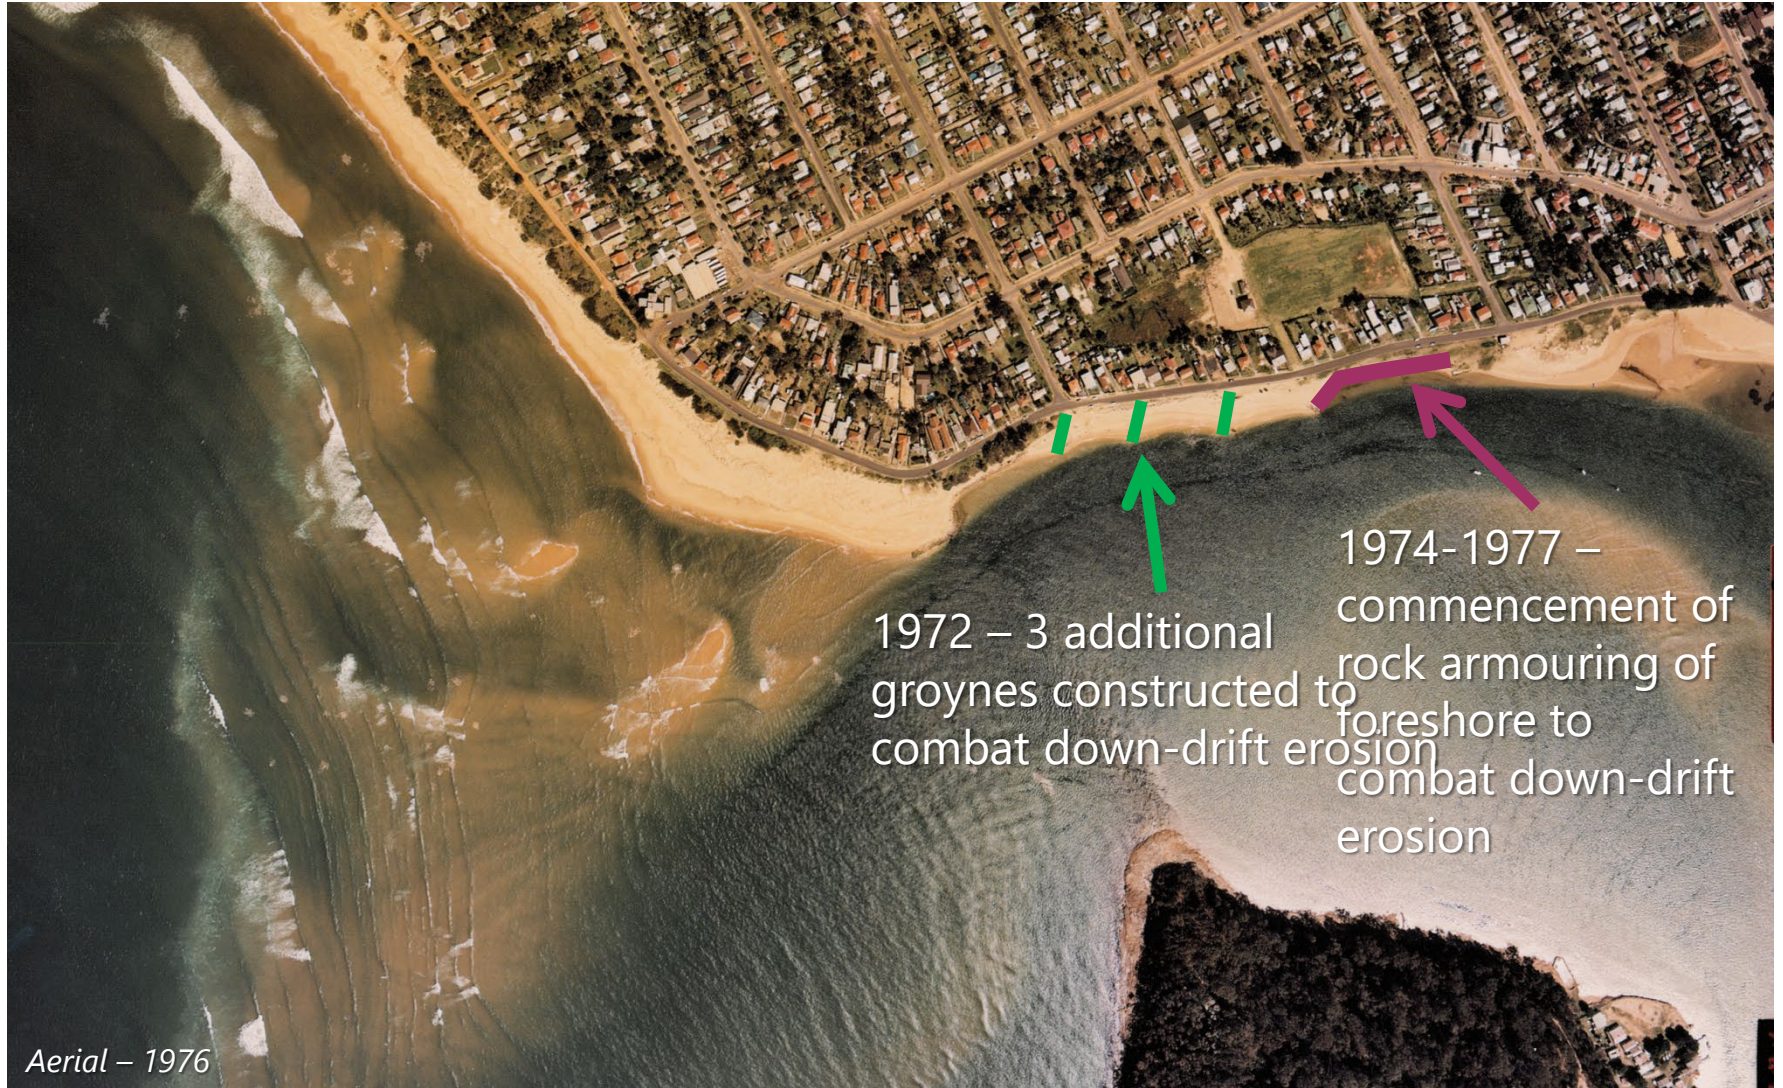
Coastal Protection Works – 1970's

Aerial – 1976

1972 – 3 additional groyne structures constructed to combat down-drift erosion

1974-1977 – commencement of rock armouring of foreshore to combat down-drift erosion

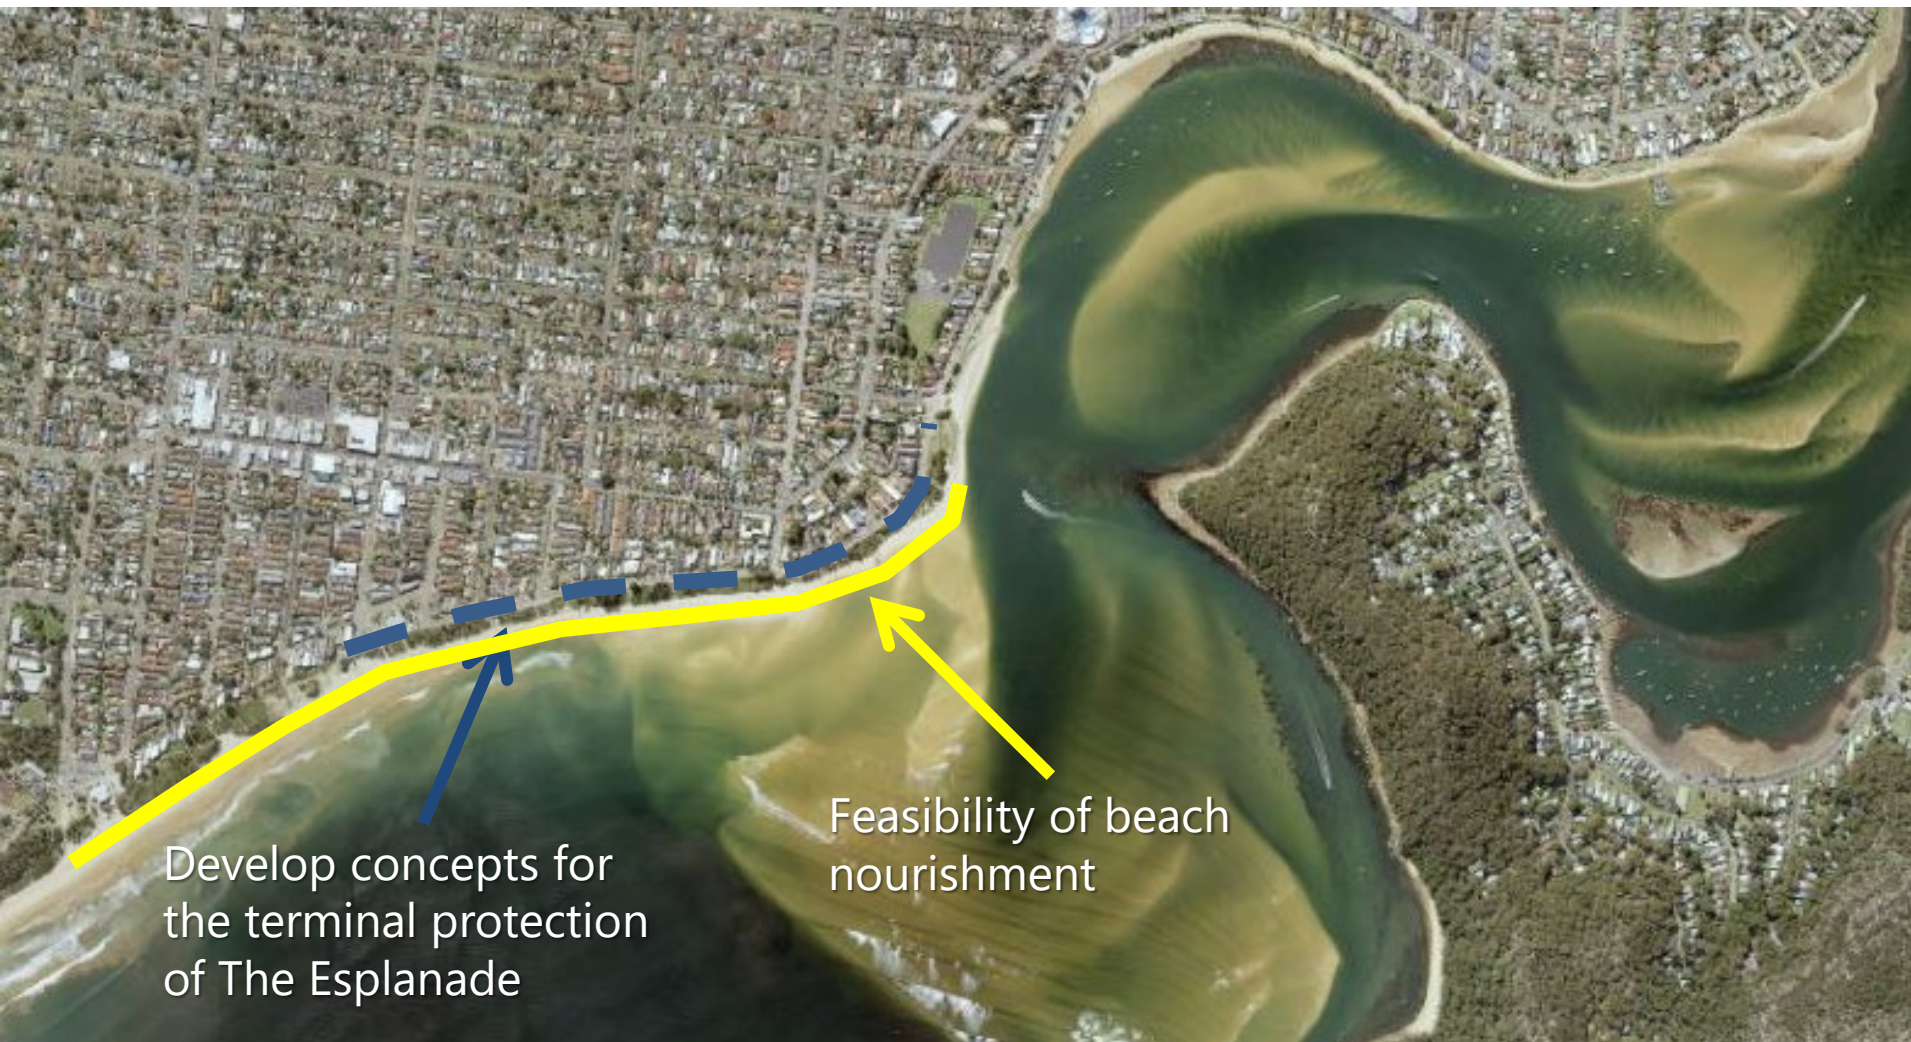
Umina-Ocean Beach Erosion Management Strategy

Develop concepts for the terminal protection of The Esplanade

Feasibility of beach nourishment
