17 April 2019

Ref: E32217BTlet_ASSMP

**ACID SULFATE SOIL MANAGEMENT PLAN
PROPOSED FORESHORE REHABILITATION
RIP ROAD RESERVE, BLACKWALL, NSW**

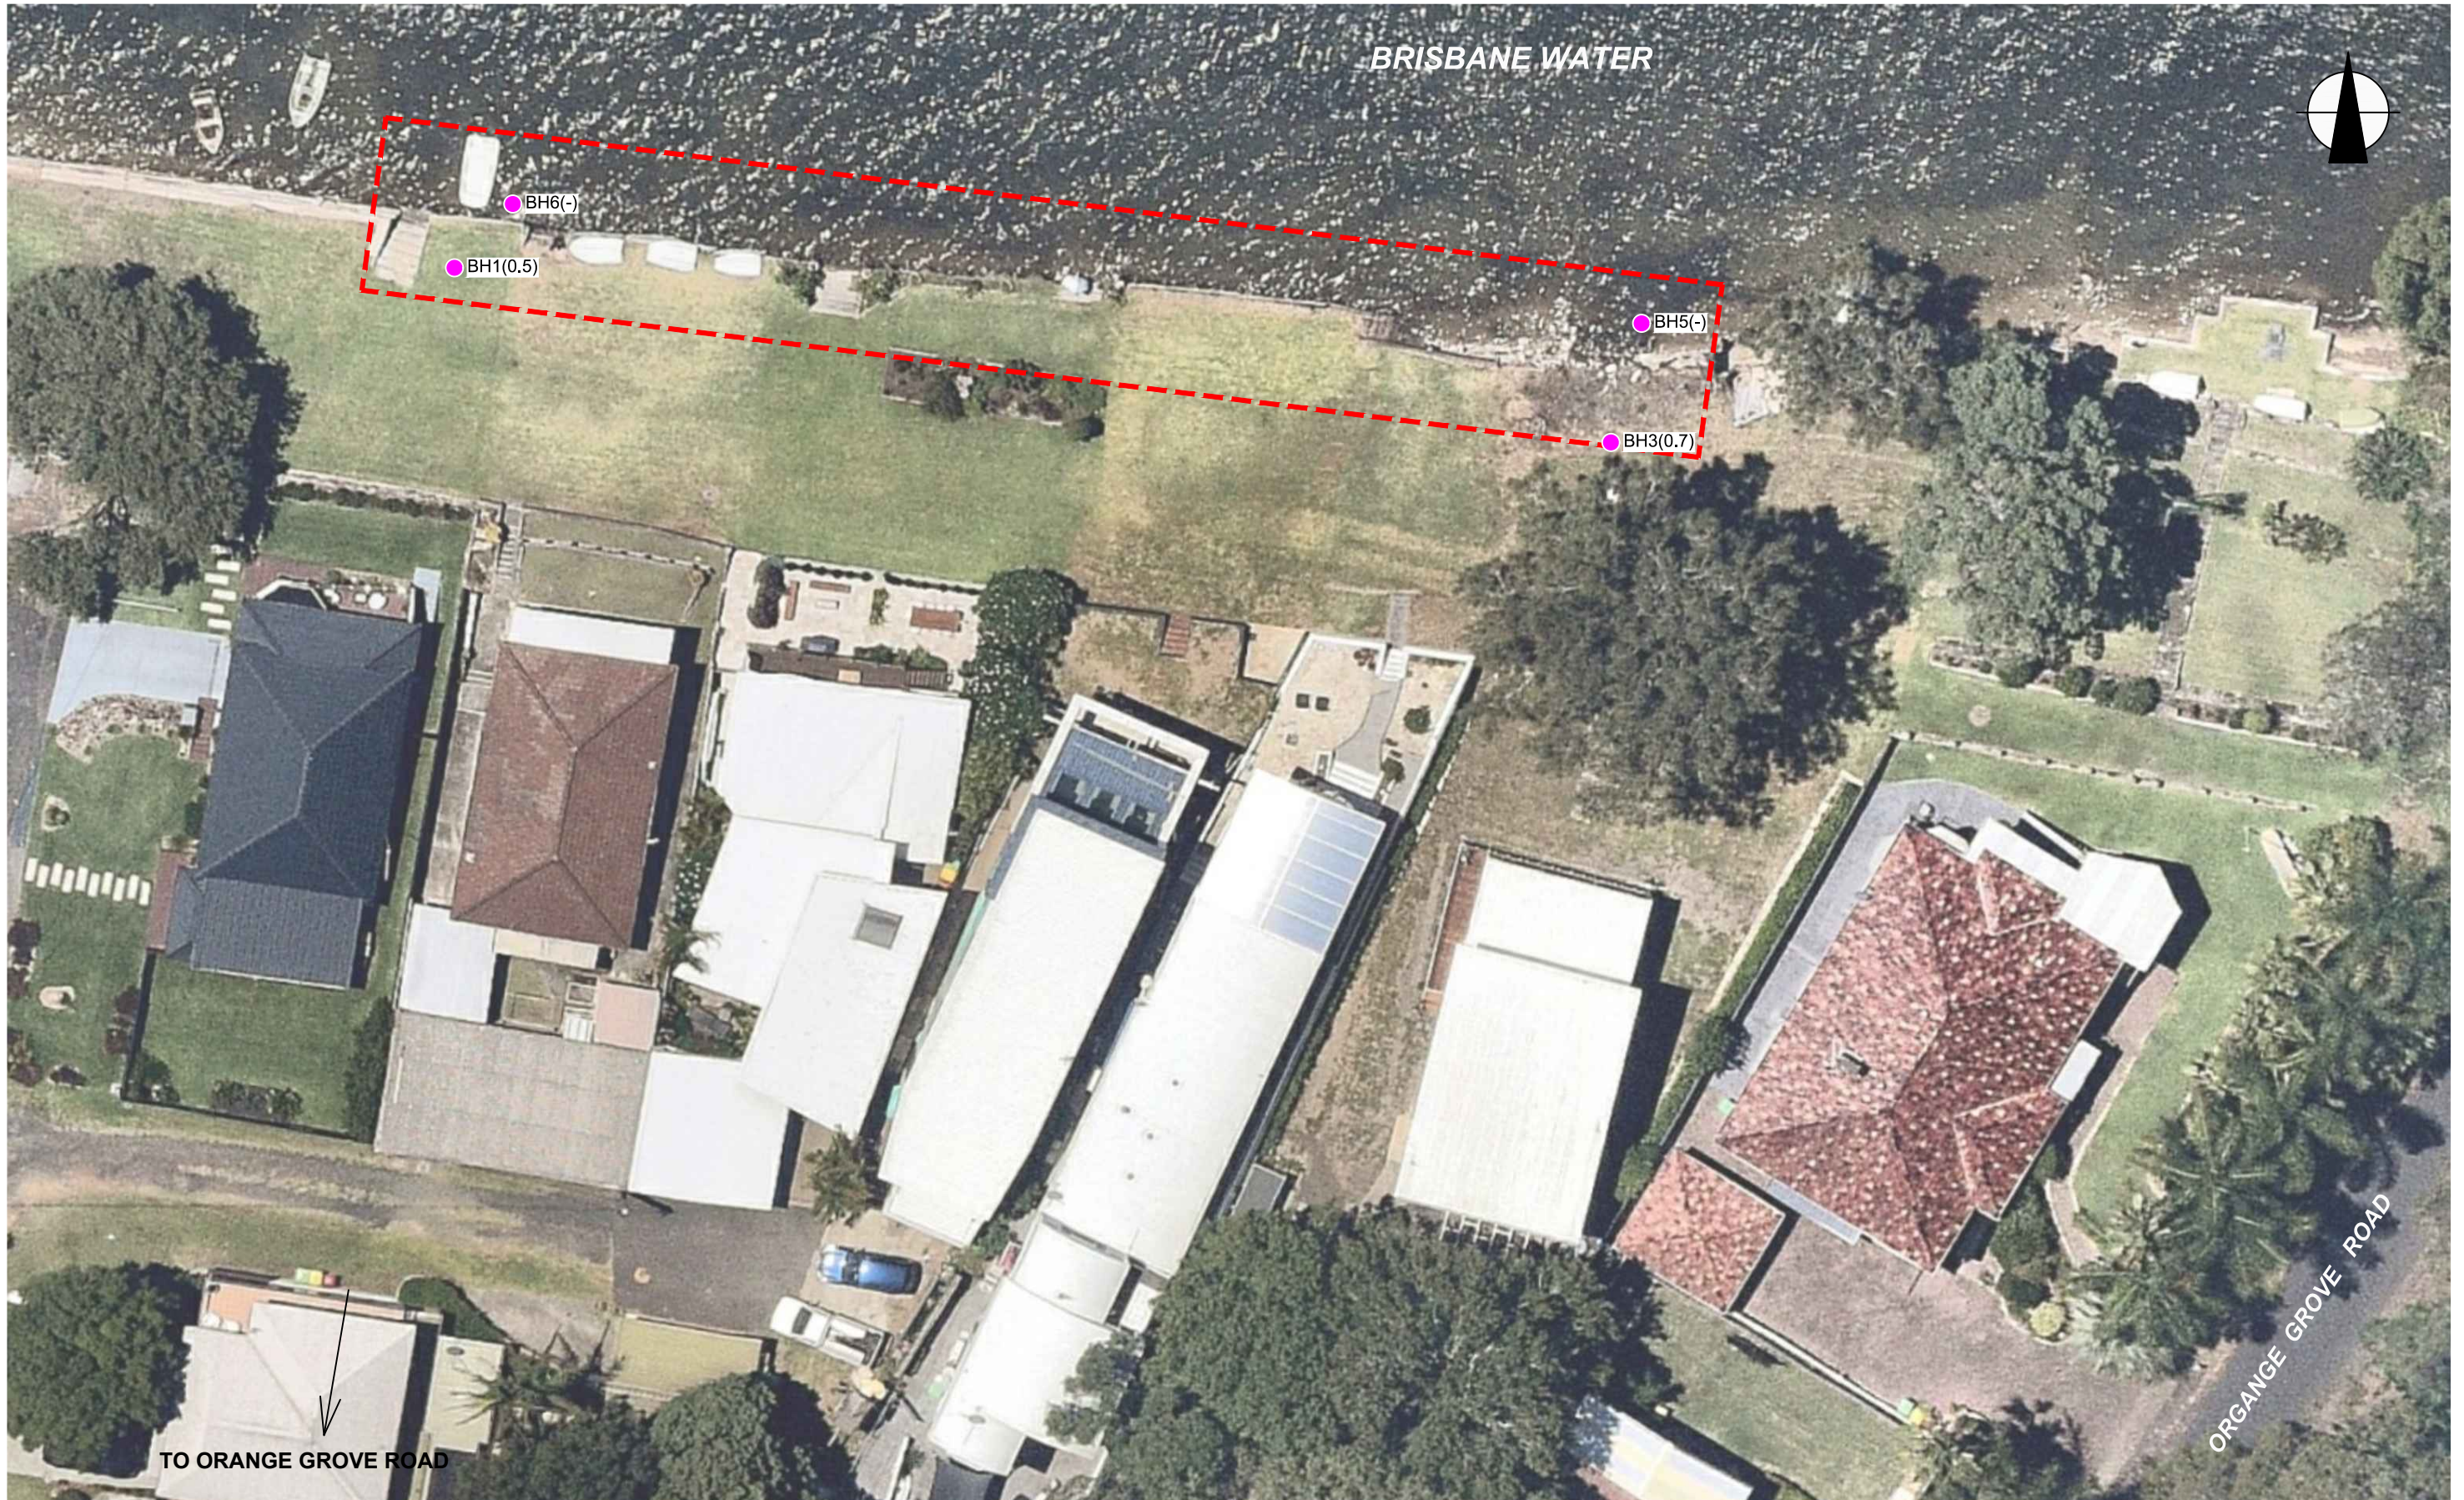
Title: SAMPLE LOCATION PLAN	
Location: RIP ROAD RESERVE BLACKWALL, NSW	
Report No: E32217BT	Figure No: 2
JKEnvironments

- - - - - APPROXIMATE SITE BOUNDARY
- BH (Fill Depth) BOREHOLE LOCATION, NUMBER AND DEPTH OF FILL (m)

Central Coast Council ('the client') commissioned Environmental Investigation Services (EIS)¹ to prepare an acid sulfate soil management plan (ASSMP) for the proposed foreshore rehabilitation at Rip Road Reserve, Blackwall, NSW. The site is part of Lot 94 in DP6327. The site location is shown on Figure 1 and the management plan is confined to the proposed development area as shown on Figure 2.

In February 2019, EIS undertook an acid sulfate soil (ASS) assessment at the site. Soil samples were collected from four locations across the site to a maximum depth of 2.4m below ground level (BGL). The natural soils at the site generally comprised of sandy clay, clayey sand, sand or silty clay.
