WRL Ref: WRL2018024 LR20200402

**Water Research
Laboratory**

Ocean Beach Nourishment Exercise: April to December 2019

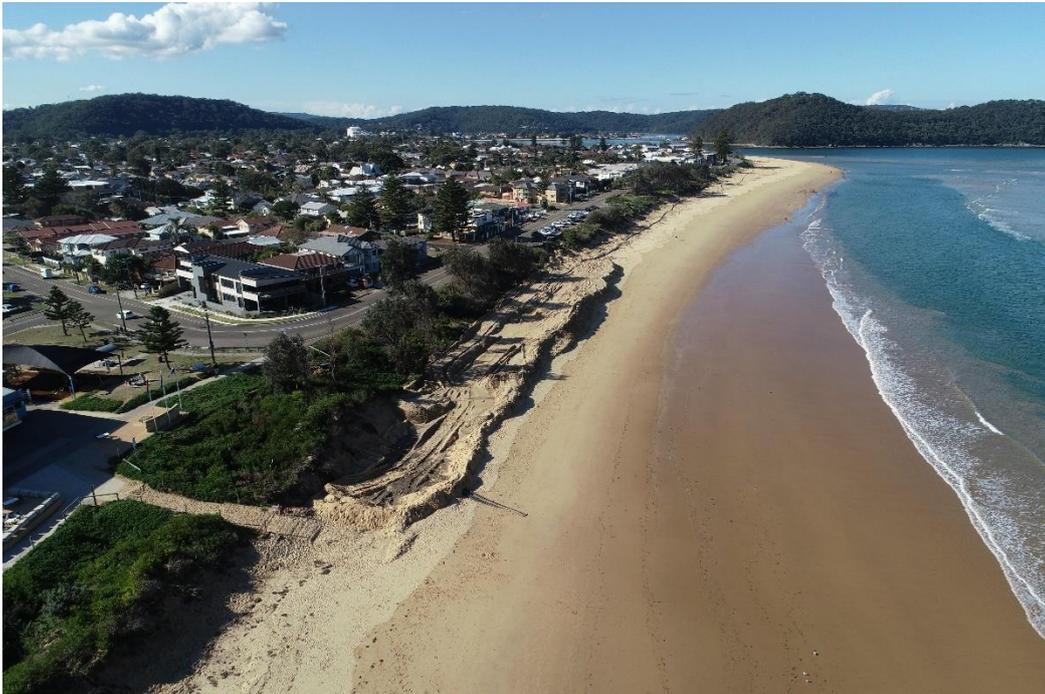
Figure 1: Oblique aerial view of the nourishment progress on 1st August 2019

The Water Research Laboratory (WRL) of the School of Civil and Environmental Engineering at UNSW Sydney was engaged by Royal HaskoningDHV on behalf of Central Coast Council to monitor a nourishment trial undertaken at Ocean Beach on the NSW Central Coast (Figure 1). During the nourishment works, sediment originating from the Ocean Beach ebb tide shoal navigation channel was delivered to a zone between the Ocean Beach SLSC and Augusta Street between April and September 2019. WRL progressively monitored the movement of the sand on the beach throughout the nourishment works using a remote sensing ensemble comprising drone photogrammetry, airborne LiDAR scanning and fixed camera monitoring. This report summarises the data collection methodology, analysis techniques and conclusions about sediment transport processes throughout the trial exercise.

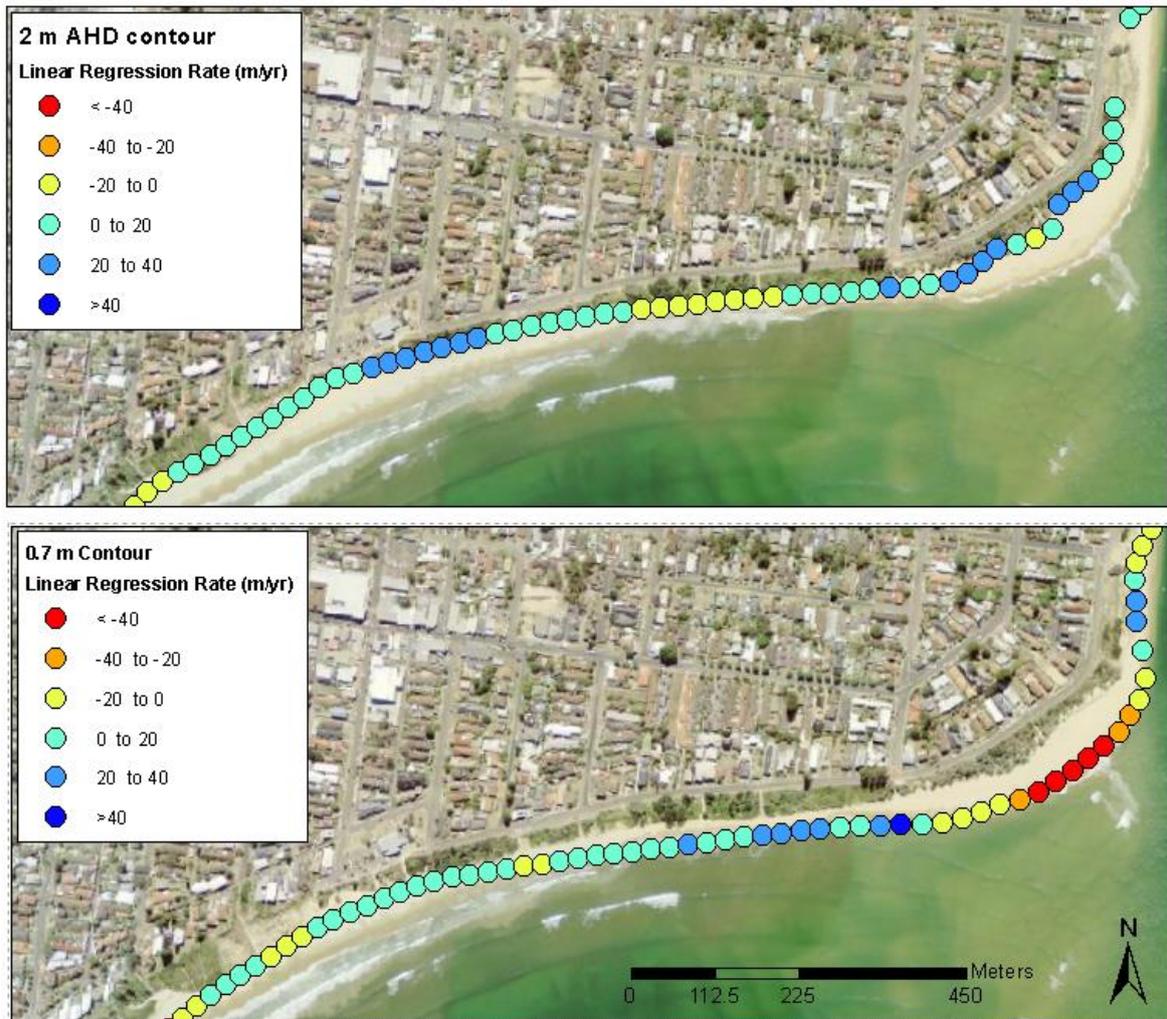
Figure 9: Analysis of the linear regression rate of movement between April and Dec 2019 of the 2 m AHD contour (top) and the 0.7 m AHD contour (bottom)

A number of shoreline indicators exist to measure beach width variability including the mean high water springs (MHWS) shoreline at an elevation of 0.7 m AHD for short term processes and the 2 m AHD contour for longer term changes. The trend in the position of these contours has been extracted from surveys at 50 m alongshore intervals to indicate whether a location has been eroding or accreting during the monitoring period (Figure 8). This has been calculated using the *linear regression rate* statistic (unit: m/year) determined by fitting a least-squares regression line to all shoreline points for a transect (Figure 9). Results indicate that between April to November 2019, the 0.7 m contour generally accreted at a rate of 10 m per year between Ocean Beach SLSC and Barrenjoey Road while Ettalong point eroded at a peak rate of -40 m per year. Additionally, the 2 m AHD contour accreted at a rate of 20 to 40 m per year in the vicinity of Ocean Beach SLSC which is most likely attributed to placement of nourishment material. The 2 m AHD contour was stable or accreting along most of Ocean Beach with the exception of a small region between Augusta Street and Barrenjoey Road that showed a mild trend of erosion.

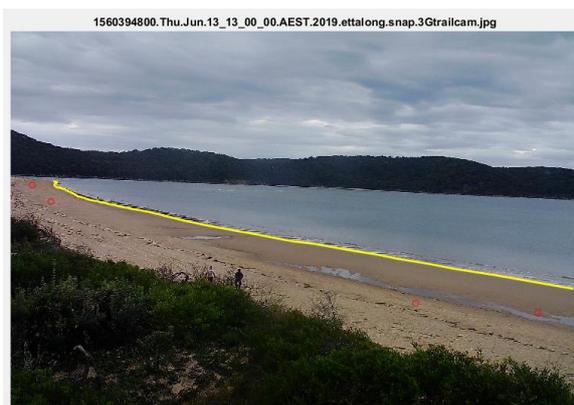
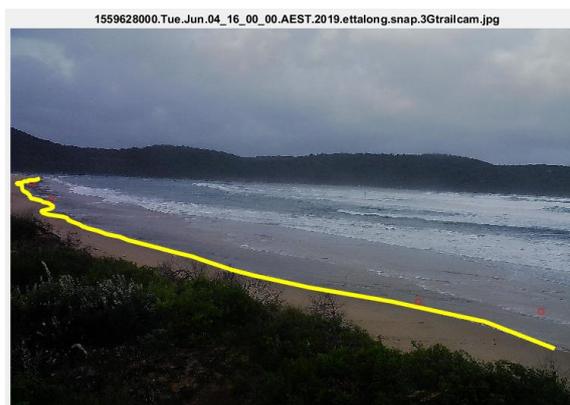
Beach width trend
+10.57 metres/year

13 June 2019 Tide level -0.29 m AHD

4 June 2019 Tide level -0.34 m AHD

Figure 10: Results of camera based shoreline monitoring at Ocean Beach (top), most seaward waterline identified during monitoring period (bottom left) and waterline midway through a storm event (bottom right)

The position of the instantaneous waterline was extracted from the camera based monitoring system from images taken at the same stage of the tide (within 0.1 m). The position of the MSL shoreline was then averaged into a beach width over the 800 m region between Ocean Beach SLSC and Augusta Street (Figure 10). Results indicate that Ocean Beach had an overall accretionary trend at a rate of +10 m per year for the period between April and December 2019. The widest beach width identified during the monitoring period occurred on 13th June 2019 when a low tide terrace bar welded to the shoreline, whereas the most landward waterline captured during monitoring occurred on 4th June 2019 midway through a major storm (Figure 10). While shorelines extracted during storm conditions are useful for understanding processes such as wave runup, they have been excluded from analysis of beach width. This is because storm conditions are usually dominated by factors such as wave setup, runup and barometric setup which are not accounted for in the analysis technique. The accuracy of camera derived shorelines were investigated through comparison with field measurements (Figure 11) with results showing very close agreement in changes to the shoreline position.
