Umina-Ocean Beach Erosion Management Strategy

Terminal Protective Structure
Concept Design Report

Client: Central Coast Council

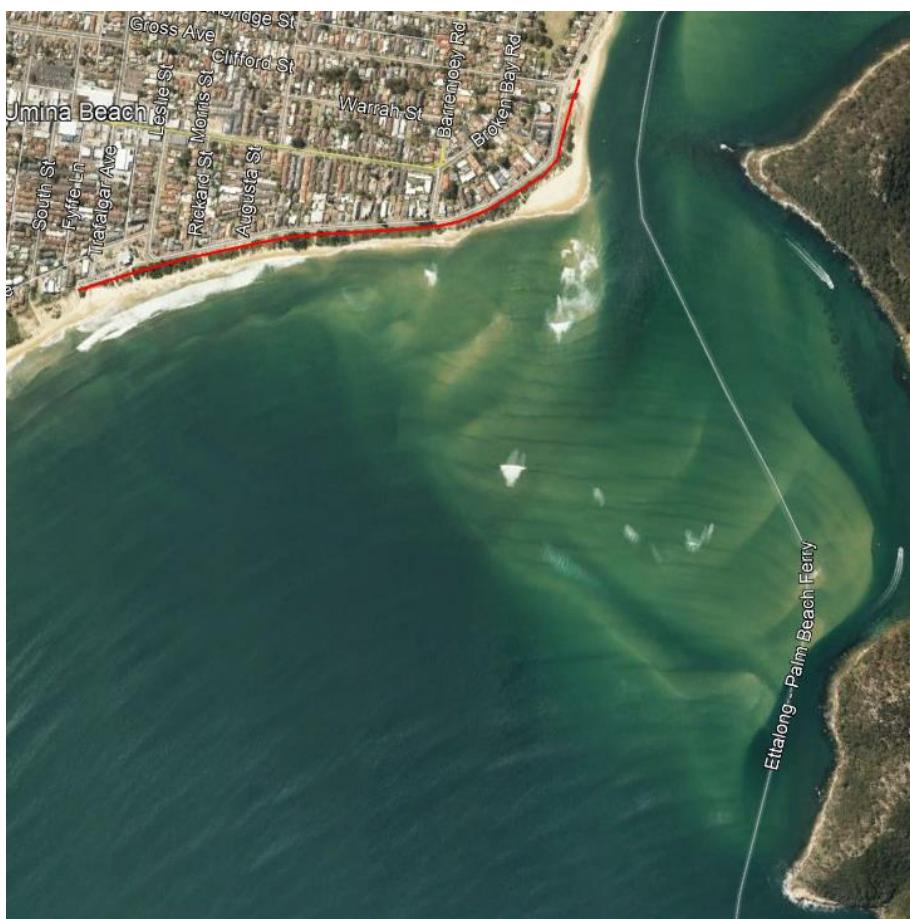
Figure 1: Umina-Ocean Beach showing the extent of terminal protection and beach nourishment from western end of carpark at Ocean Beach SLSC (Trafalgar Ave), to northern end of informal carpark and boat ramp at Kourung Street, a shoreline distance of approximately 1,300m. Entrance shoals and channel to Brisbane Water also shown.

The length of shoreline under consideration for implementation of TPS comprises the section along Umina-Ocean Beach between Ocean Beach SLSC to the Kourung Street Boat Ramp. This covers a length of approximately 1,300 metres. The beach and foreshore to be protected by the TPS is shown in **Figure 1**.

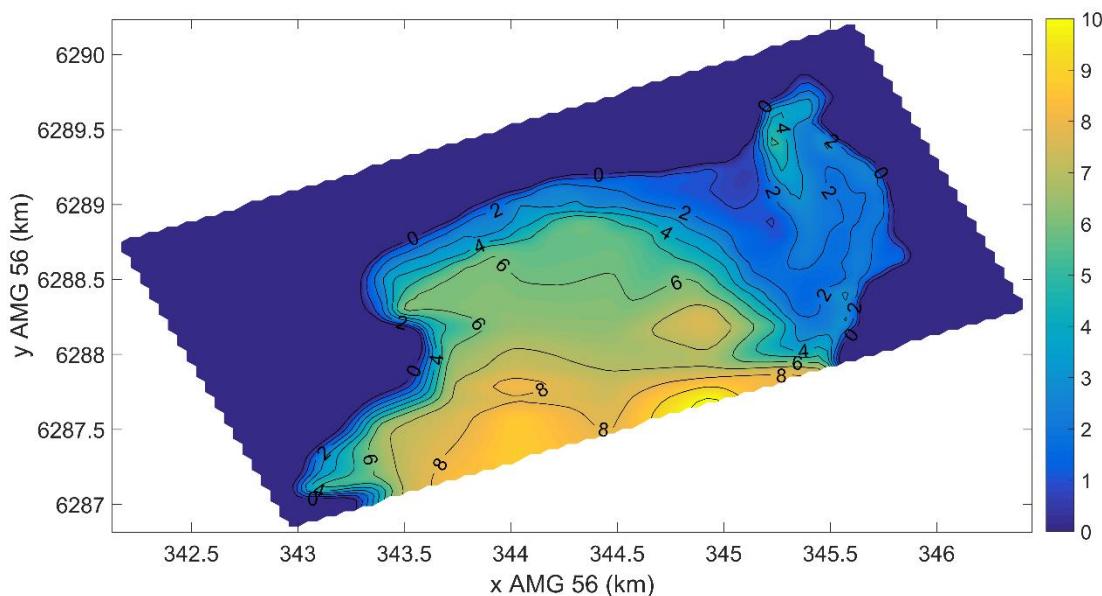
Figure 4: Interpolated bathymetric data to 10 m SWAN grid

High resolution nearshore bathymetric data of the study area was available from a combination of sources including a nearshore jet ski survey conducted by WRL, hydrographic survey in Broken Bay completed by Astute Survey, and hydrosurvey within the Brisbane Water entrance obtained from Crown Lands. This survey data extended to approximately the 10 m depth contour. Additional offshore bathymetric data to cover the model grid was sourced from Geoscience Australia. The combined nearshore and offshore bathymetric data was interpolated to the model grid. An example of the interpolated nearshore 10 m grid can be seen in **Figure 4**.

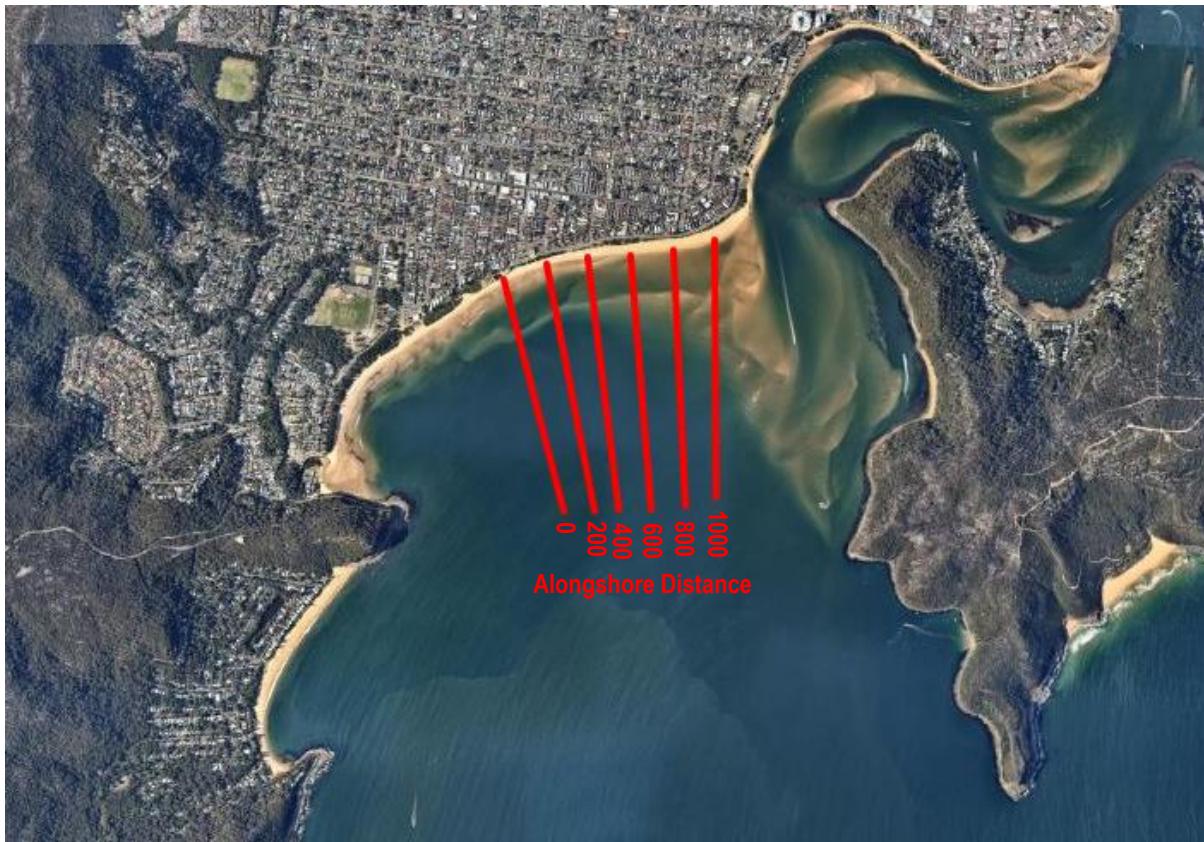
Figure 5: Location of profile transects used for SWAN model data extraction

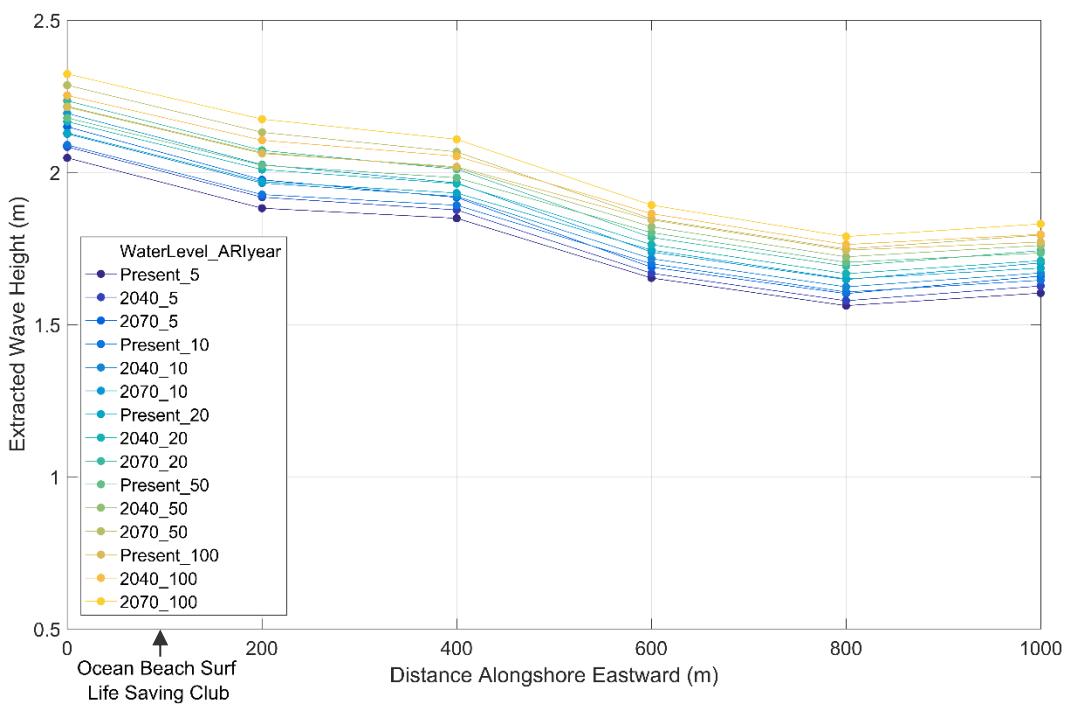
Figure 6: The 10-year, 20-year, 50-year and 100-year ARI swell wave heights extracted from the SWAN model at different alongshore locations and for different water levels

Figure 6 and **Figure 7** show that modelled wave heights are higher at the western end of Umina-Ocean Beach likely due to greater exposure to offshore conditions. The highest waves occurred directly in front of Ocean Beach Surf Life Saving Club and reduced in height alongshore towards Ettalong Beach. Further, the magnitude of the swell waves extracted from the SWAN model runs are roughly 1 m higher than the modelled wind-wave heights. Wave heights in **Figure 6** and **Figure 7** can be seen to increase with higher water levels and for larger ARI events. However, the difference between different ARI events is marginal, suggesting that waves are depth limited. The overall maximum wave heights that could reach the proposed TPS based on the SWAN modelling occur at the western end of the study area, directly in front of Ocean Beach Surf Life Saving Club, as shown in **Figure 6** and are presented in **Table 11**.

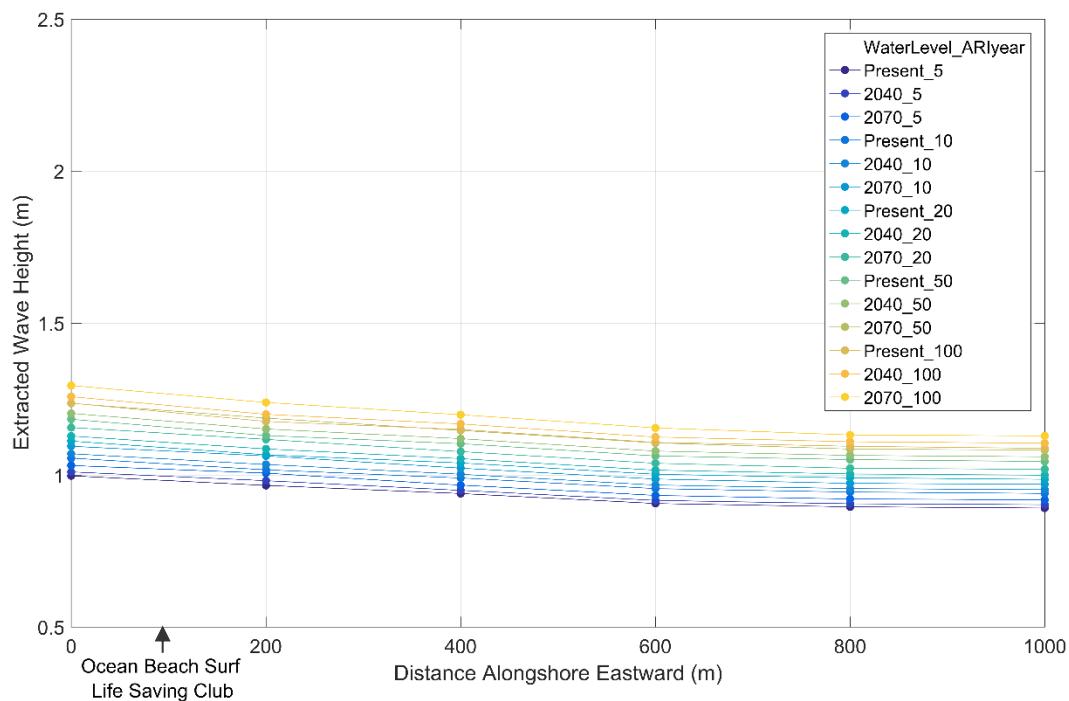
Figure 7: The 10-year, 20-year, 50-year and 100-year ARI wind-wave heights extracted from the SWAN model at different alongshore locations and for different water levels

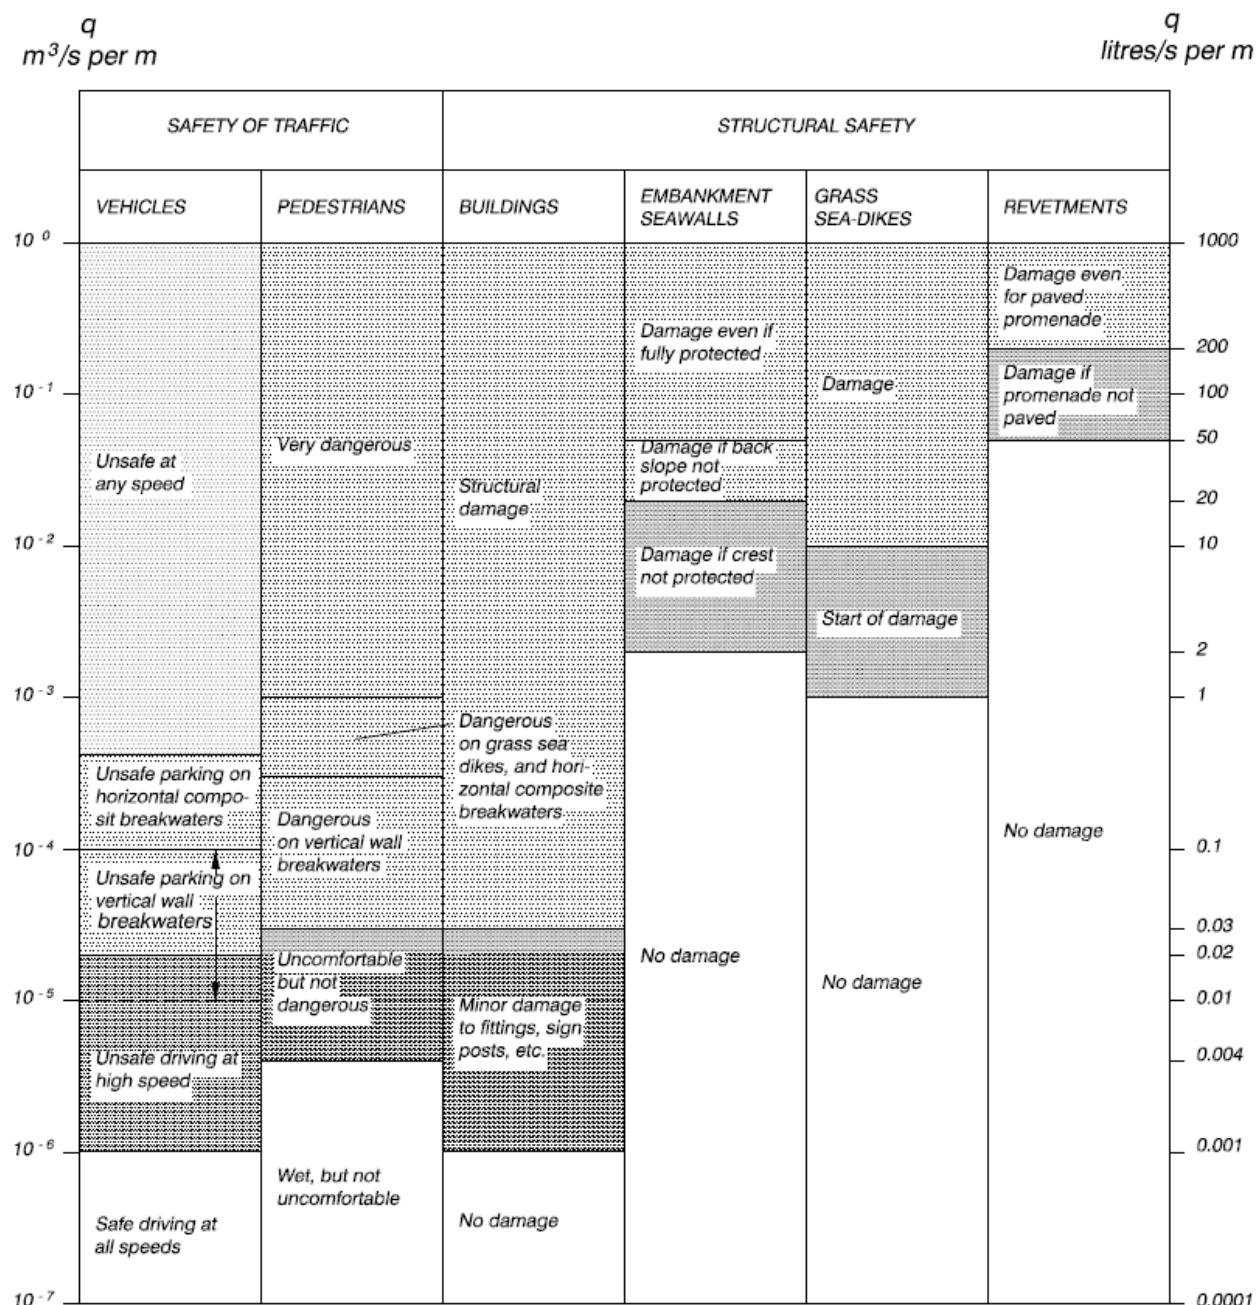
Figure 8: Critical Values of Average Overtopping Discharges (USACE, 2006)

Coastal Engineering Manual (USACE, 2006) and the EurOTop Manual (2016) are reproduced below in **Figure 8**, **Figure 9**, **Figure 10**, and **Figure 11**. These guideline values cover limits for structural damage to the seawall and landward areas (e.g. grassed or paved areas), damage to buildings or equipment, and safety of pedestrian and vehicle traffic, and will be considered in the assessment of different TPS design options. It is noted that while the Coastal Engineering Manual limits the overtopping criteria to a mean overtopping discharge, EurOTop includes a maximum overtopping volume as well, taken to represent the maximum overtopping volume for an individual wave that is predicted over the duration of a storm event.

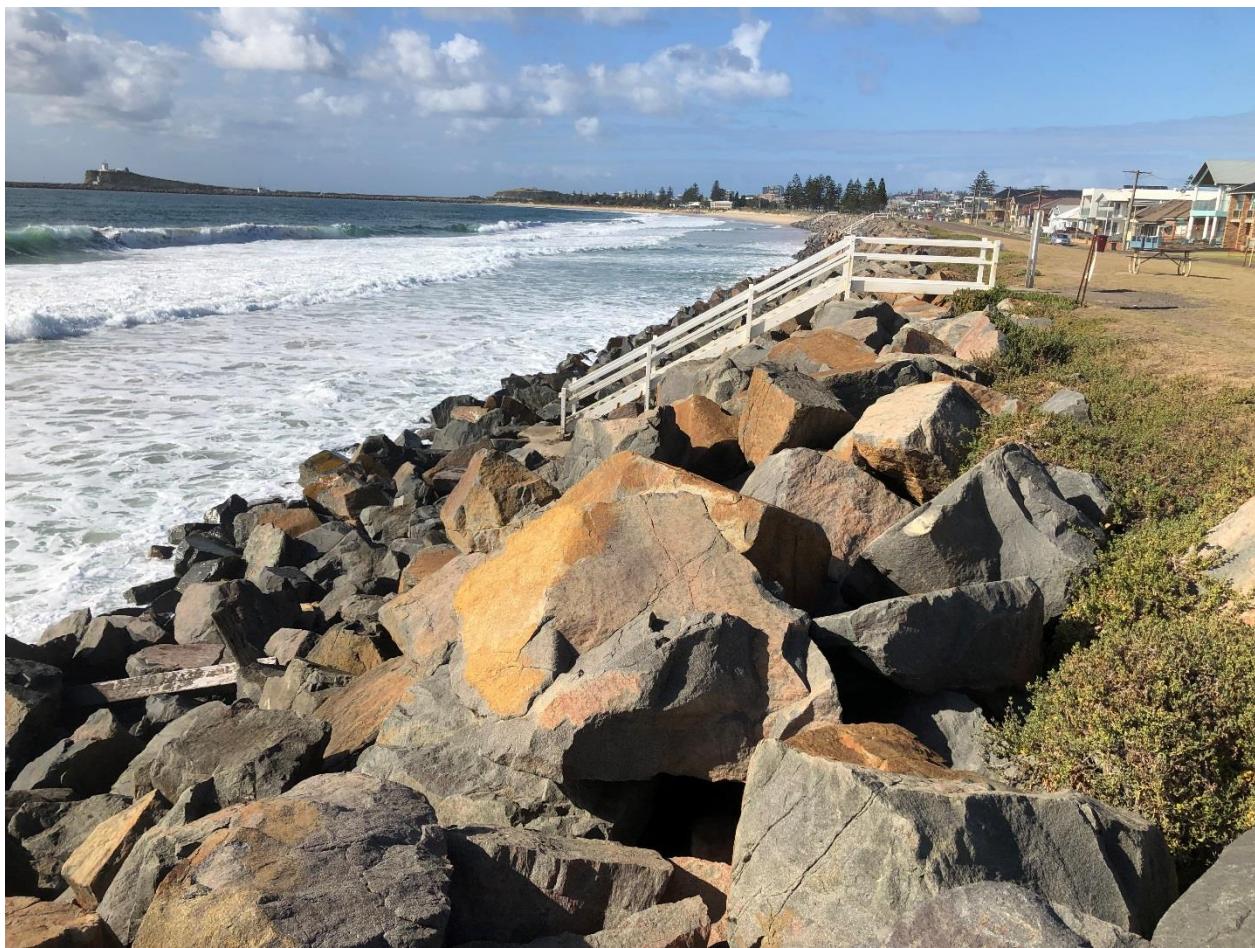
Figure 12: Seawall constructed from igneous rock at Stockton Beach, NSW

This option comprises a conventional rock revetment, which would be constructed from three(3) layers of rock armour underlain by a heavy grade geotextile fabric (refer **Appendix C** for typical section and example photo in **Figure 12**). The rock revetment structure would be positioned as far landward as is practicable to minimise encroachment on the available beach width. The rock revetment crest would be set at 5.5m AHD so that it is generally lower than the crest of the existing natural dune profile, which varies along the beach from around 7.5m AHD immediately east of Ocean Beach SLSC and progressively lowers to around 5-5.5m AHD at Ettalong Point. This should allow for subsequent dune re-building and revegetation so that the rock revetment is a buried structure that is only uncovered during major coastal storms that cause depleted beach conditions and erosion of the dune. The toe of the rock revetment would extend down to the design scour level of -1m AHD. The width of the rock revetment from the crest (seaward face) to the toe would be approximately 13.5m.

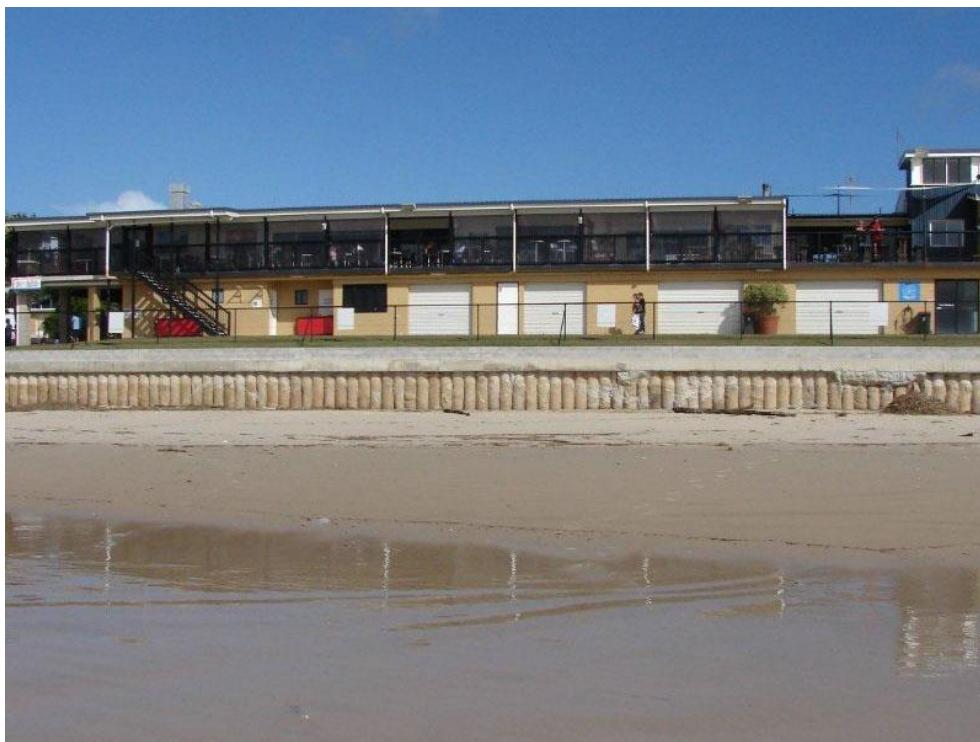
Figure 13: Secant pile wall with concrete capping beam installed in front of Cudgen Surf Club, Kingscliff (Source: ASP)

An example of a secant pile seawall with a concrete capping beam at Cudgen Surf Club, Kingscliff Beach is shown in **Figure 13** and installation of secant pile walls at Kingscliff Beach and South Curl Beach are shown in **Figure 14** and **Figure 15**.

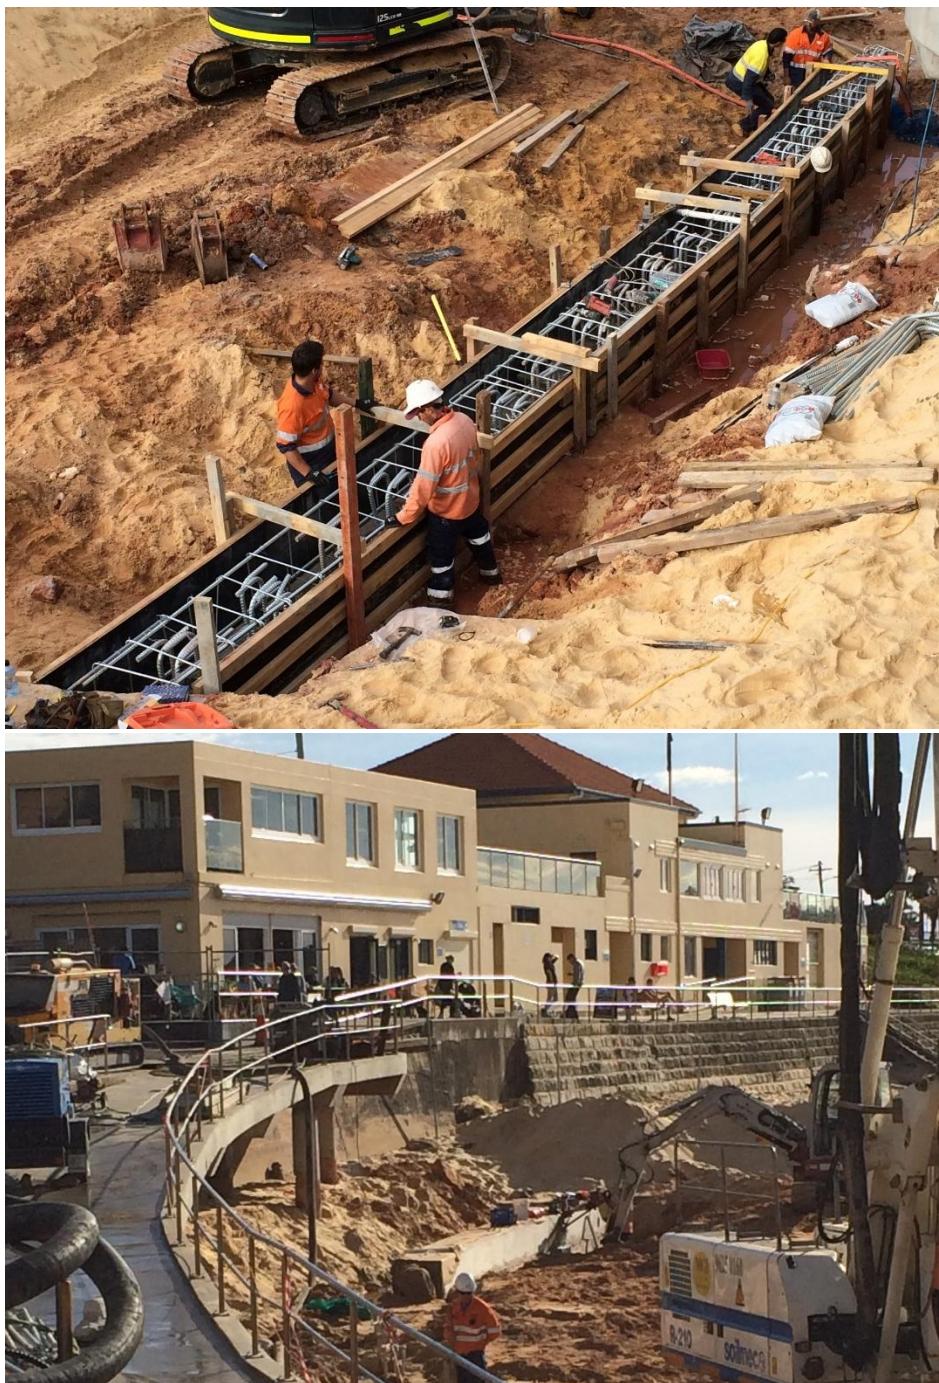
Figure 15: Construction photos during installation of an anchored secant pile wall and capping beam installed at South Curl Curl Beach

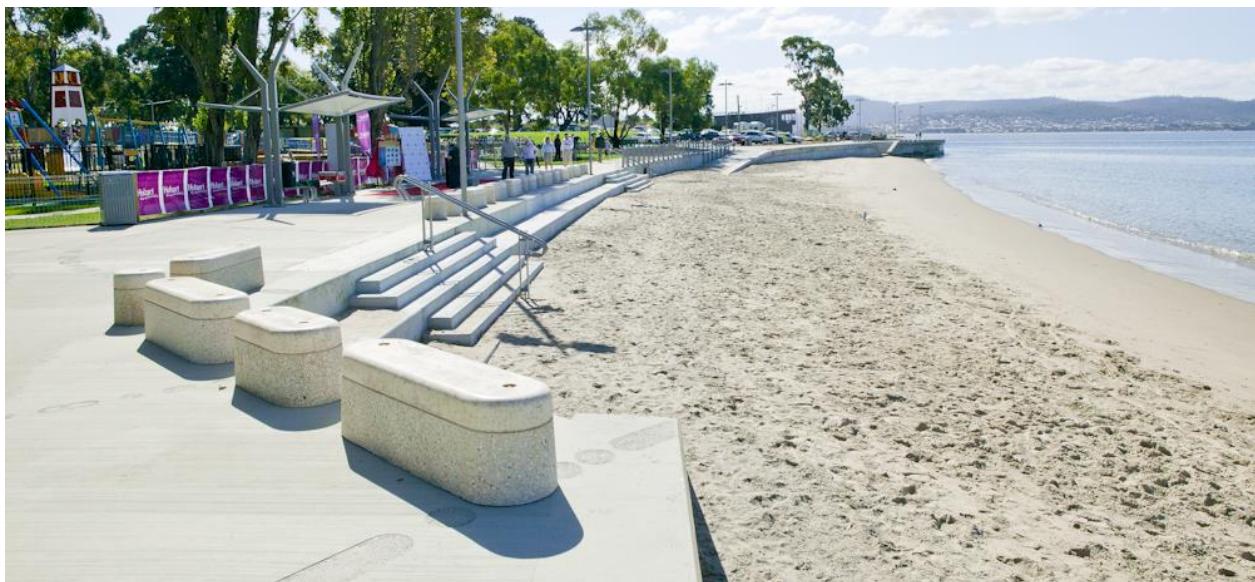
Figure 16: Stepped seawall at Sandy Bay, Hobart incorporating beach access steps

Architectural design input is recommended to integrate the structure into the local setting and to incorporate urban and landscape design futures. For example, the stepped concrete seawall recently constructed at Kingscliff Beach in Tweed Shire (refer **Figure 18**) included a varied plan alignment for sections of bleachers within the upper structure, separated by footpaths and planters. Here public artwork is included in the form of stencilled phrases imprinted along selected bleacher risers, conveying a cultural connection to the local area and landscape. Colouring can also be introduced into the concrete to match the native sand as has been very successfully achieved within the stepped seawall at Dee Why Beach (refer **Figure 17**).

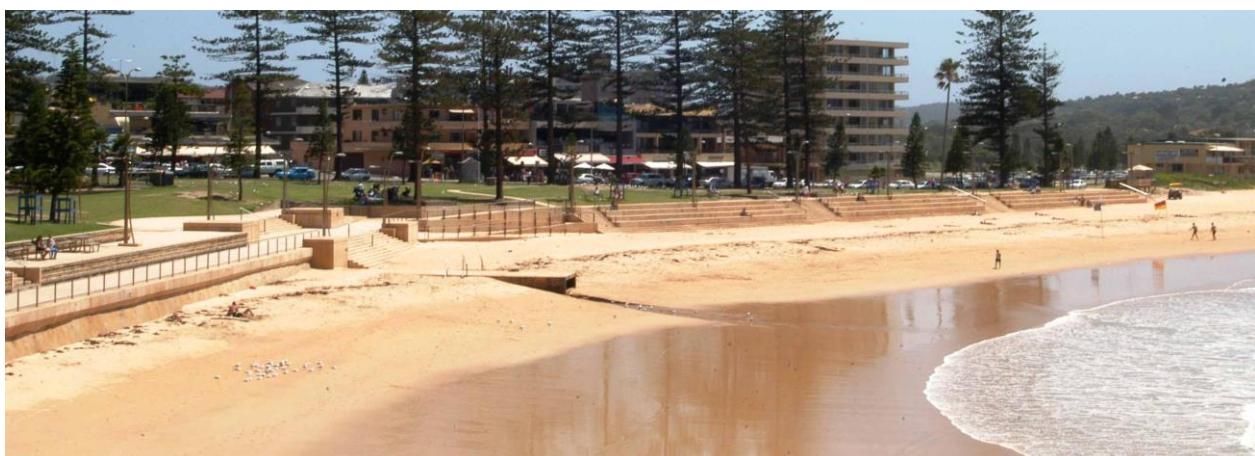
Figure 17: Stepped seawall at Dee Why Beach constructed in 1999, coloured to match natural colour of beach sand

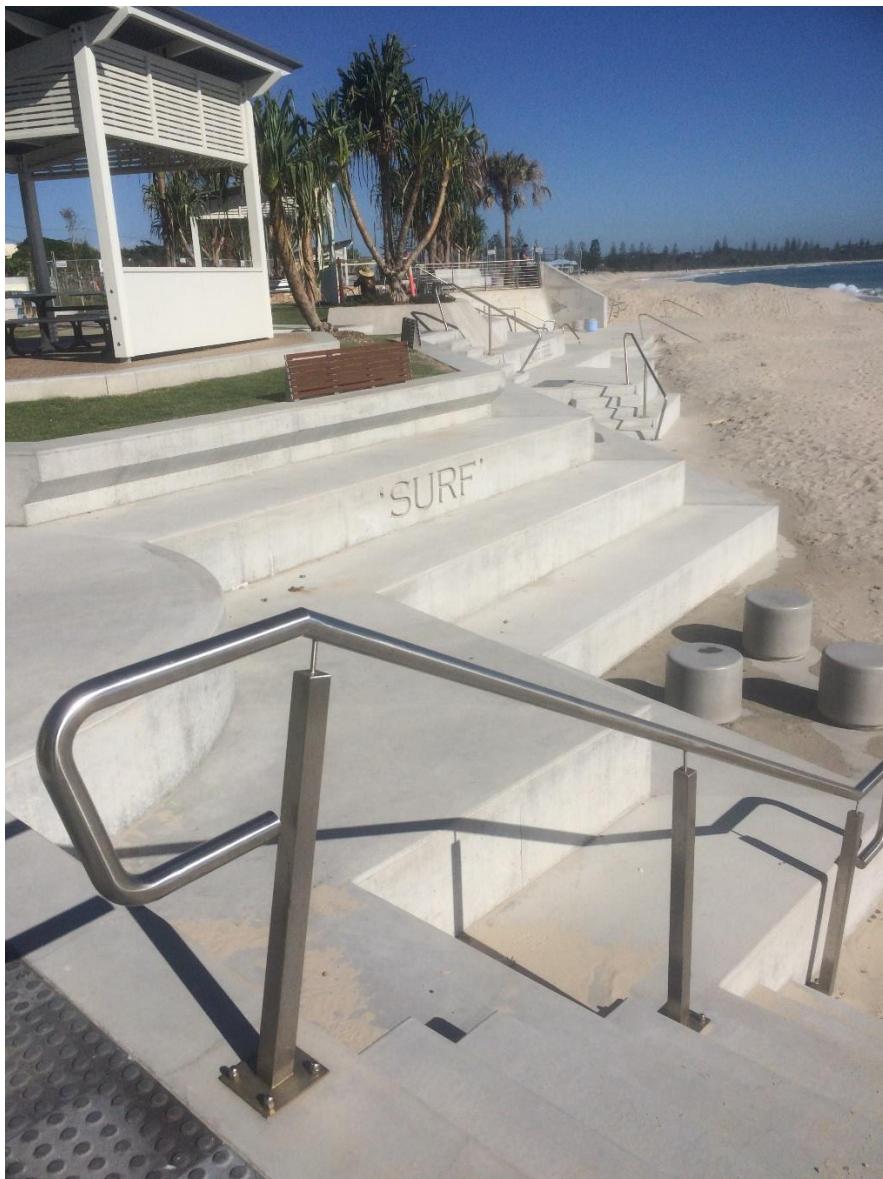
Figure 18: Recent stepped seawall installation at Kingscliff Beach (2018)

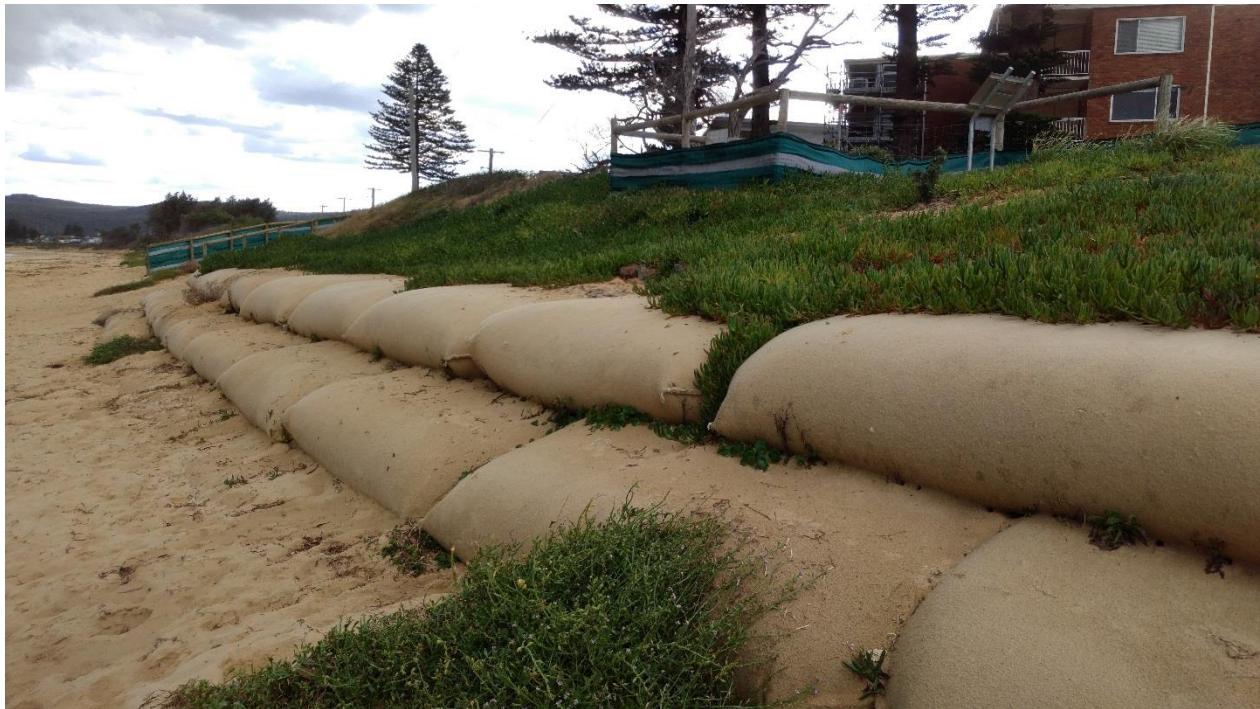
Figure 19: Geotextile container wall installed at Barrenjoey Road

This option comprises a wall constructed from stacked sand-filled geotextile containers (refer **Appendix C** for typical section). This wall would be similar to the existing geotextile container wall at Barrenjoey Road (refer **Figure 19**), which has been in place for around 3 years now. The proposed wall would be constructed from 2.5m³ geocontainers (ELCOROCK manufactured by Geofabrics Australasia or approved equivalent) stacked in two layers at a 1V:1.5H slope from a maximum crest level of 7.5m AHD down to a toe level of -1m AHD. To accommodate toe scour along the wall an additional 2.5m³ geotextile 'scour flap' container would be provided along the base of the wall to act as a 'falling toe' in event of localised scour. This may allow for minor lifting of the toe level as part of the detailed design. The scour flap containers would be wrapped in geotextile fabric to integrate them with the wall structure. The outer layer of geocontainers would be manufactured from vandal-deterrent geotextile fabric to minimise damage over their design life.

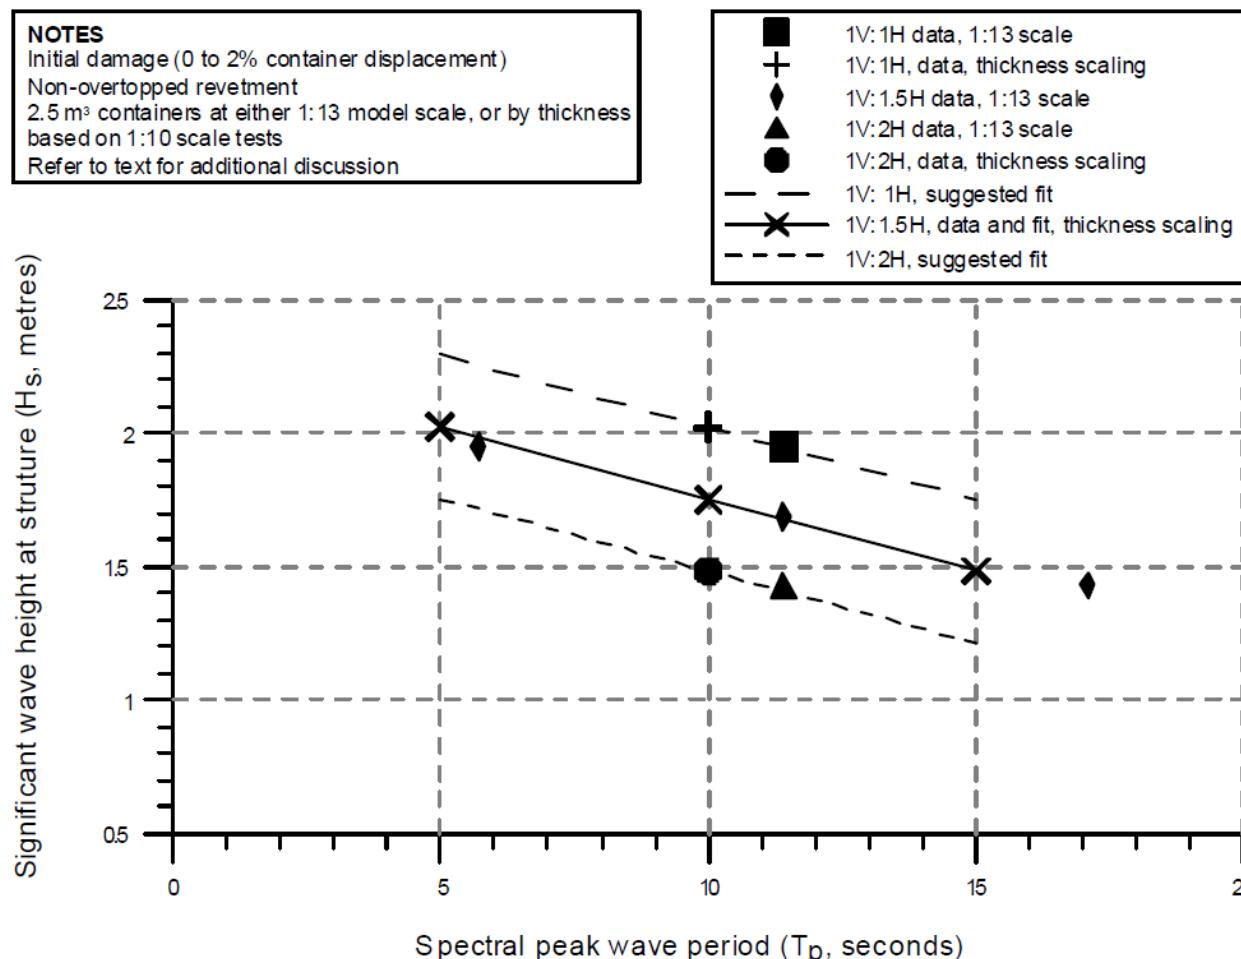
Figure 20: Design wave height for "initial damage" criterion for 2.5m³ geocontainers (Coghlan et al, 2009)

The design wave climate (refer **Section 2.9**) was applied to the design plot for stability of 2.5m³ geocontainers (sand filled geotextile containers) under wave action within Coghlan et al (2009) (refer **Figure 20**). This determined that 2.5m³ geotextile containers would not be stable in the most exposed area at the western end of the site (Ocean Beach SLSC) and would likely incur significant damage under the 100 year ARI design conditions ($H_s=2.2\text{-}2.3\text{m}$, $T_p=13\text{-}13.2\text{s}$), even if a reduced design life of 20 years (2040 water level) is considered. The 100 year ARI design wave conditions reduce moving eastward along the beach to around $H_s=1.7\text{-}1.8\text{m}$ and $T_p=12\text{s}$, which would result in marginal stability of 2.5m³ geotextile containers based on **Figure 20**. However, these reduced alongshore wave heights are dependent on the configuration of the offshore shoals at the entrance to Brisbane Water, which are dynamic and cannot be relied upon to provide wave attenuation to eastern areas of the beach at all times.

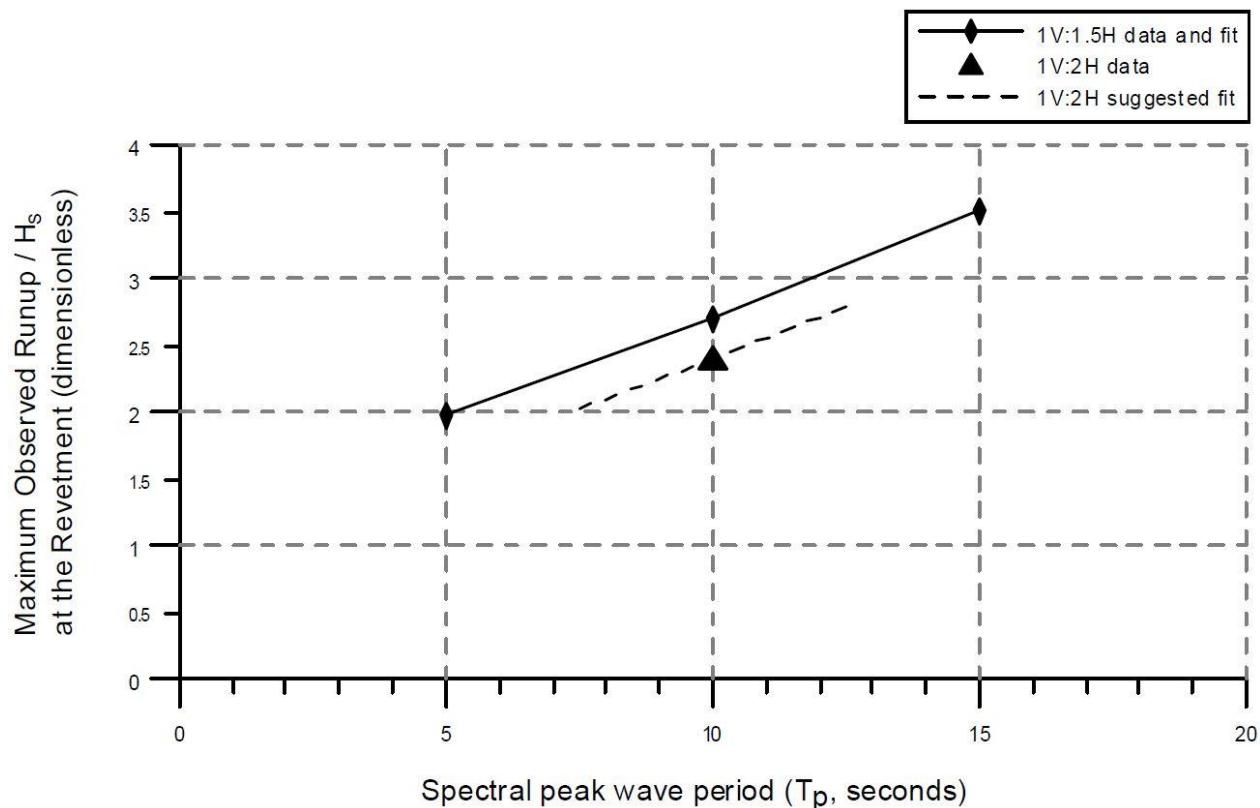
Figure 21: Maximum observed wave runup for 0.75m³ geocontainers (Coghlan et al, 2009)

Once the geotextile containers have settled into place and the sand within the containers is wet, the wall would act as an impermeable stepped structure with a relatively low roughness. As a result, measured wave runup over the geotextile containers structures is high and based on testing by Coghlan et al (2009) would be in the order of 2.7 to 3.4 times the significant wave height (above the still water level) for typical storm wave periods of between 10 and 14 seconds (refer **Figure 21**). For the 100 year ARI design event at the present time ($H_s = 2.2m$, $T_p=13s$) this would result in a runup height of 7m above the 100 year ARI still water level (1.44m AHD) and significant overtopping of the structure. This would worsen over time due to sea level rise. The geotextile container wall would need to extend up to the full height of the dune in order to completely protect landward areas from wave action, although wave overtopping would still create a public safety hazard and cause potential damage to property.

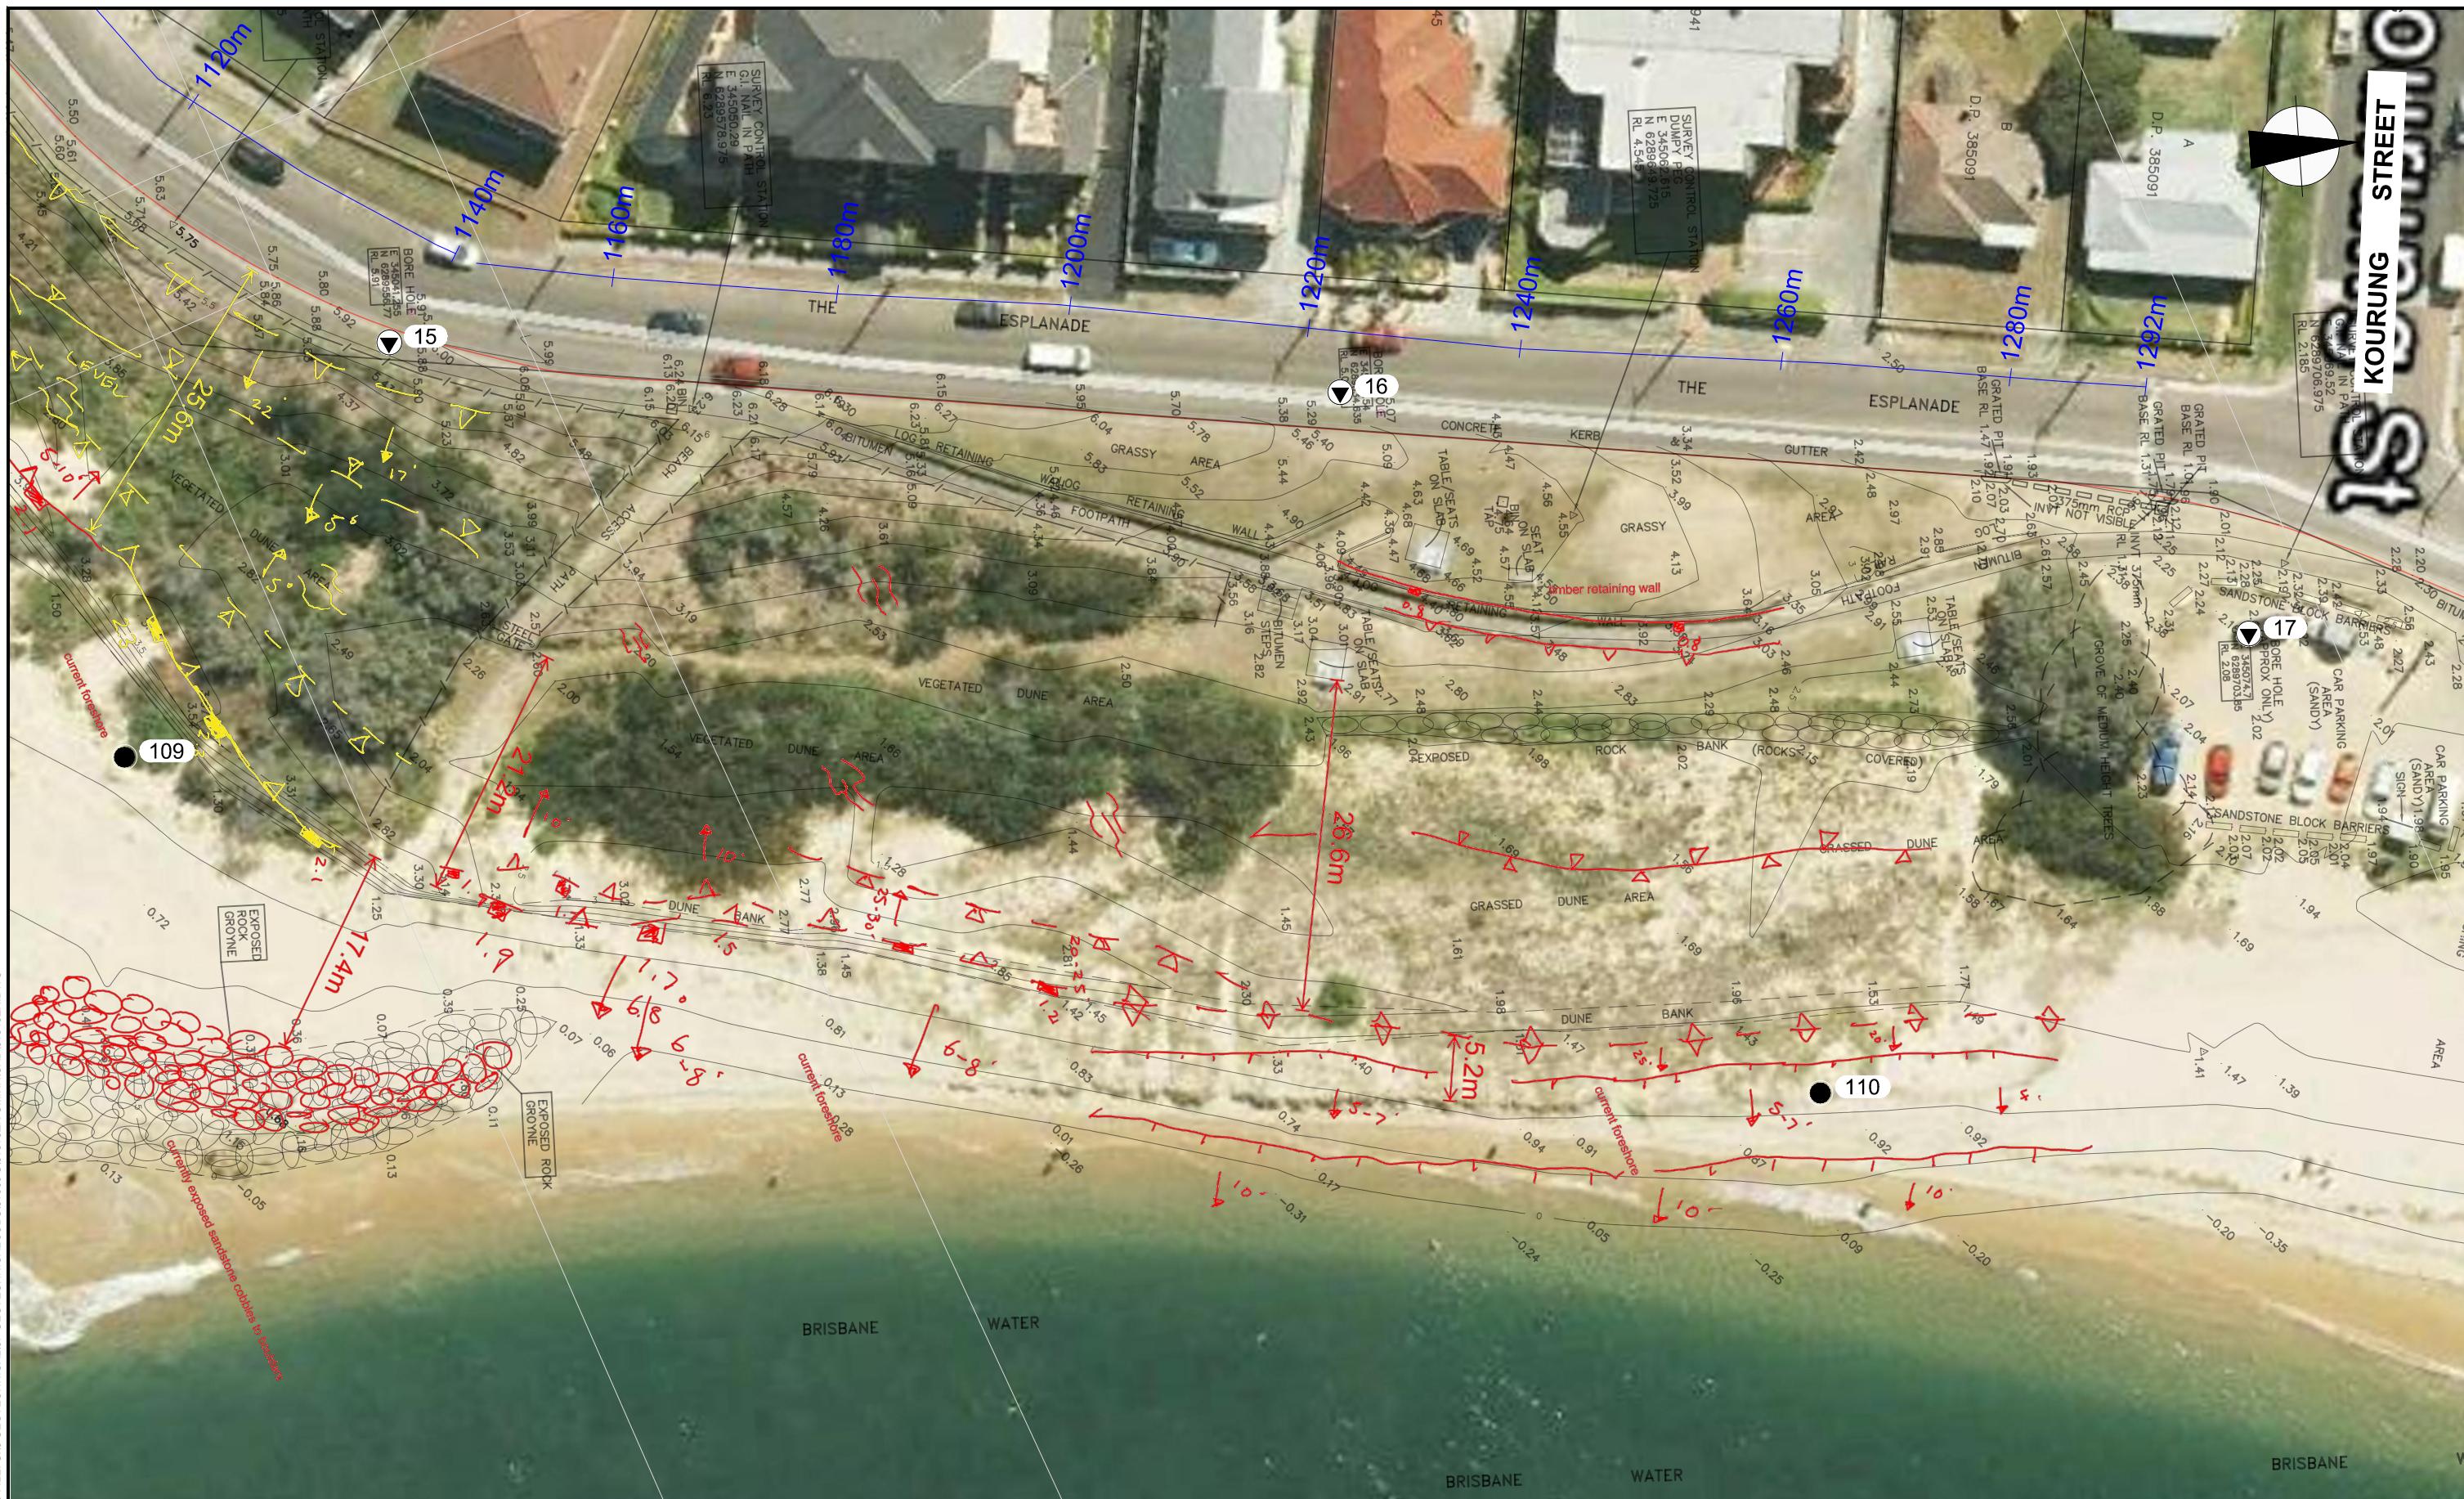
GEOTECHNICAL SITE PLAN (CH1120m - CH1292m)	
Title:	
Location:	OCEAN BEACH SURF LIFE SAVING CLUB TO KUORONG STREET BOAT RAMP, UMINA, NSW
Report No:	31518ZR
Figure No:	8
