Catchment to Coast
Terrigal Catchment Audit
Sub-Committee Meeting
19-9-2019

Water Quality Investigations

Catchment Audits

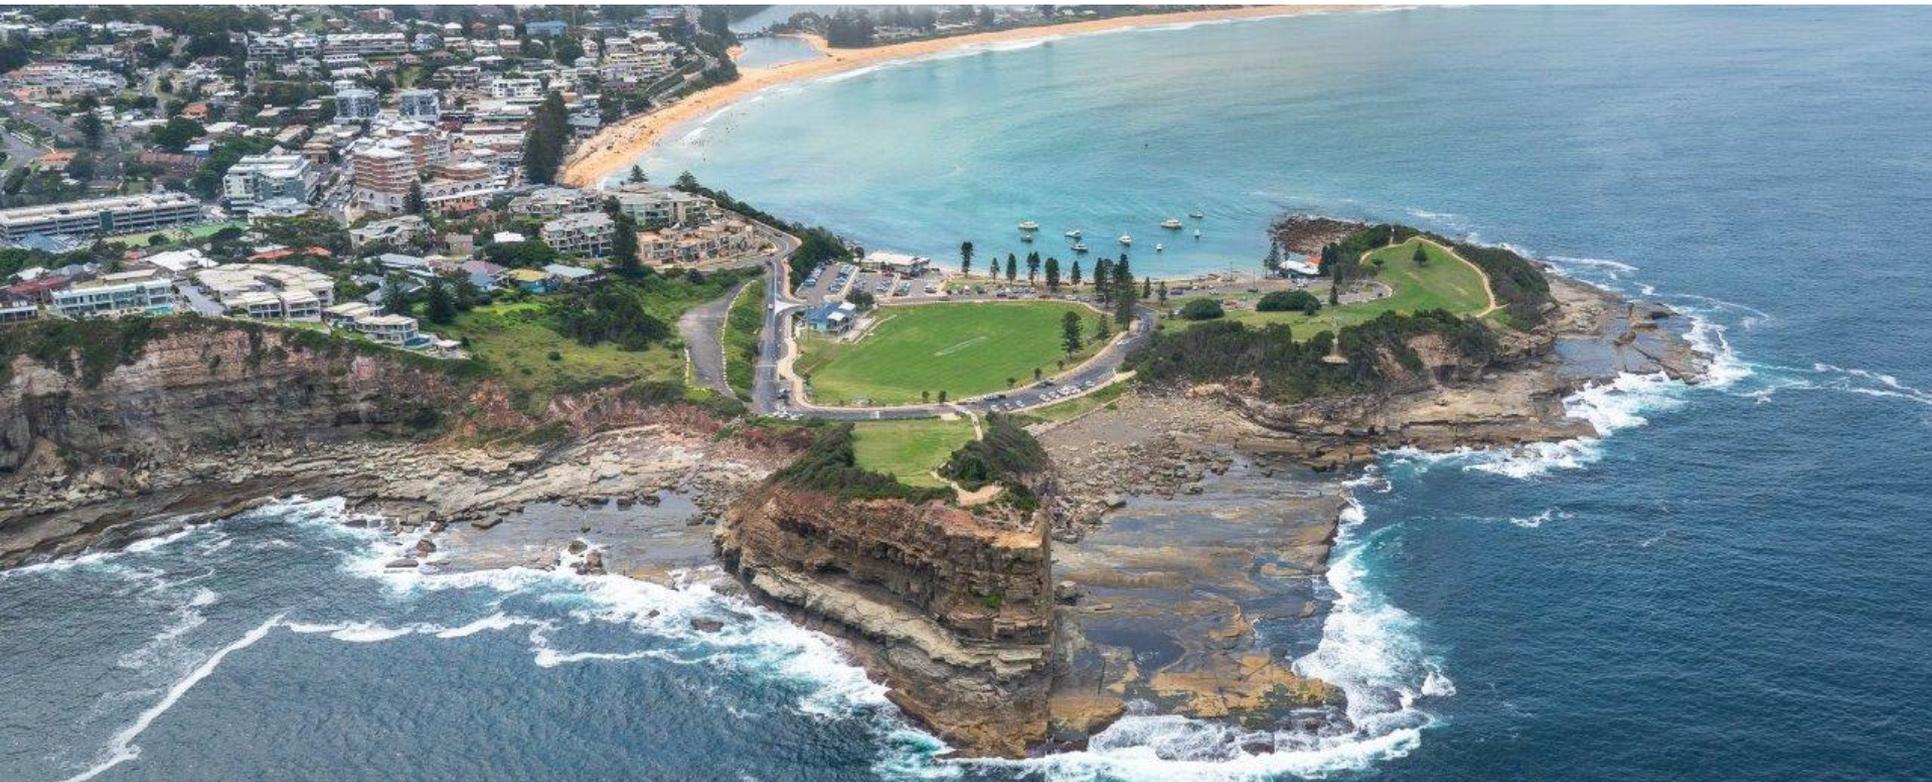
Possible sources of contamination seen internationally

- A point source is a single, identifiable source of pollution, e.g. industrial waste discharged into a river, usually discharged through a dedicated discharge structure
- 'Diffuse' pollution refers to inputs of pollution that are not deliberate, which occur over a wide area and are not easily attributed to a single source activity. Diffuse source pollution may be collected and discharged through drains (e.g. stormwater)

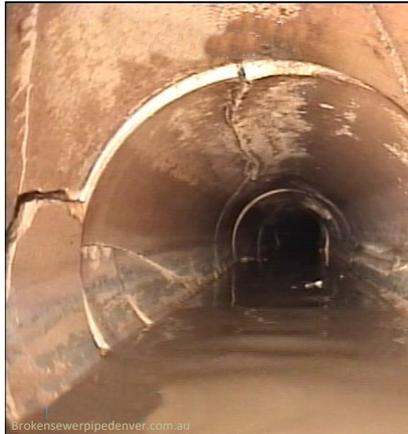
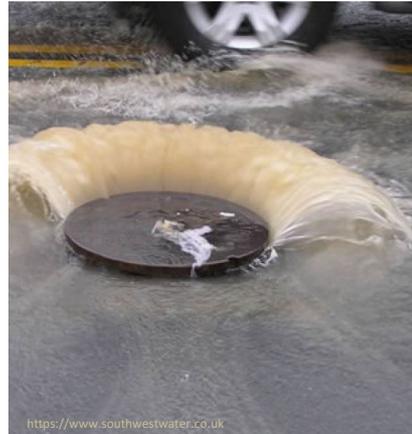
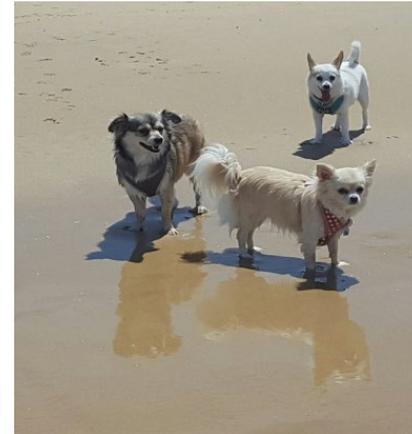
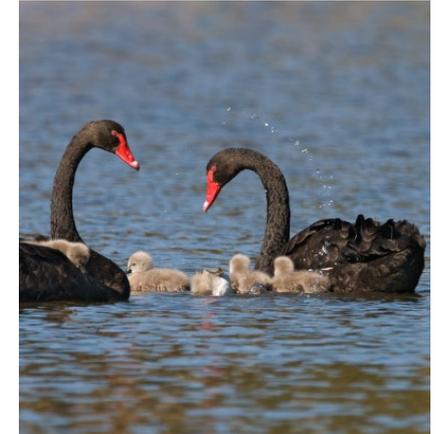
Cont. Possible sources of contamination seen internationally

- Cracked sewer pipes or septic tanks - direct infiltration into stormwater or groundwater
- Infiltration of contaminated groundwater into stormwater or waterway
- Illegal connections - sewer to stormwater
- Illegal connections - stormwater to sewer – overloads
- Wildlife faeces via direct input and overland flow (birds etc)
- Domestic and agricultural faeces (dogs, cats, horses, cows etc)
- Sediment – reservoir and resuspending
- Seaweed – reservoir

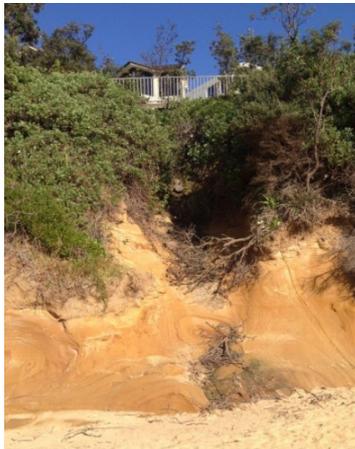
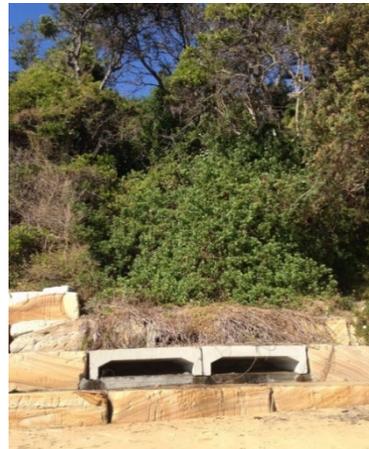
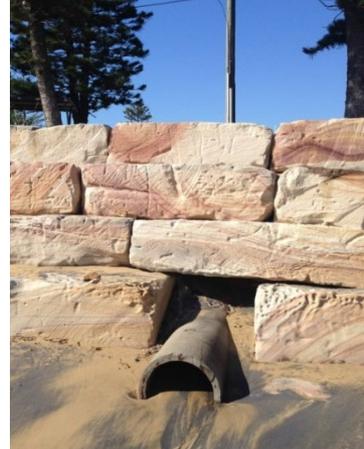
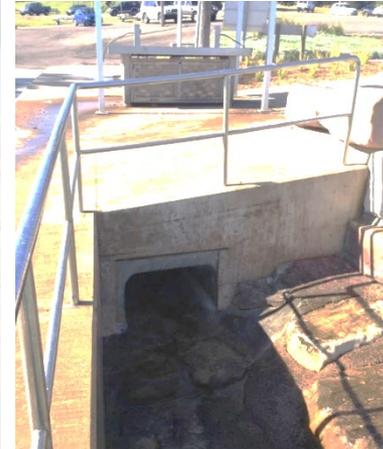
Investigation methods

Currently sampling:

- Pipe outlets and at the beach
- Controls (neighbouring beaches Forresters and Avoca/North Avoca)
- Catchment sampling in stormwater pipes

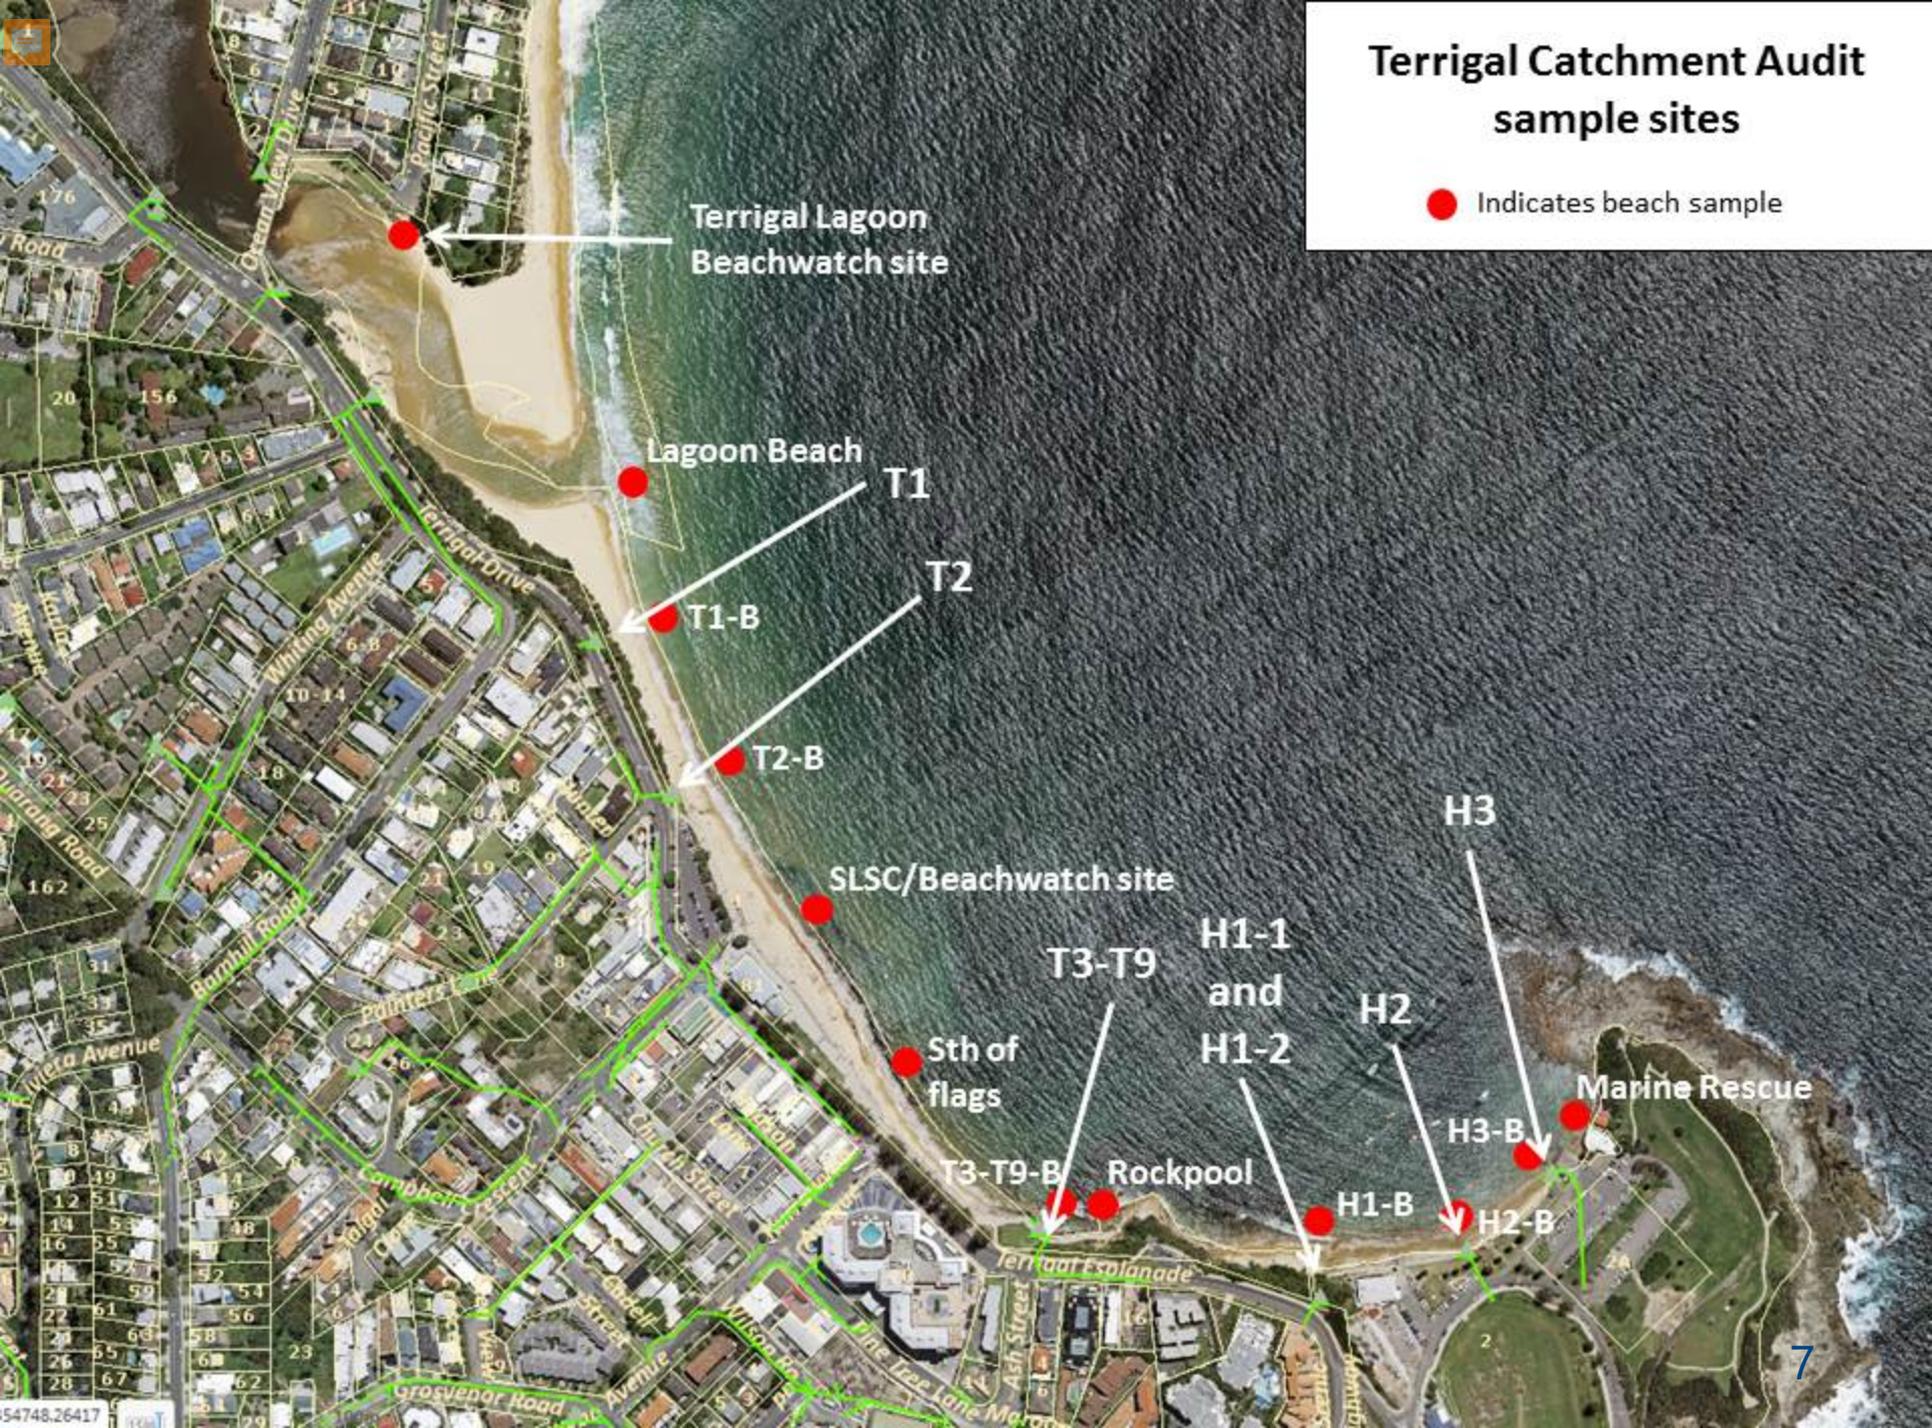
Terrigal Catchment Audit sample sites

● Indicates beach sample

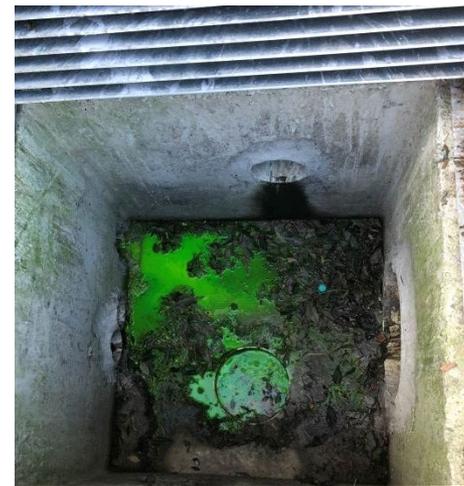
Using dye to assess connections within the catchment

Dye tests - Ensuring unmapped connections are only stormwater

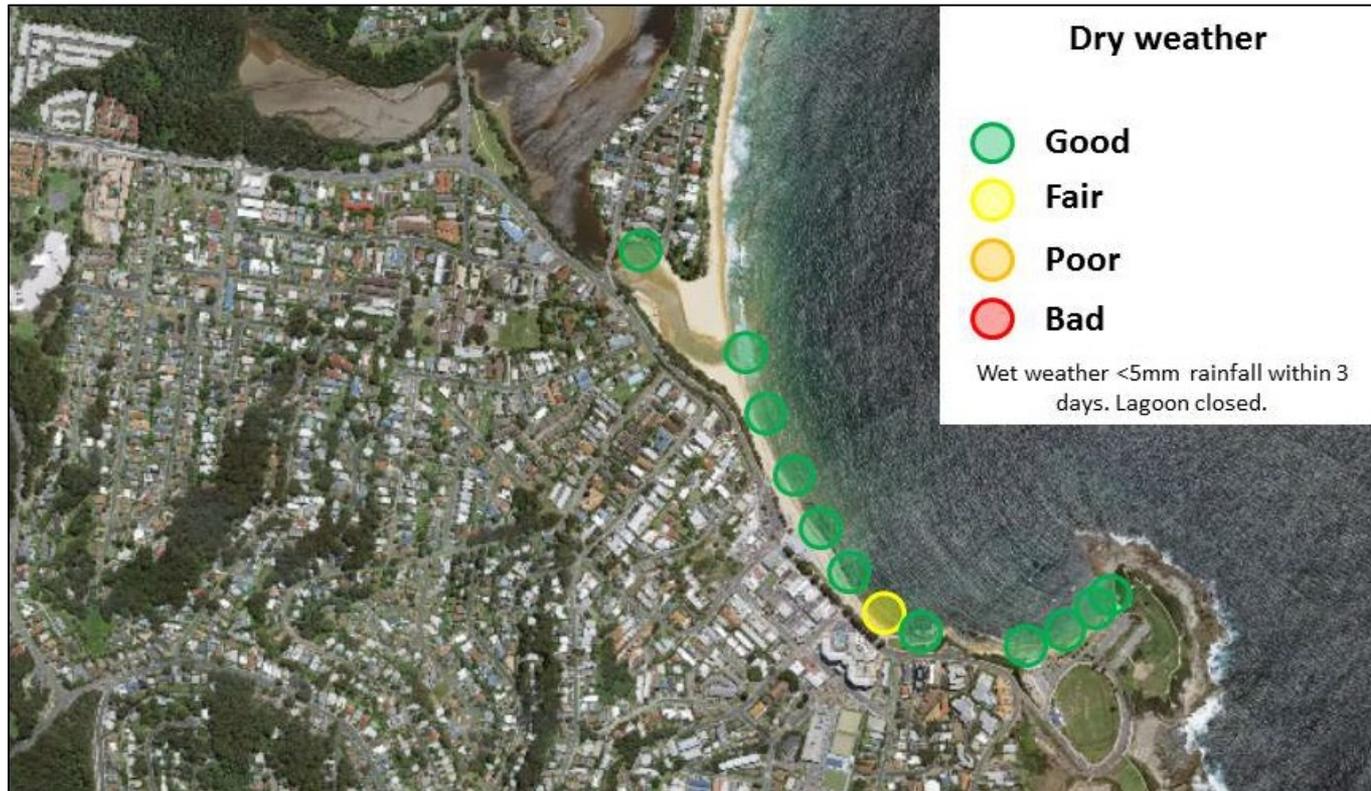
Figure 11: Average water quality

Report map - dry weather

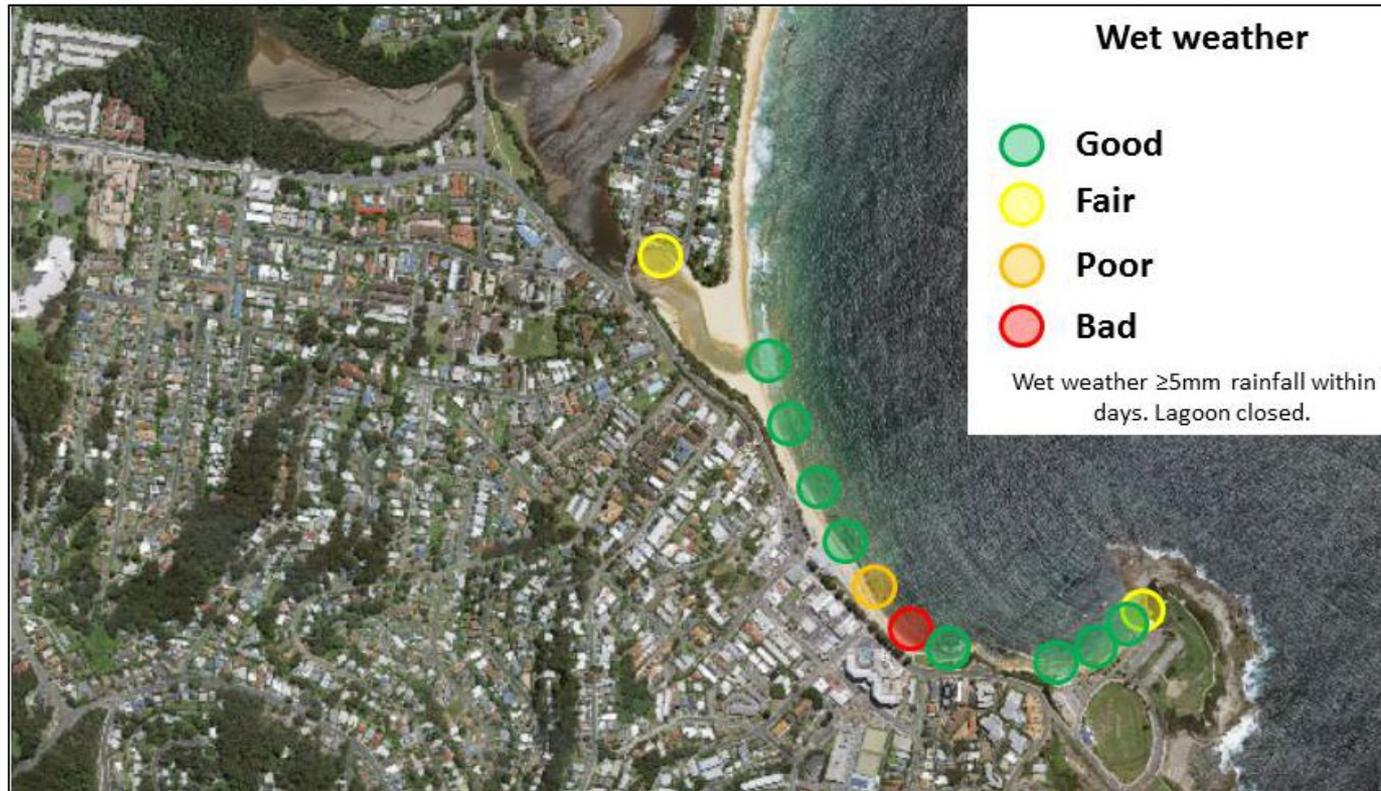
Figure 12: Average water quality

Report map - wet weather

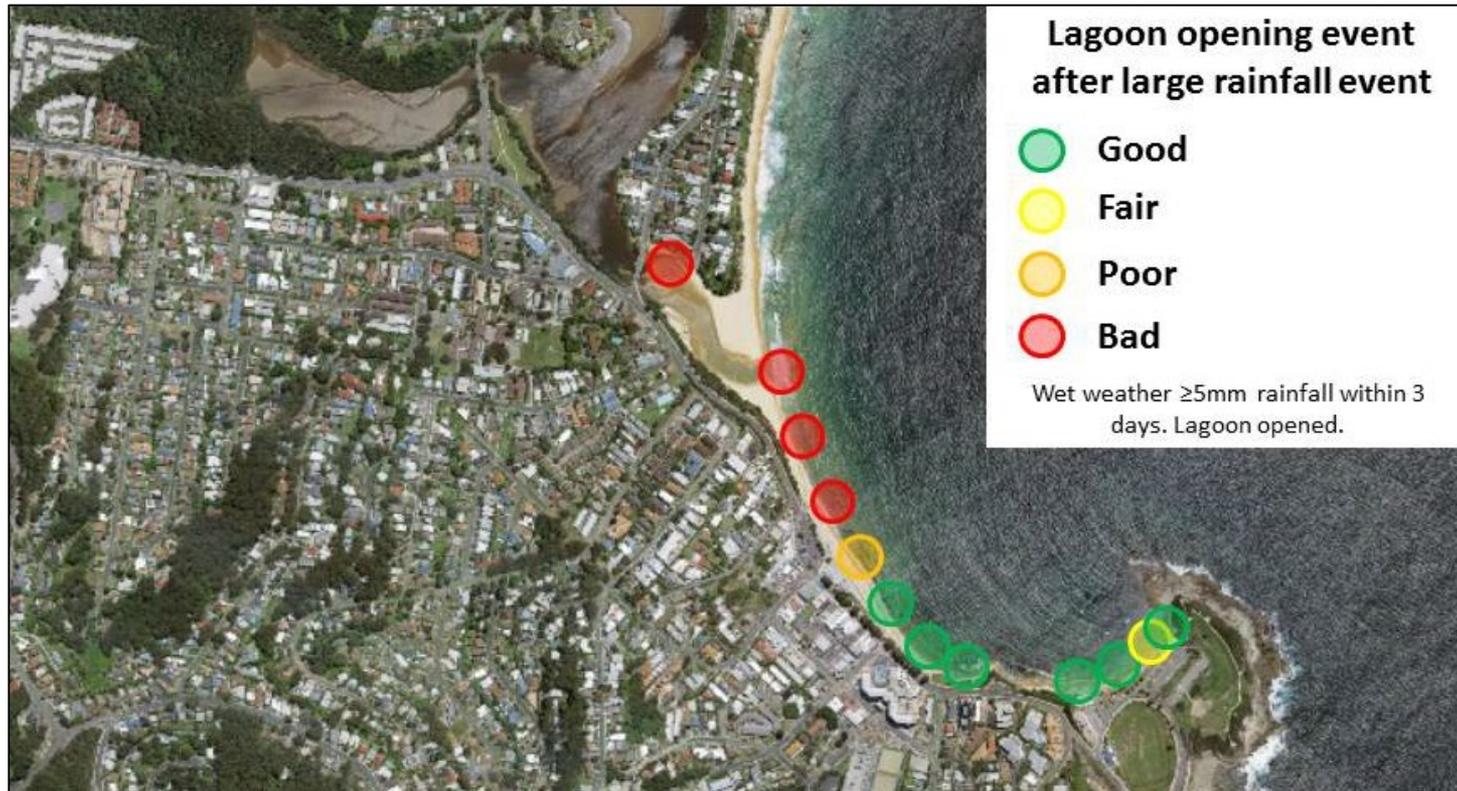
Figure 14: Water quality (single day sample 3/4/2019).

Report map - lagoon opened

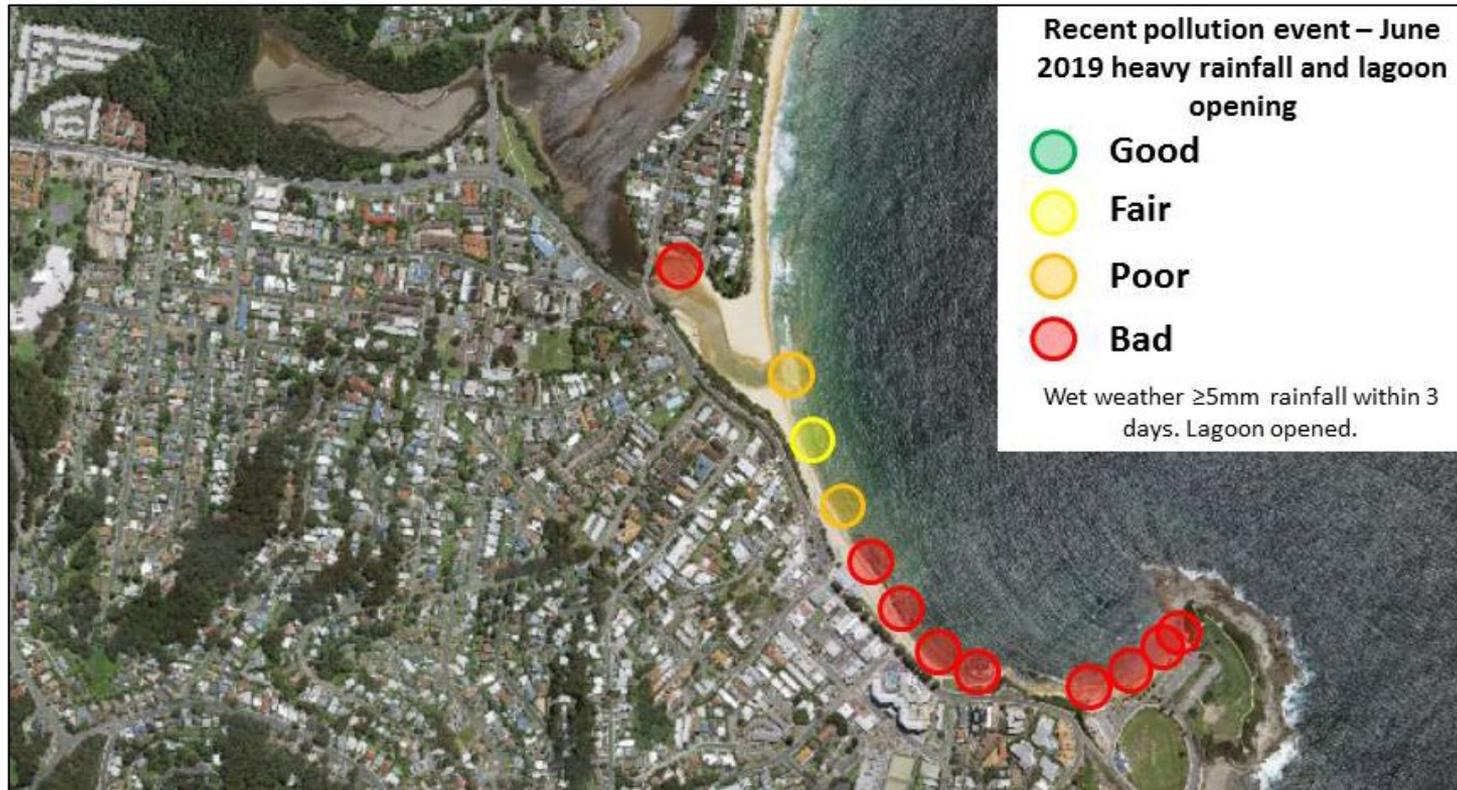
Figure 15: Water quality after large rainfall event and lagoon opening (single day sample 24 June 2019).

Report map – Extreme rainfall event June 2019

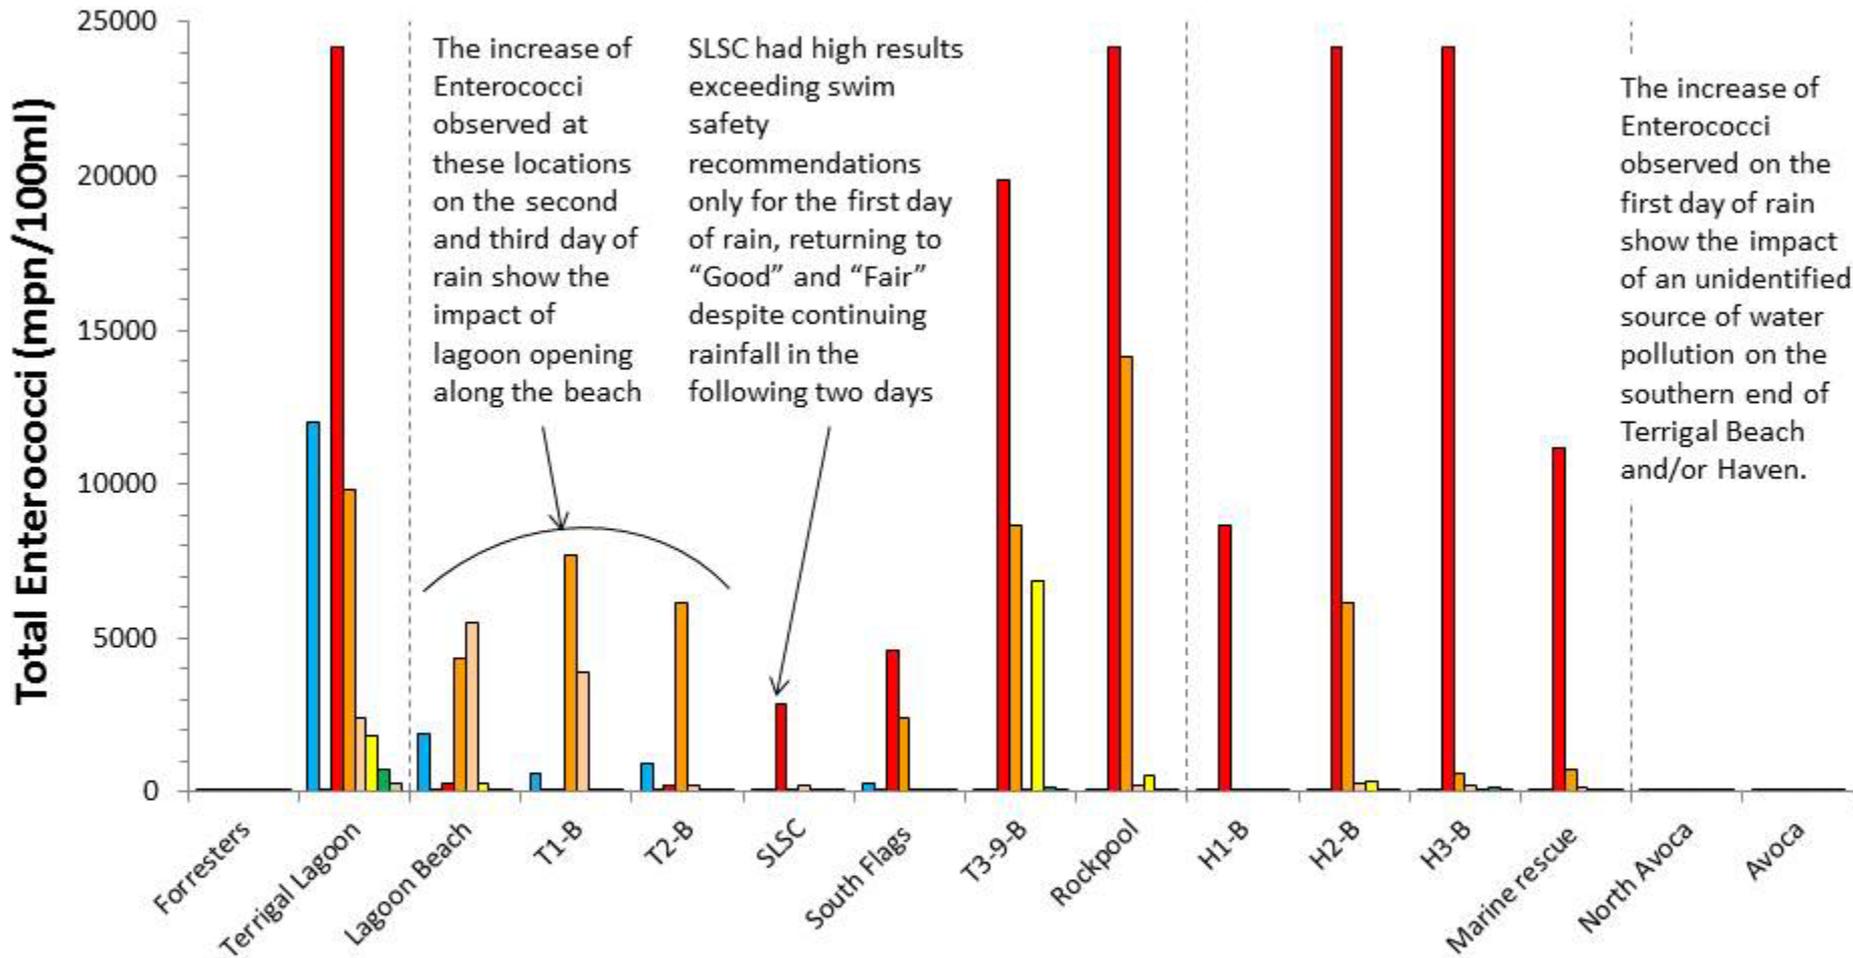
Extreme rainfall event June 2019

The increase of Enterococci observed at these locations on the second and third day of rain show the impact of lagoon opening along the beach

SLSC had high results exceeding swim safety recommendations only for the first day of rain, returning to "Good" and "Fair" despite continuing rainfall in the following two days

The increase of Enterococci observed on the first day of rain show the impact of an unidentified source of water pollution on the southern end of Terrigal Beach and/or Haven.

Rainfall
24th 59.5mm
25th 18mm
26th 25.5mm
27th 2.5mm
28th 0mm

Lagoon opened by the 25th June

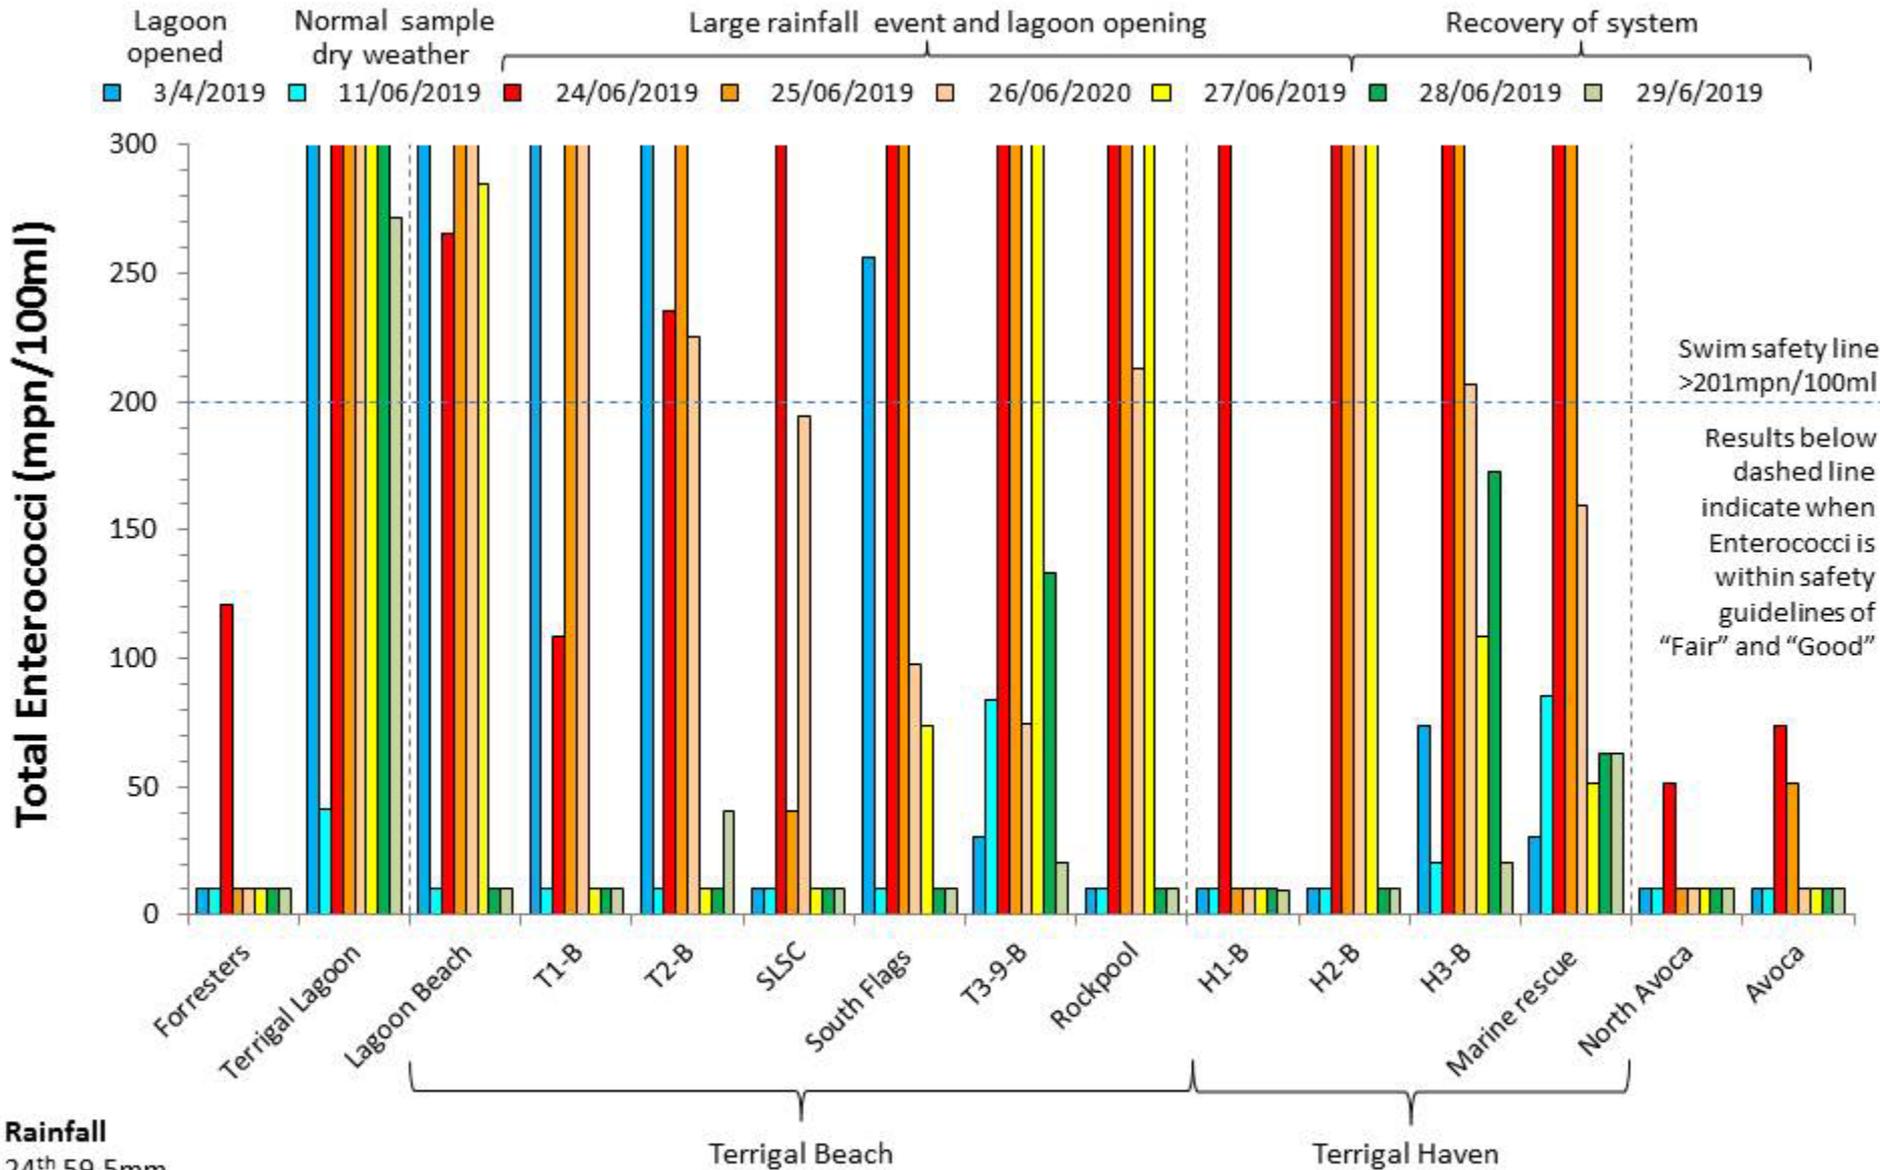
Extreme rainfall event June 2019

Rainfall
 24th 59.5mm
 25th 18mm
 26th 25.5mm
 27th 2.5mm
 28th 0mm

Lagoon opened by the 25th June

Results in green for the 28th June indicate that Enterococci results were below 201mpn/100ml at ocean locations.

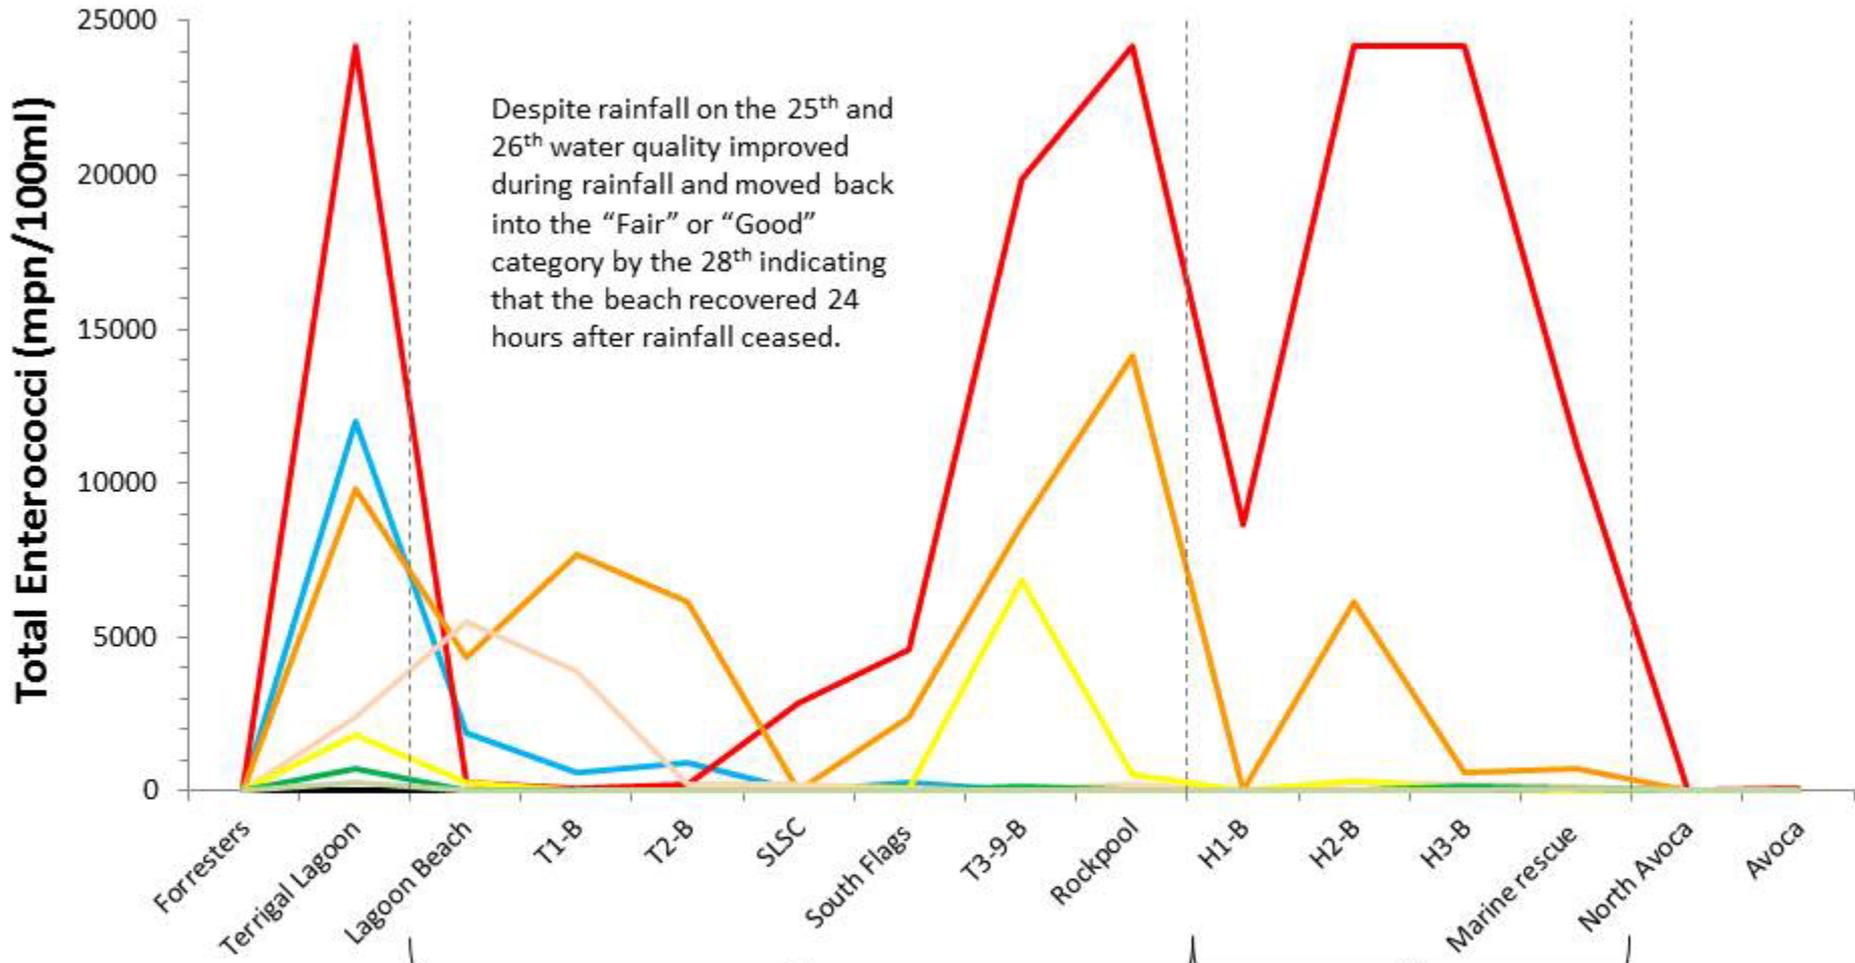
Extreme rainfall event June 2019

Lagoon opened opened Normal sample dry weather Large rainfall event and lagoon opening Recovery of system

Rainfall
 24th 59.5mm
 25th 18mm
 26th 25.5mm
 27th 2.5mm
 28th 0mm

Lagoon opened by the 25th June

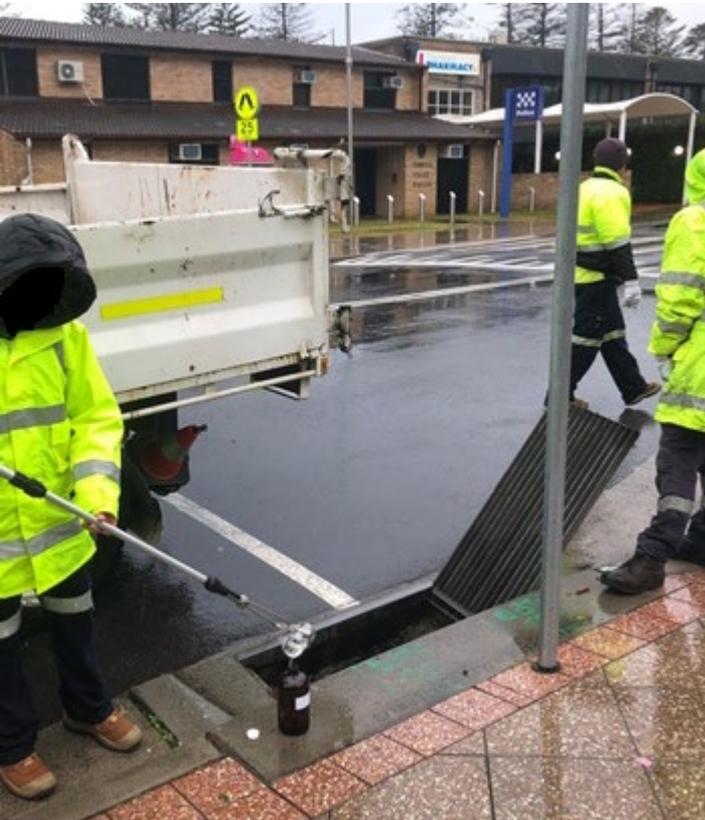
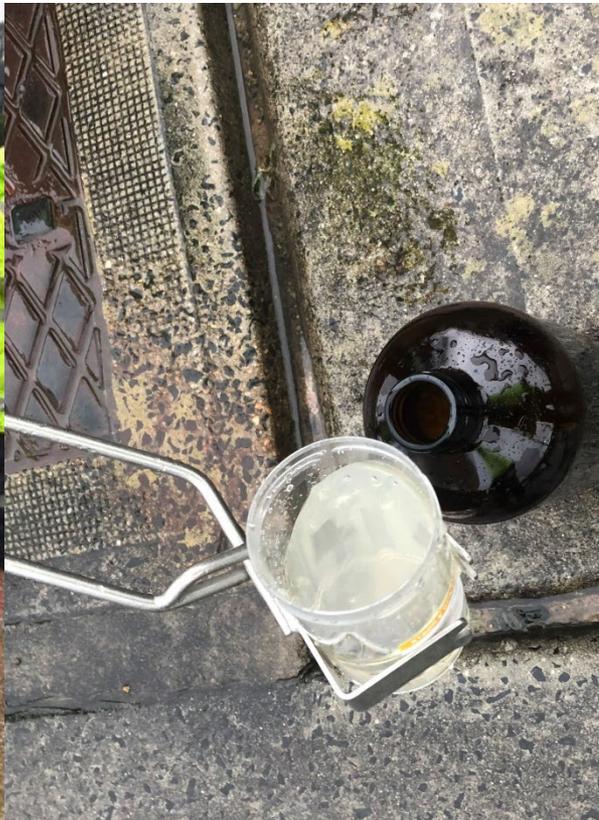
Sampling sub-catchments in wet weather

Wet weather sampling

Sampling throughout the catchment in wet weather targeting sub catchments to track down pollution sources

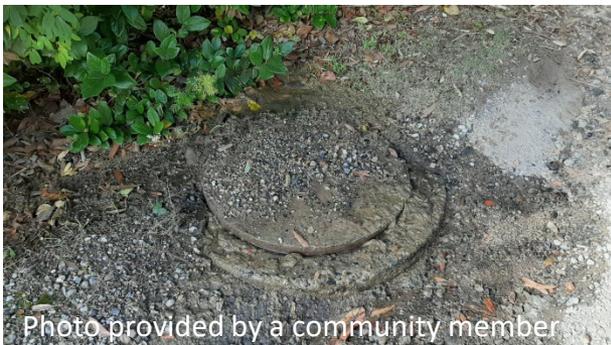
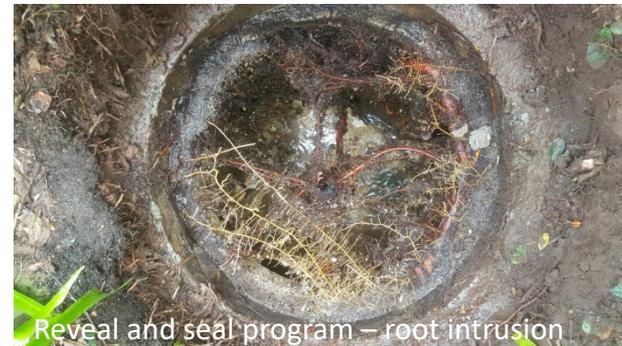
- Cracked and disjointed sewer pipes are common issues for infrastructure management internationally
- Cracked or disjointed sewer pipes may leak sewage into groundwater and contaminate stormwater either directly or via subsurface drainage
- Council has ongoing sewer network programs, and the Terrigal Catchment Audit has brought more focus on inspections for Terrigal, including:
 - Pump station monitoring
 - Ongoing CCTV to assess cracked or disjointed infrastructure
 - The 'Reveal and Seal' program which inspects manholes for tree root intrusion or other issues
- The report identified 14 cracked and disjointed pipes www.centralcoast.nsw.gov.au/terriganwaterquality
- These pipes need to be fixed but we cant definitively say they are a contributing factor (no way to assess if they are a cause of poor water quality) – continued monitoring needed on long-term trends

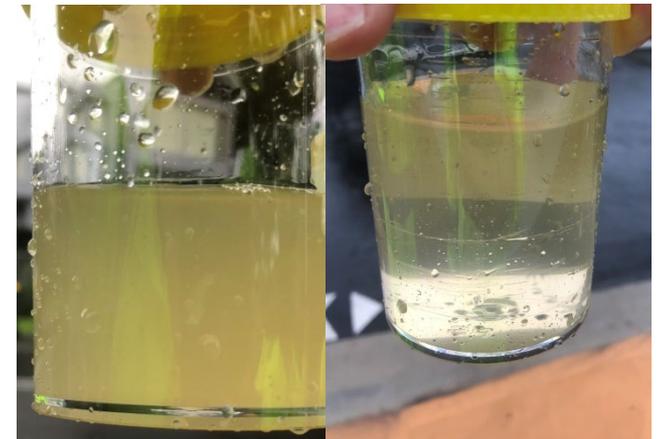
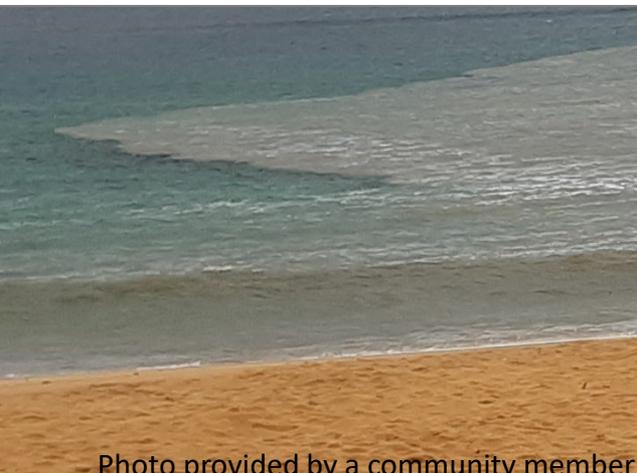
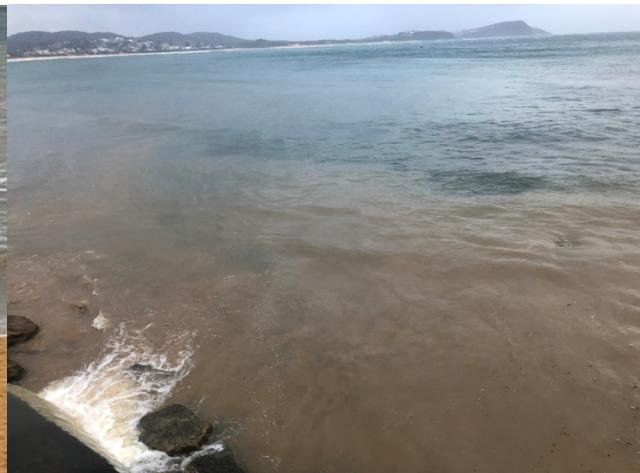
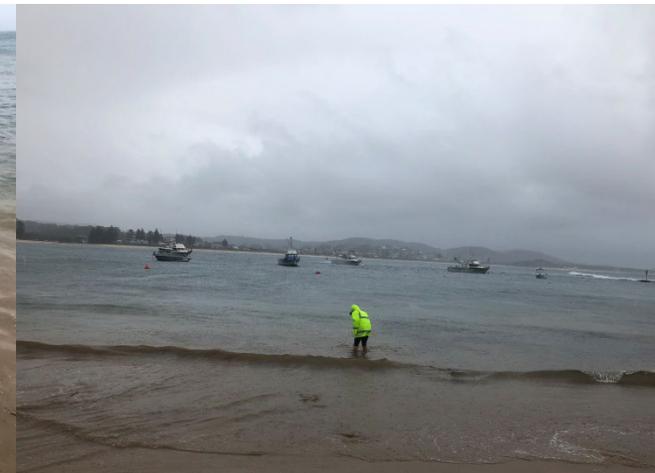
Turbidity

- Wet weather sediment plume
- Catchment stormwater turbidity being monitored throughout wet weather sampling
- CCTV camera work may help to identify sediment in stormwater infrastructure

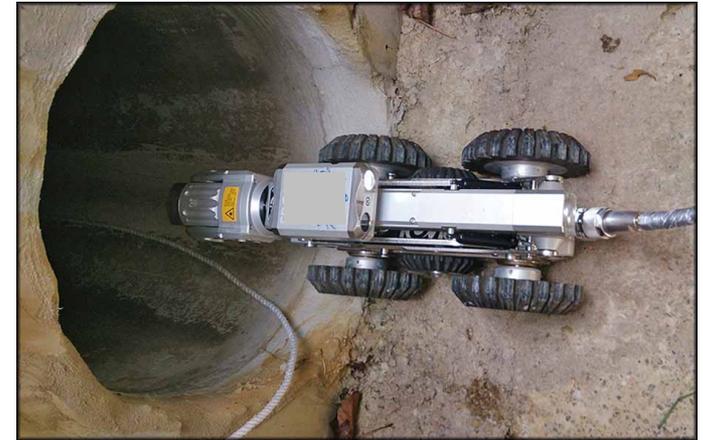
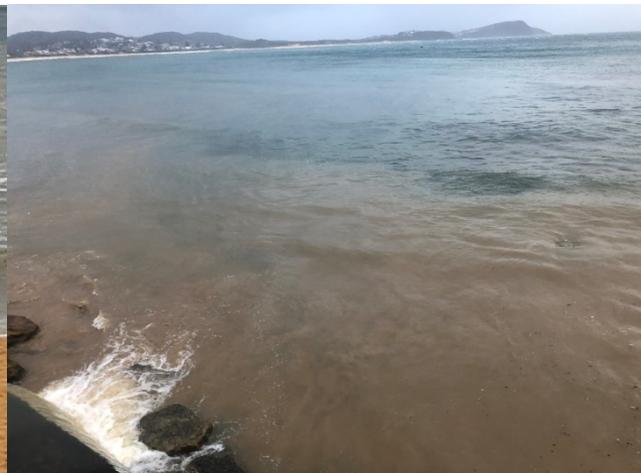
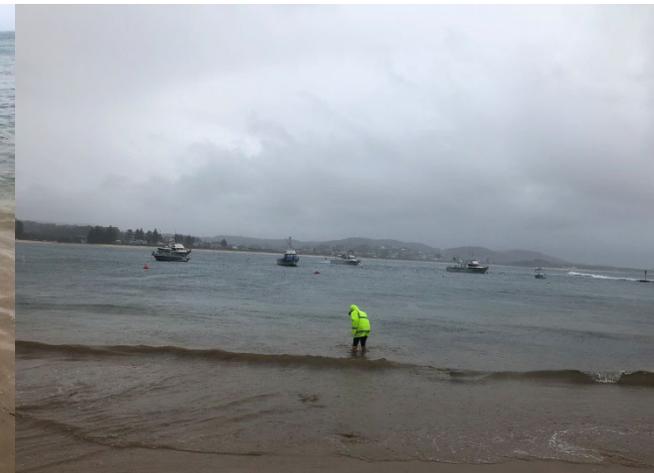
DPIE and CCC sampling sediment

(A measure of water clarity or cloudiness)

- Wet weather sediment plume
- Catchment stormwater turbidity being monitored throughout wet weather sampling
- CCTV camera work may help to identify sediment in stormwater infrastructure

- Ocean turbidity
- Sediment as a reservoir for bacteria?
- Sediment size
- Metals, pesticides/herbicides, micro plastics and organics
