# Conceptual Design of MacMasters Beach Seawall - Coastal Processes, Design Conditions and Design Concepts

Authors:	David Wainwright
Prepared For	Central Coast Council
Version	REVISED FINAL
Date	27/03/2017

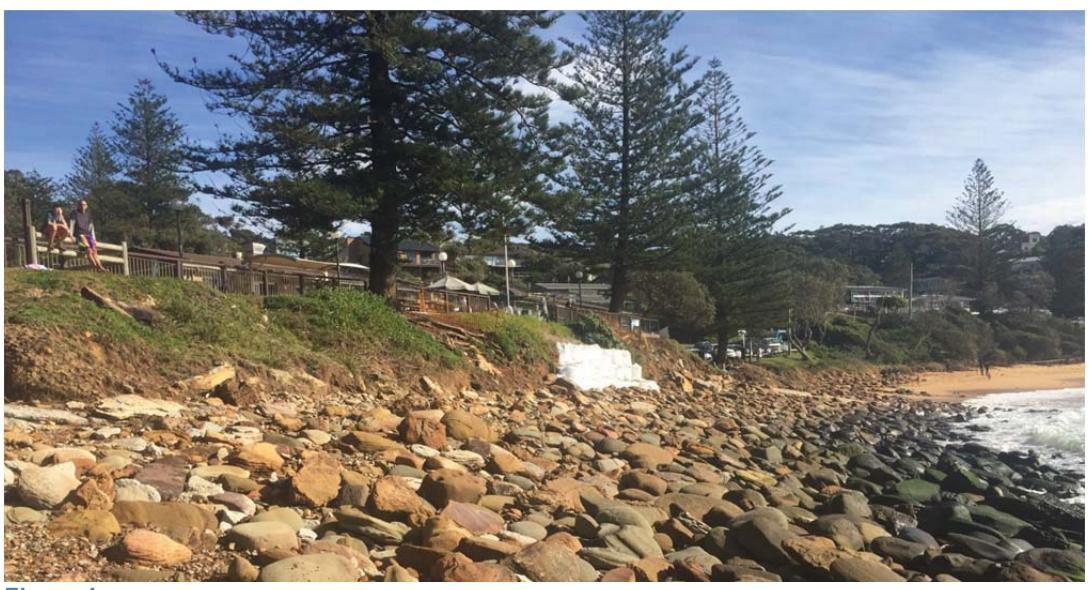
Figure 1

Following the coastal storm events of June 2016, ongoing erosion at the southern end of Macmasters Beach threatens the stability of the foreshore adjacent to the Macmasters Beach surf club. Temporary and unofficial works were undertaken in the attempt to stabilise a section of the earth batter directly in front of the clubhouse (Figure 1).

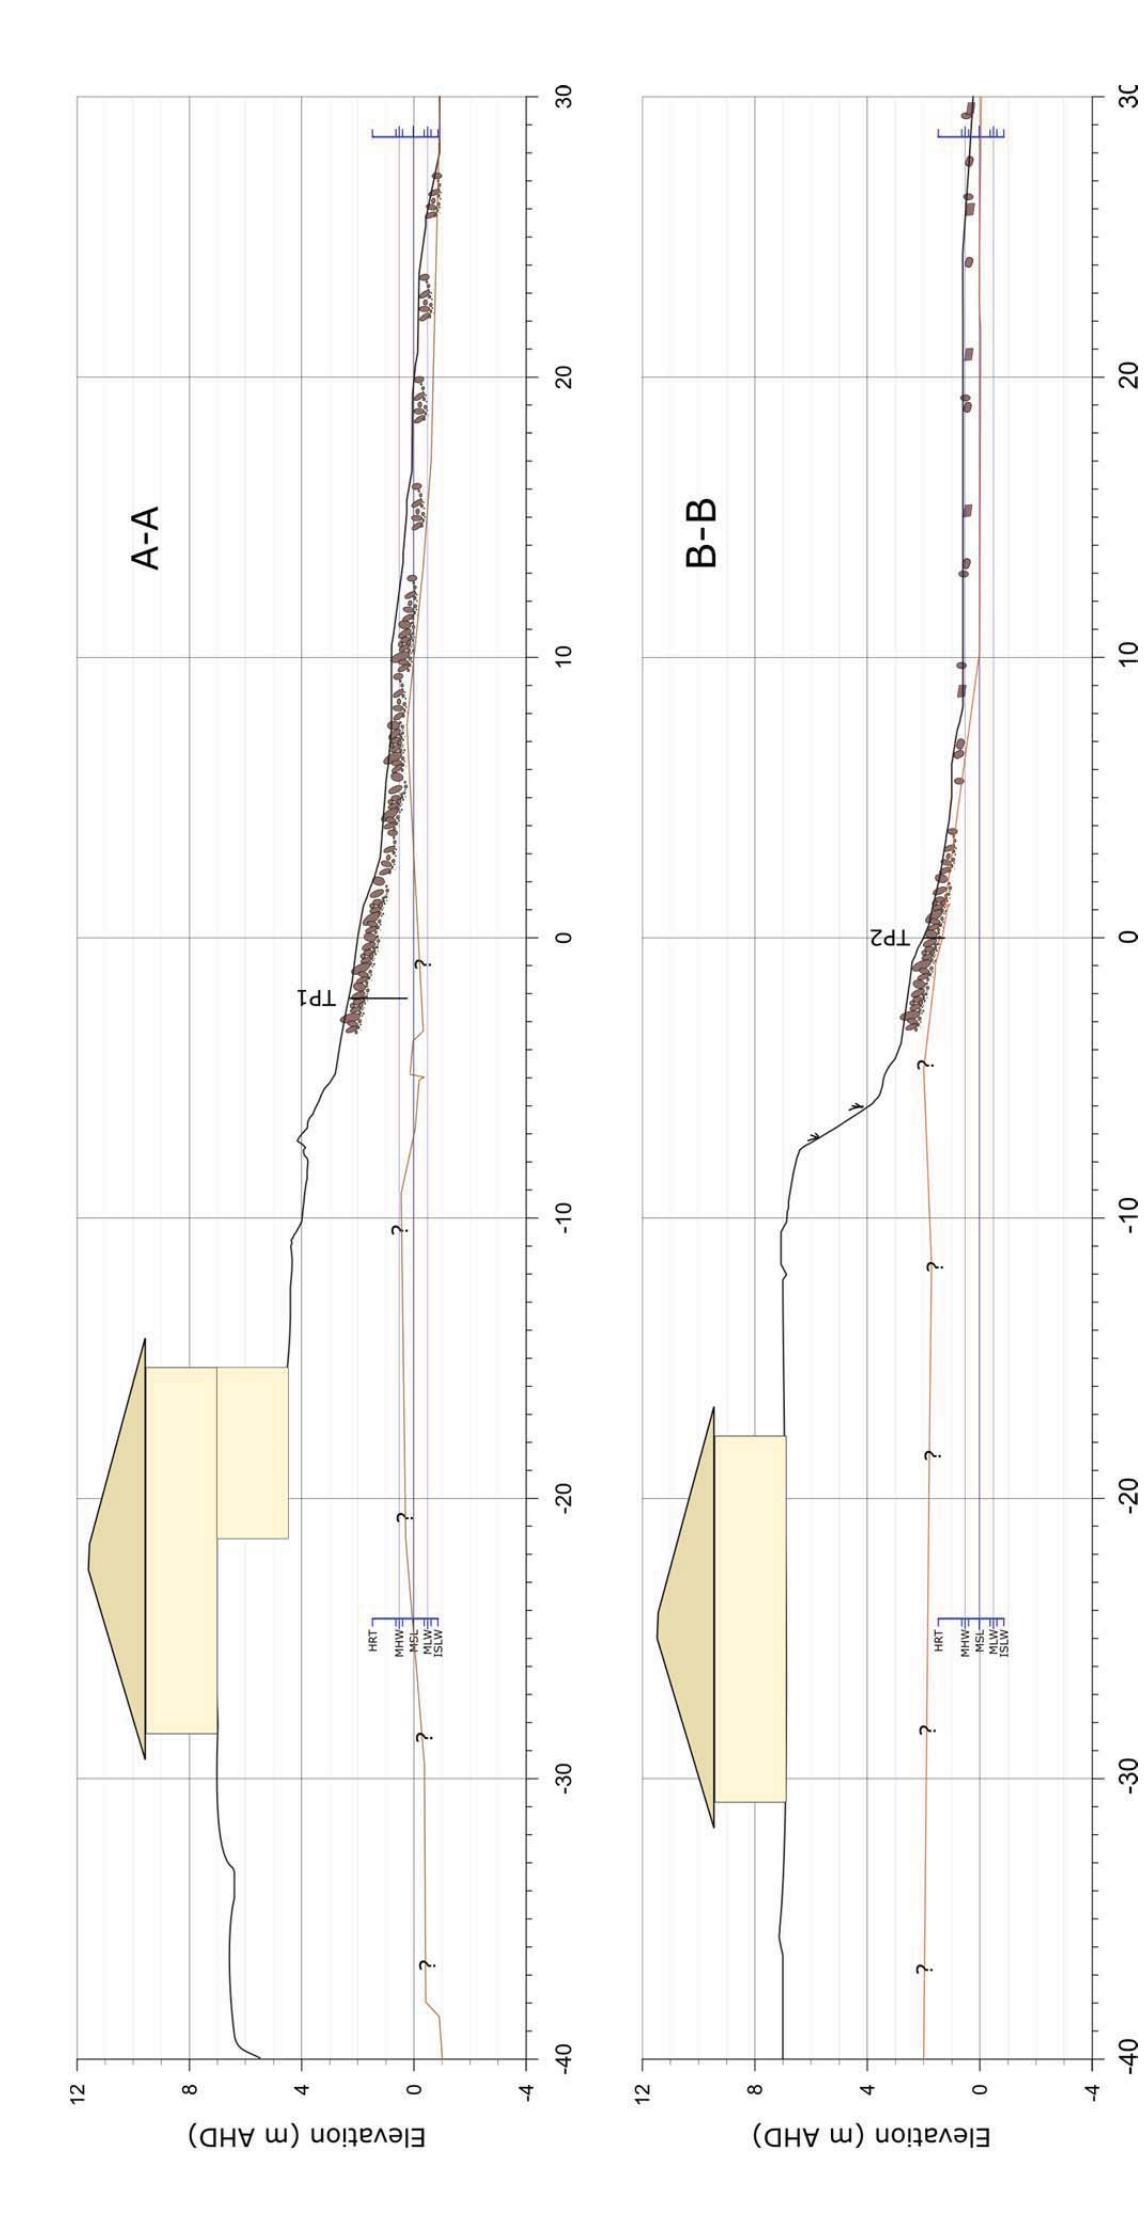
Figure 10 - Cross Sections A-A and B-B

Cross sections, at the locations shown on Figure 4, were prepared with reference to the site investigations observations, and using contour data provided by Salients. These cross sections are shown in Figures 10 and 11.

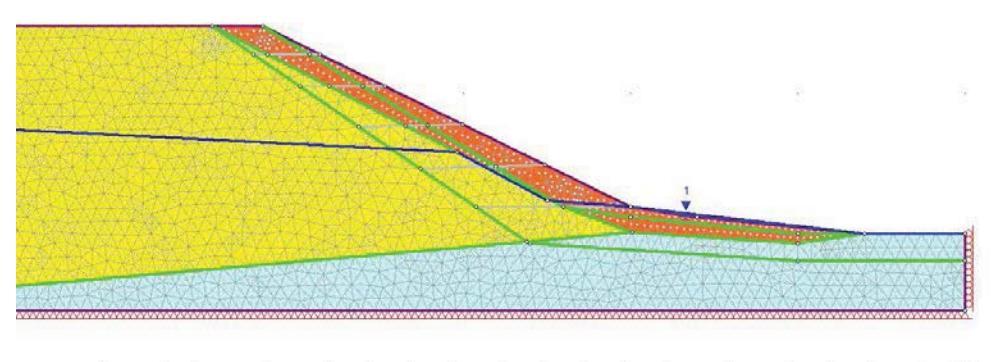
Figure 1: Finite element model

We have concentrated on the length of wall between Ch10m and Ch 35m where the draft design has a face angle of 1(v):1.5(h), and a height of about 5.5m. We have undertaken the analyses using finite element methods whereby the failure surface is not prescribed but is determined by means of stress analysis. We have studied the sensitivity of the computed safety factor to face slope, and assumed internal water pressures. We note that little is known as to the water pressures in the sand fill beneath the surf club under extreme rainfall events when the creek, which was diverted around the building, is in flood conditions for a sustained period of several days. Our finite element model assuming a slope angle of 1(v):2(h) is shown in Figure 1. This model is for what we assume to be a high piezometric level.

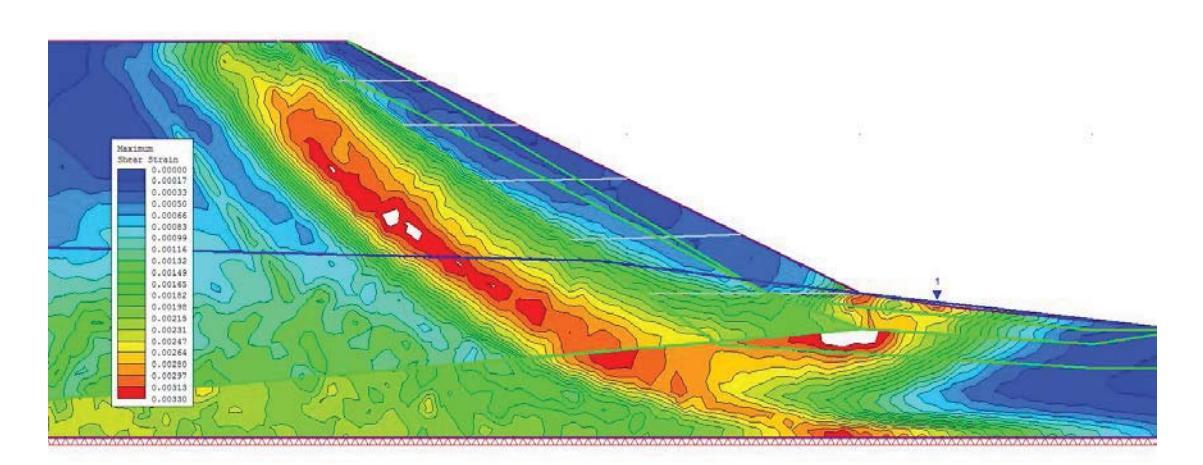
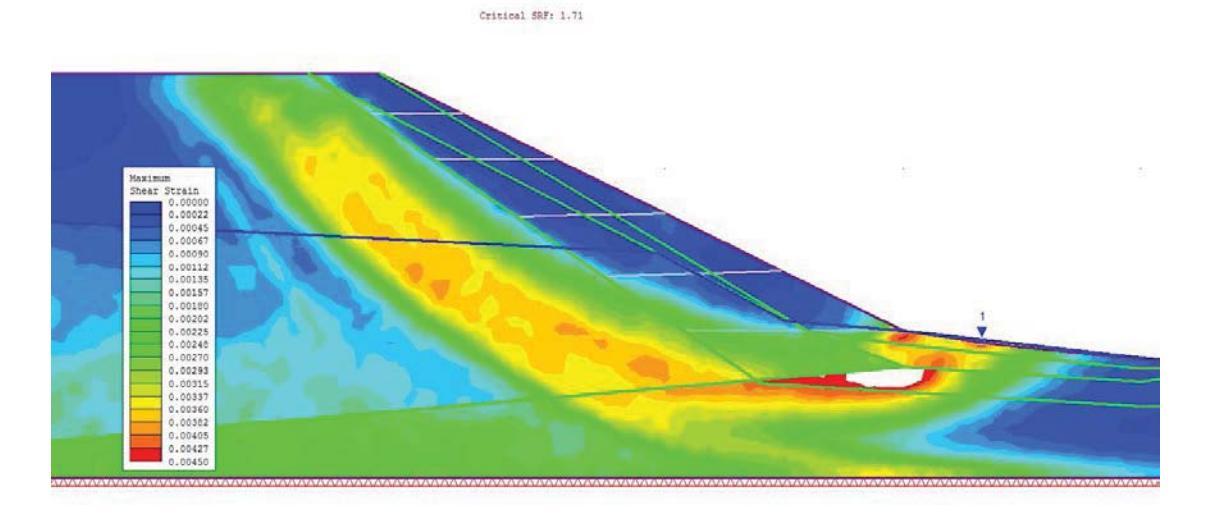
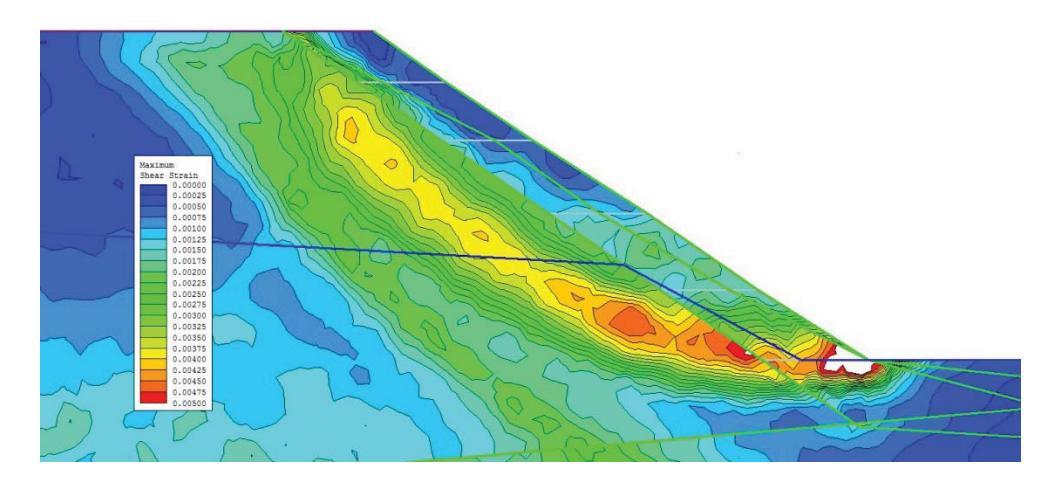
- Slope 1 in 2 low piezometric surface (Fig 2) = 1.9
- Slope 1 in 2 high piezometric surface (Fig 3) = 1.7
- Slope 1 in 1.5 high piezometric surface (Fig 4) = 1.5
- Slope 1 in 1.5 high piezometric surface plus 5kPa surface loading = 1.4
